TWO BOILERS AND A WATER HEATER

CALIFORNIA BOILER INSPECTORS
ASSOCIATION

OCTOBER 16, 2018

GEORGE WHITE, P.E.

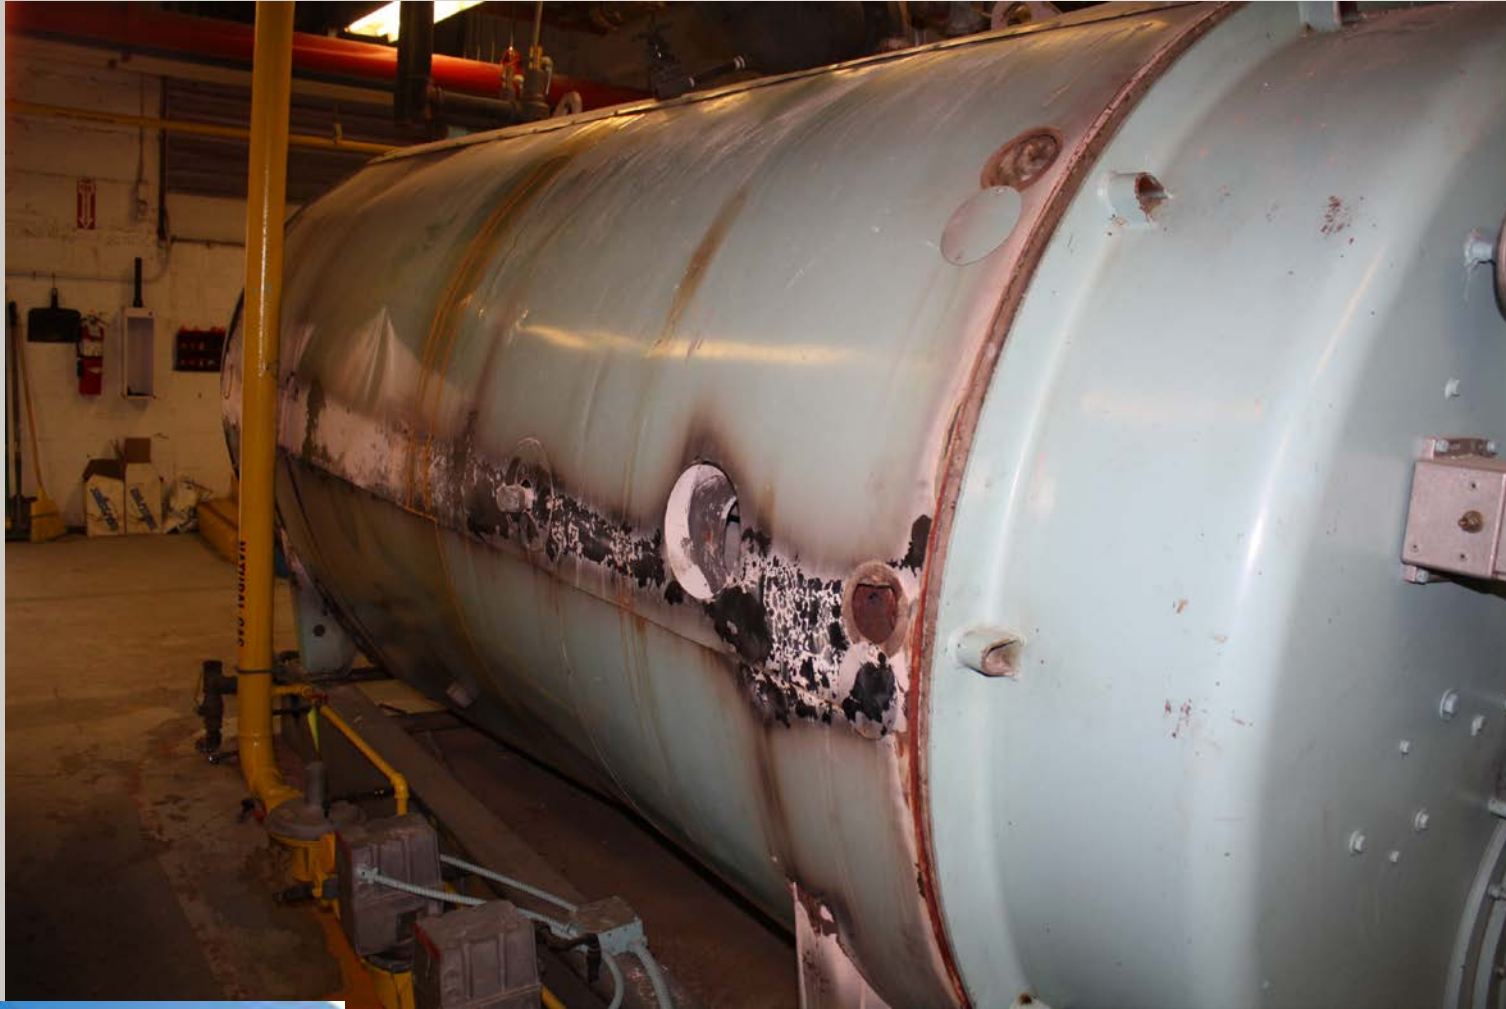
BOTH LOW
WATER CUTOUTS
FAILED –
IMMERSION
SENSOR ON TOP

+

BRAND NEW
MCDONNELL-
MILLER FLOAT
TYPE

- McDonnell-Miller low water cutout was replaced the day before this incident
- Ignoring the instructions, the boiler tech did not test the low water cutout
- The next day, the feedwater pump lost its coupling
- The McDonnell-Miller low water cutout did not shutdown the burner
- The spark-plug type immersion low water cutout also did not shutdown the burner
- Luckily someone saw smoke coming out of the boiler room and luckily, the technician shut down the burner before any water entered the boiler

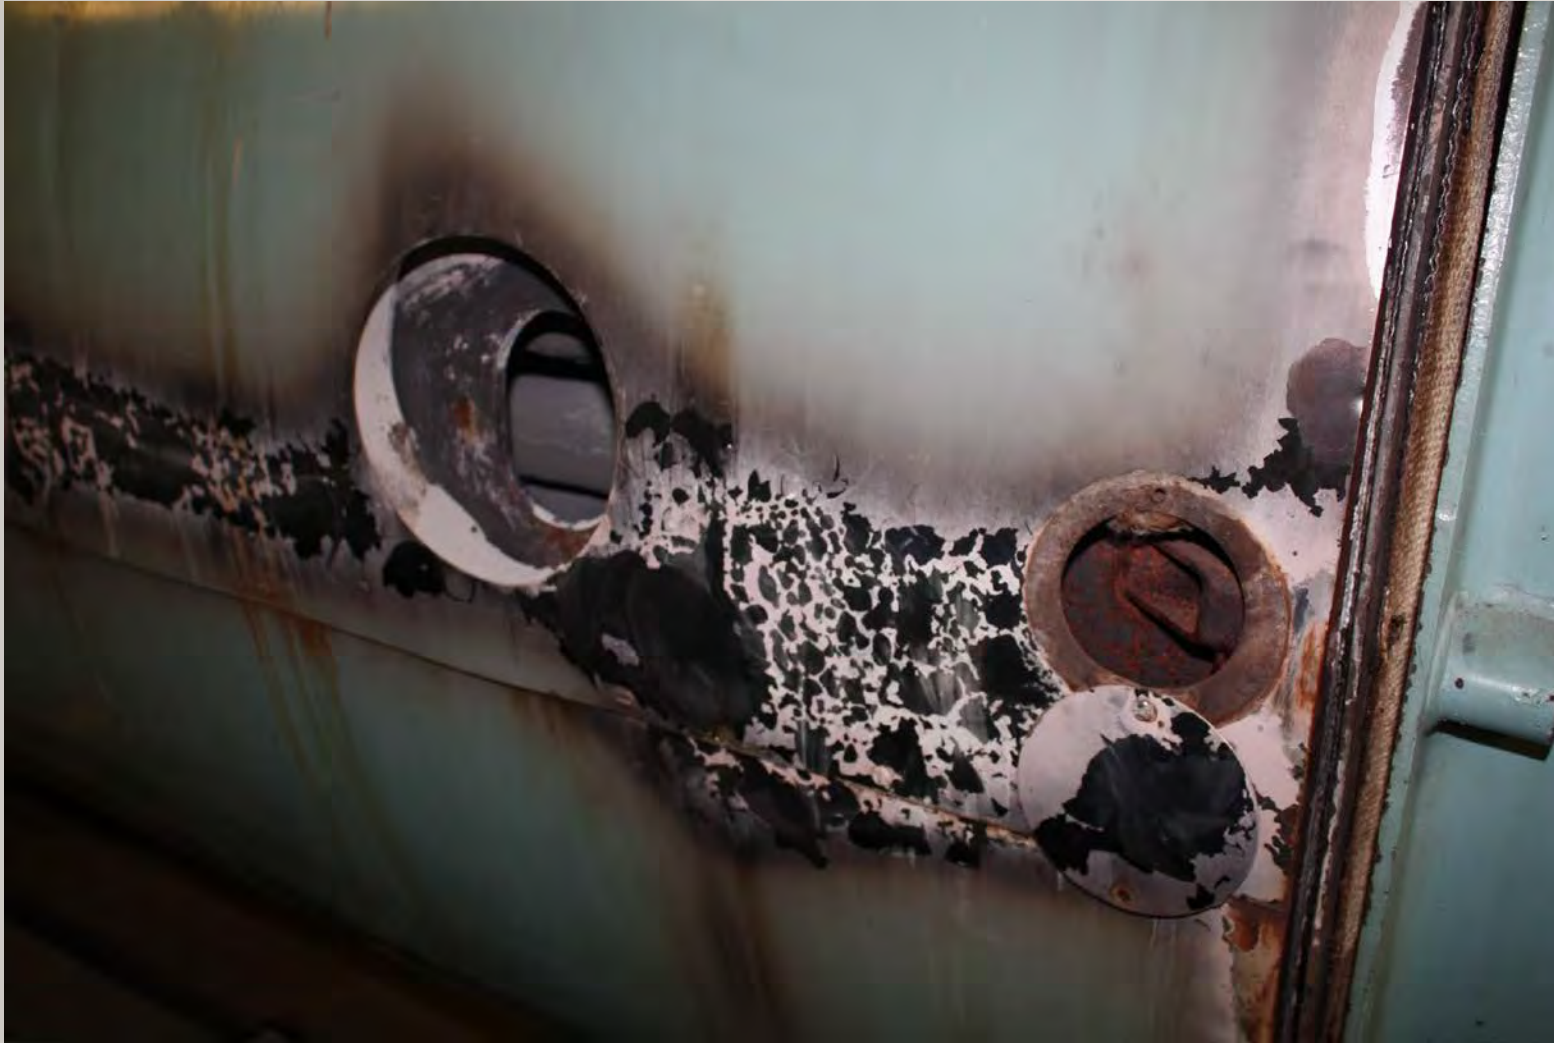
CLOSE-UP OF
DAMAGE TO
EXTERIOR

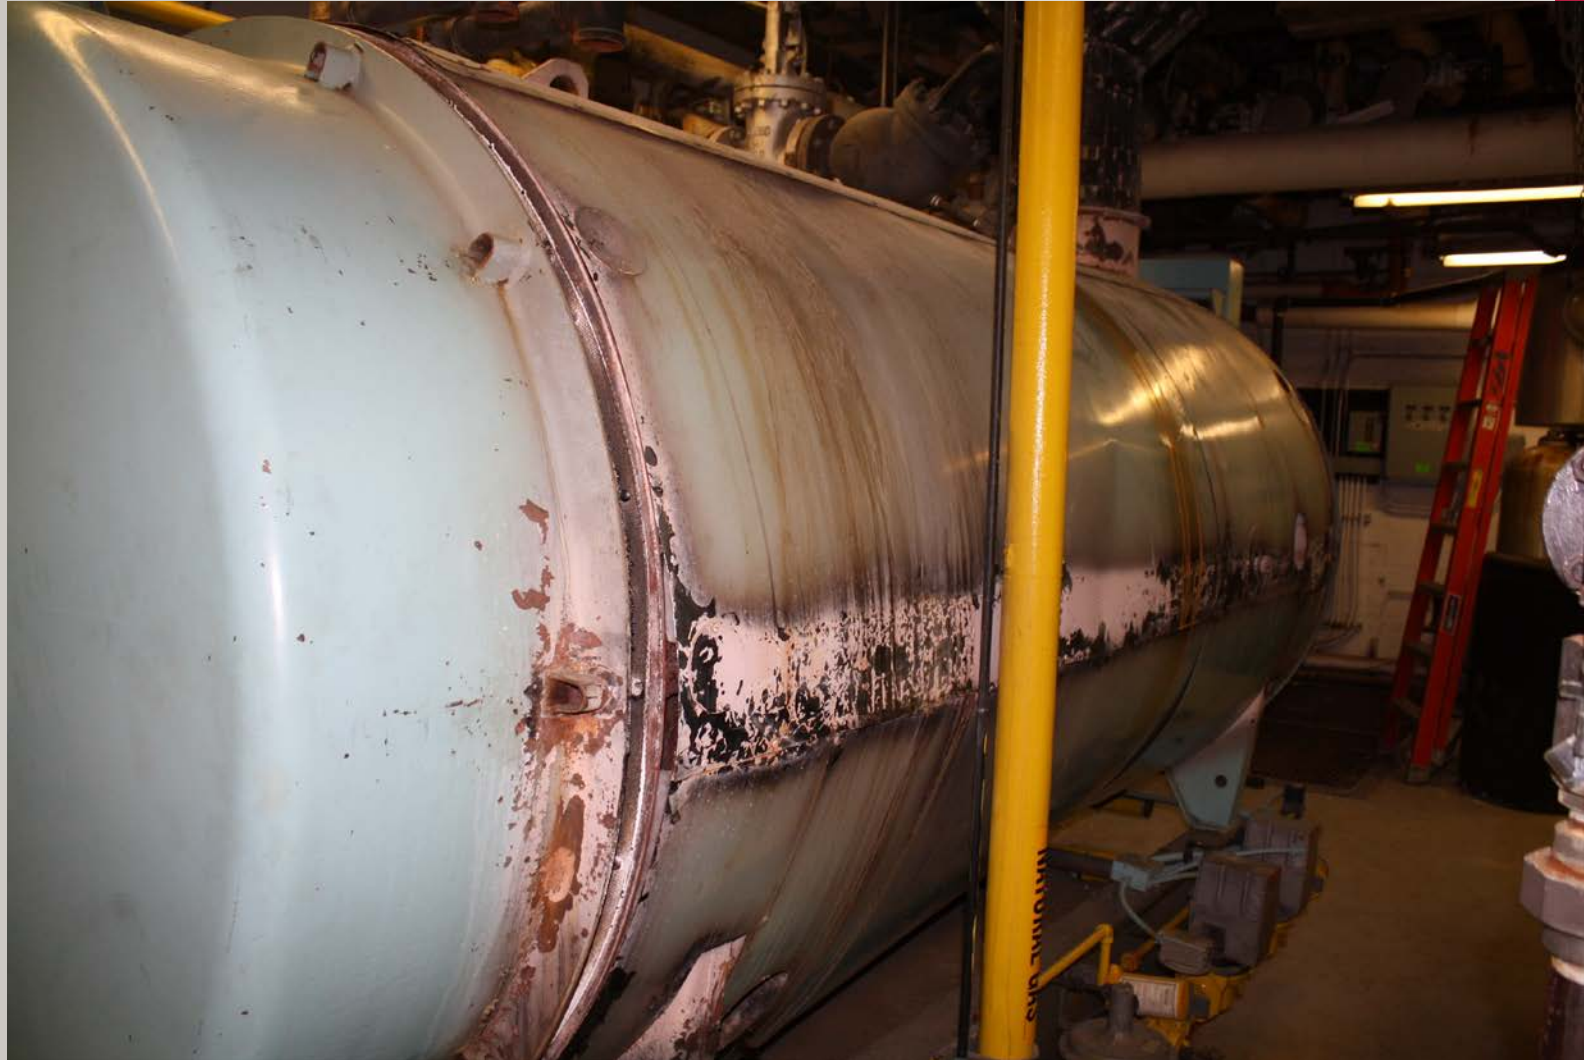
DAMAGE TO
OPPOSITE
SIDE

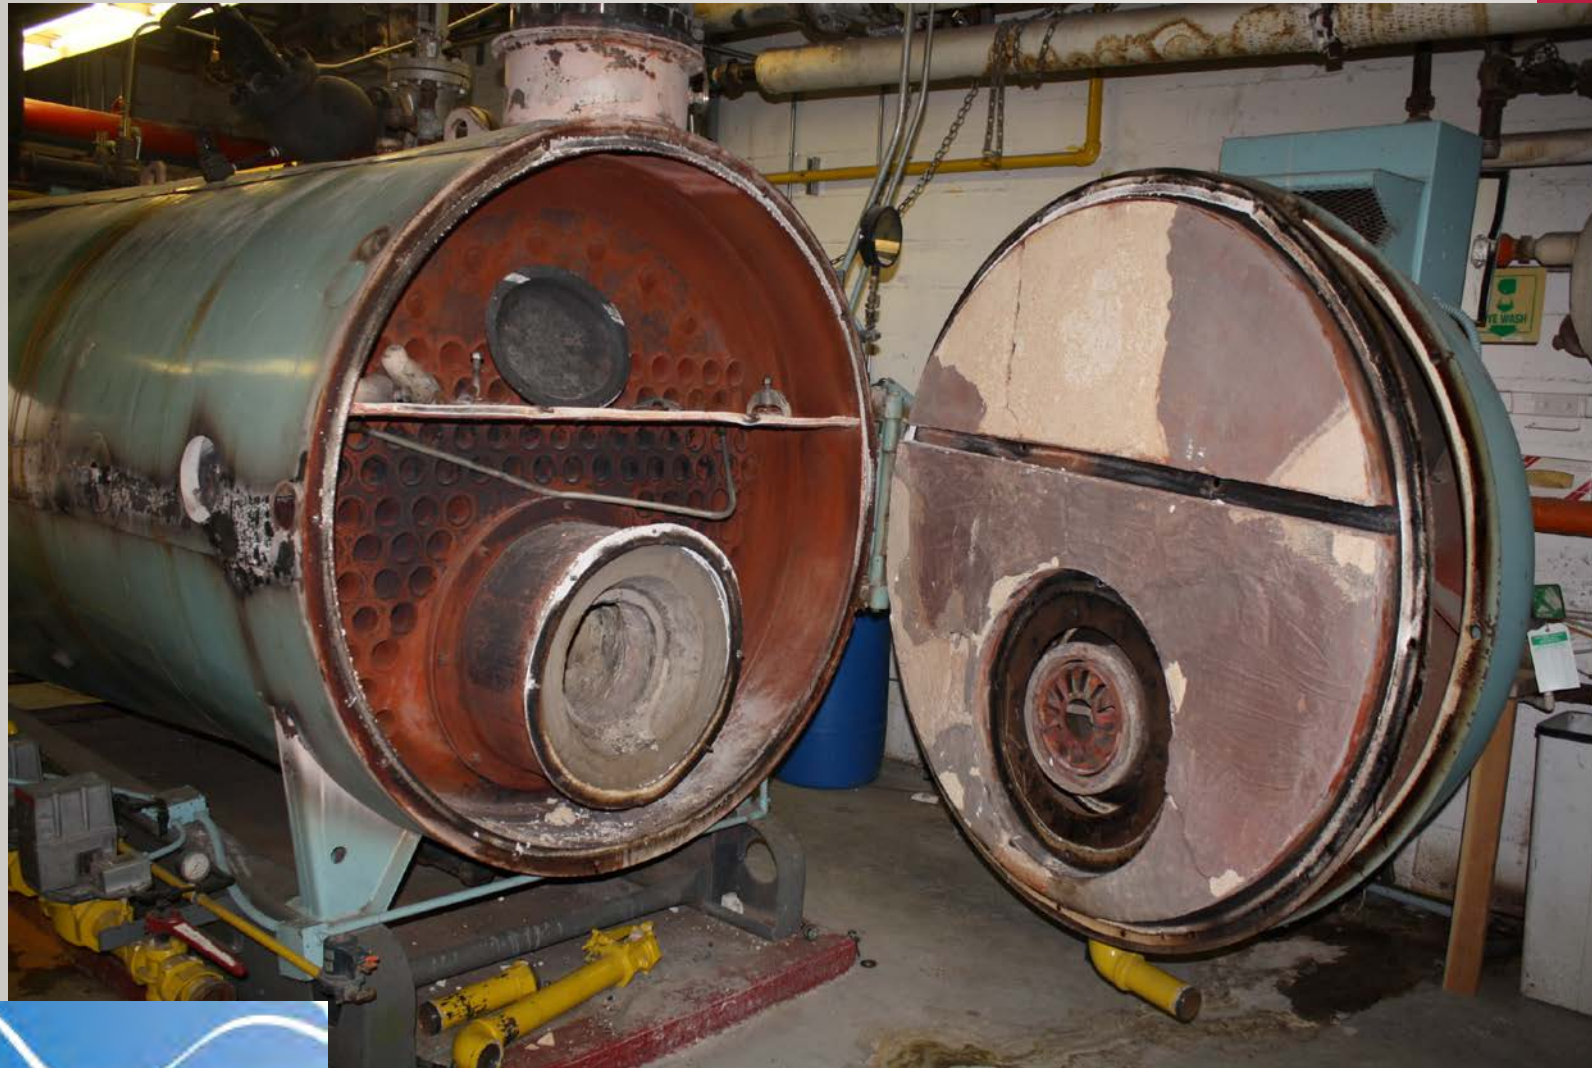
INTERIOR OF BOILER

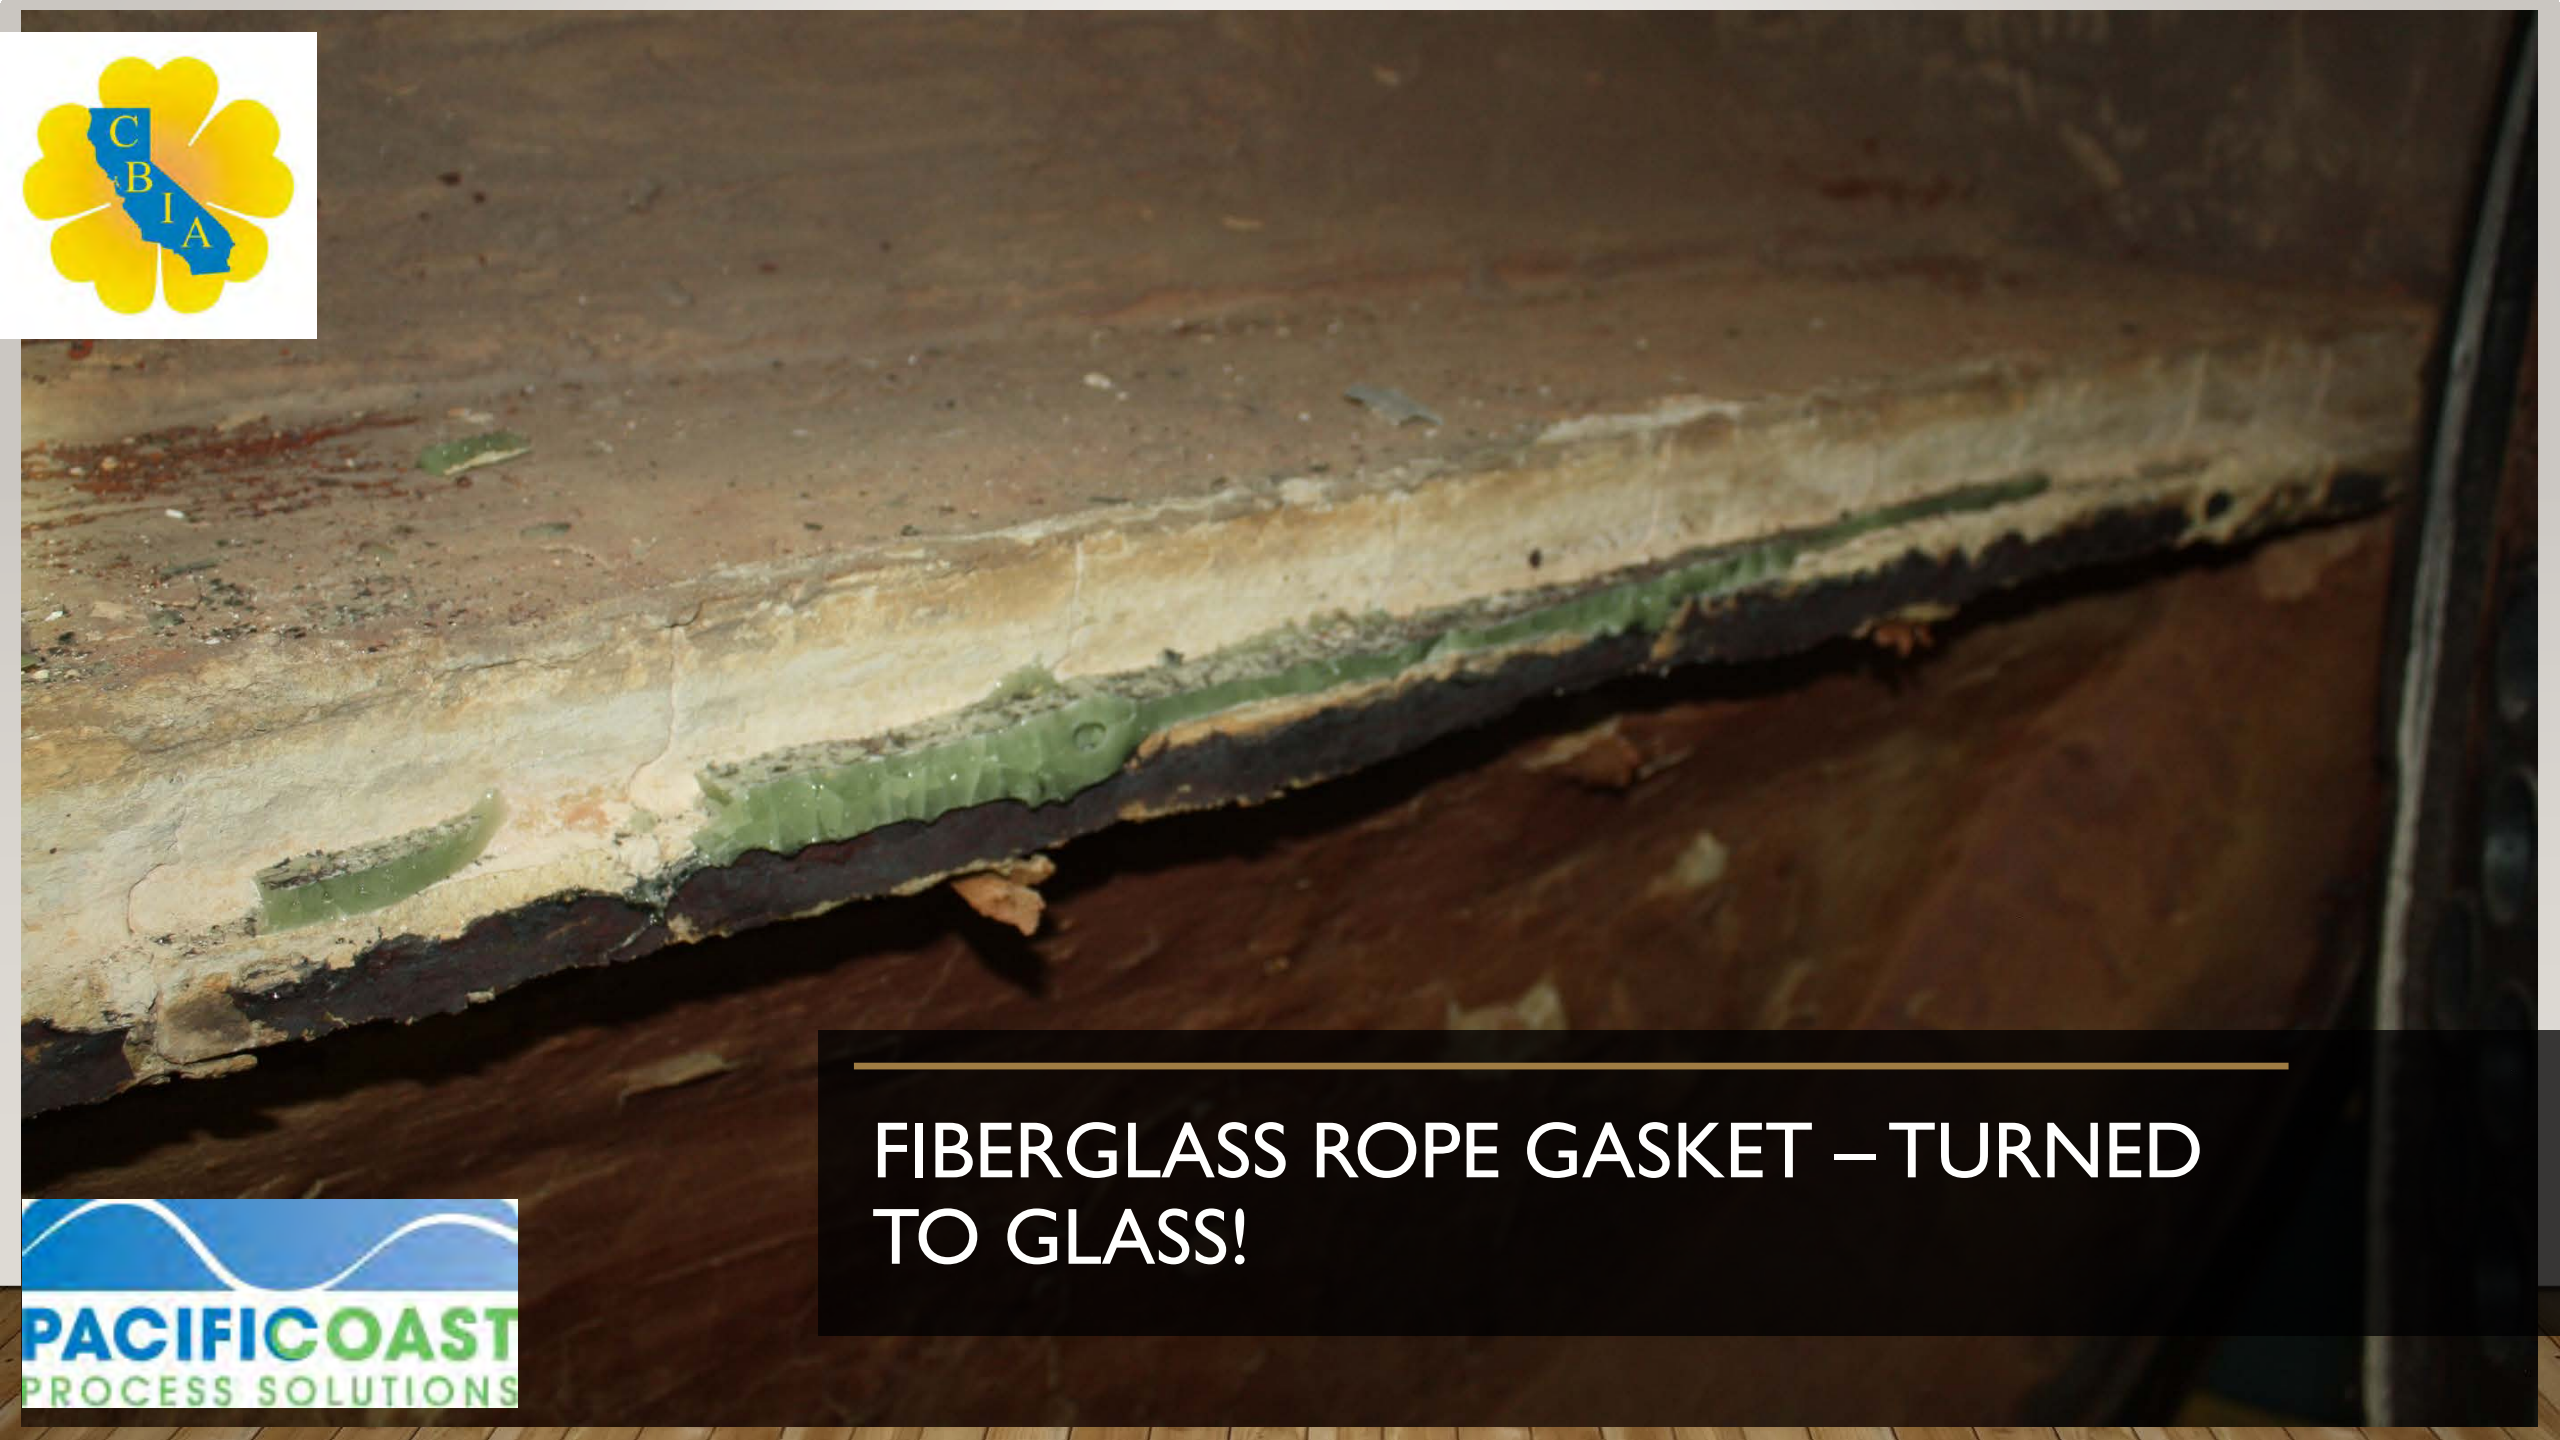
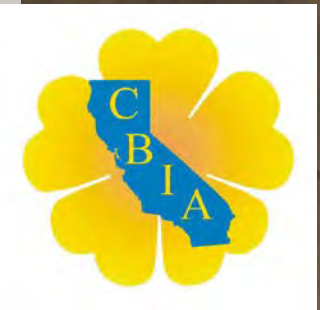
FIBERGLASS ROPE GASKET – TURNED TO GLASS!

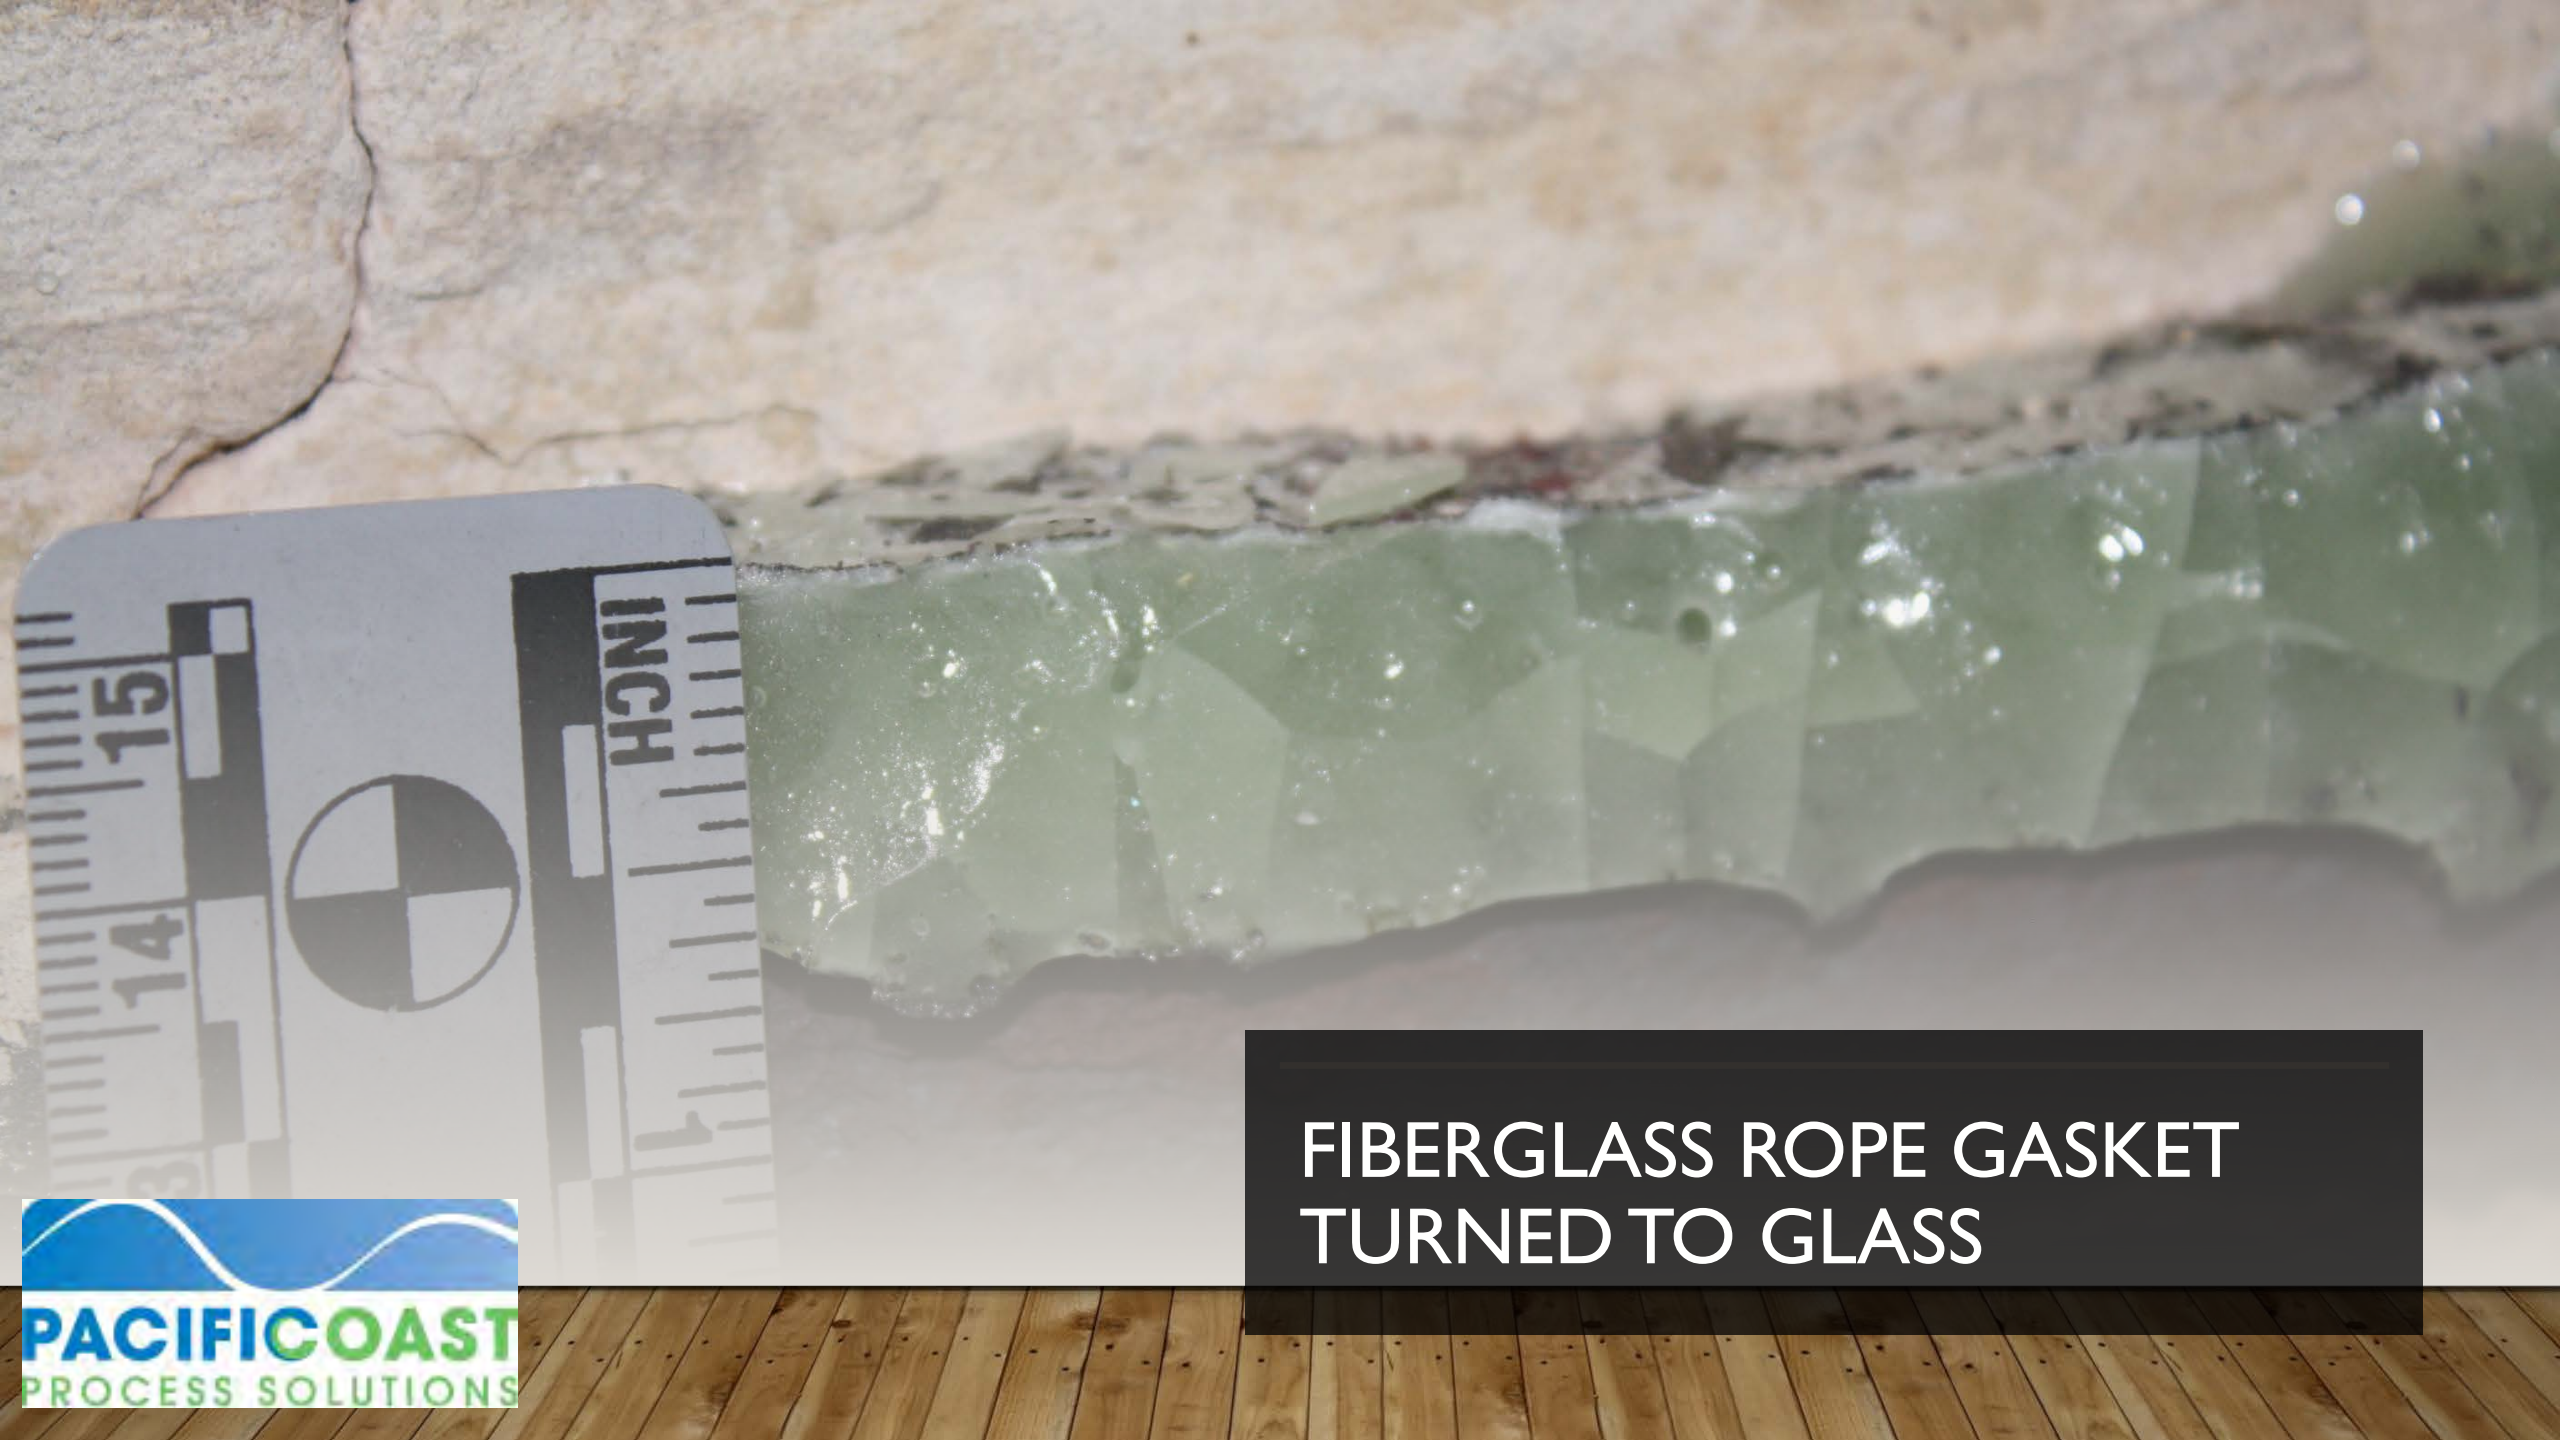
FIBERGLASS ROPE GASKET
TURNED TO GLASS

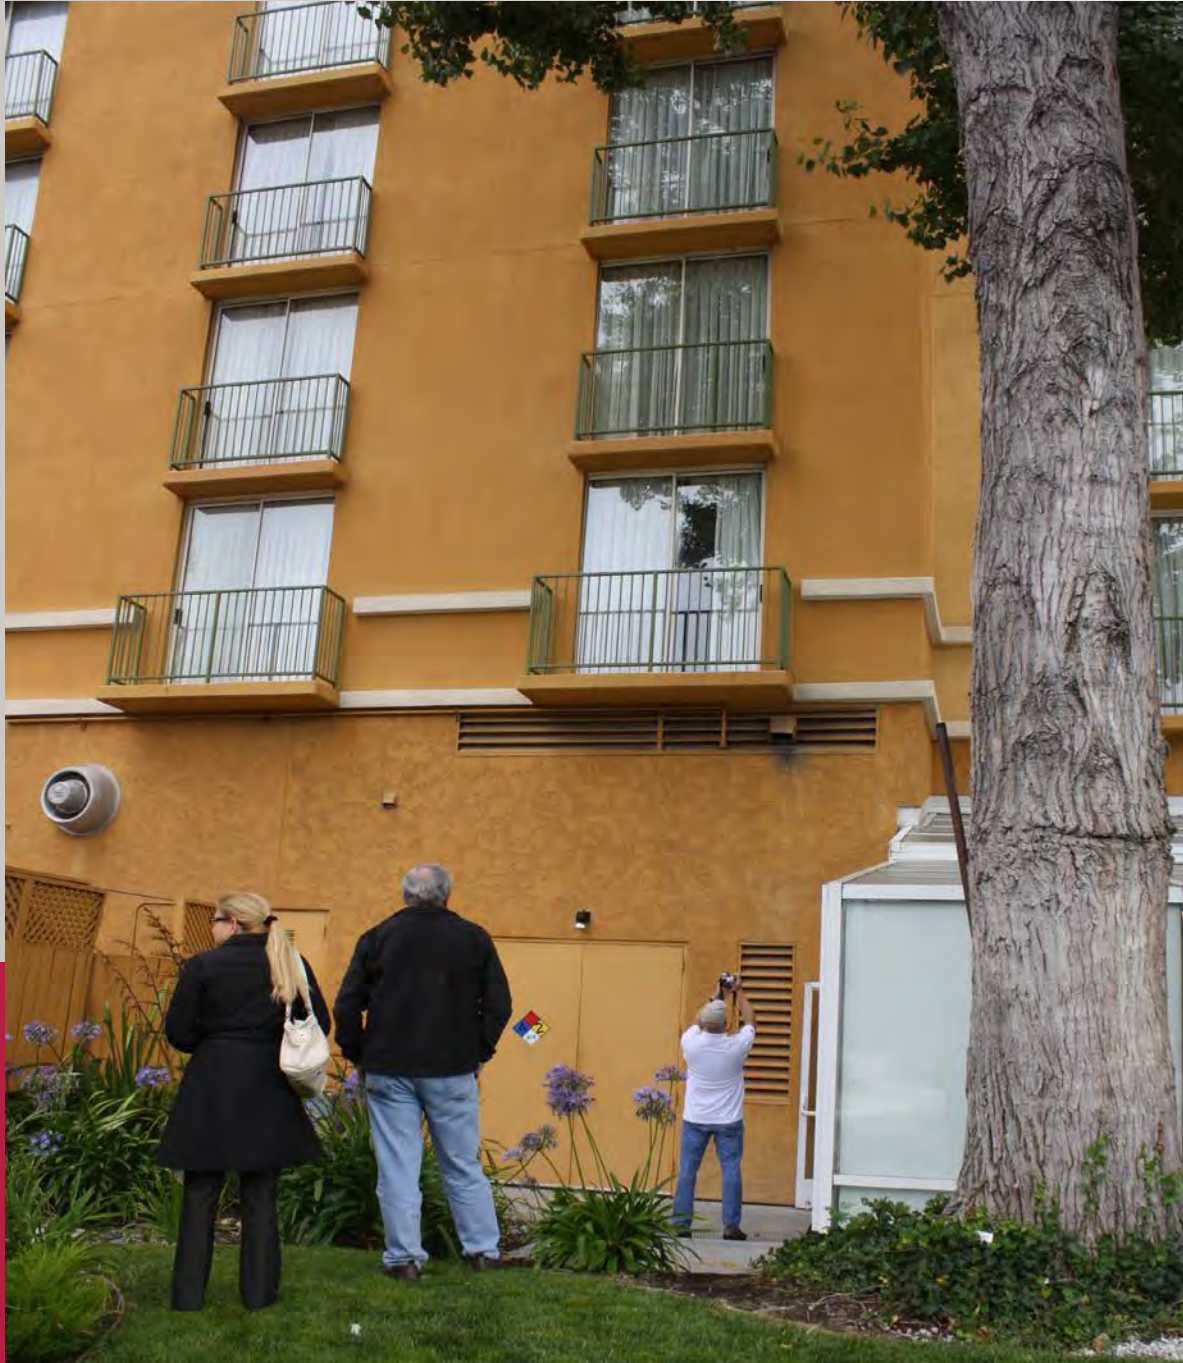
BOILER #2 – HOTEL IN BAY AREA – CARBON MONOXIDE POISONING

BOILER #2 –
BOILER
EXHAUST
RIGHT BELOW
SLIDING GLASS
DOOR

- The subject boiler was not installed per code. The exhaust was too close to the door above
- The subject boiler was not maintained. The boiler tube area was so full of rust, dirt, and debris that it interfered with the draft, causing incomplete combustion and the generation of about 50 times the normal production of carbon monoxide.
- There was not sufficient make up air, contributing to further carbon monoxide production
- The flue was perforated and allowed additional carbon monoxide to flow into hotel room
- Once the boiler tube area was “vacuumed” – the carbon monoxide produced were within acceptable levels.

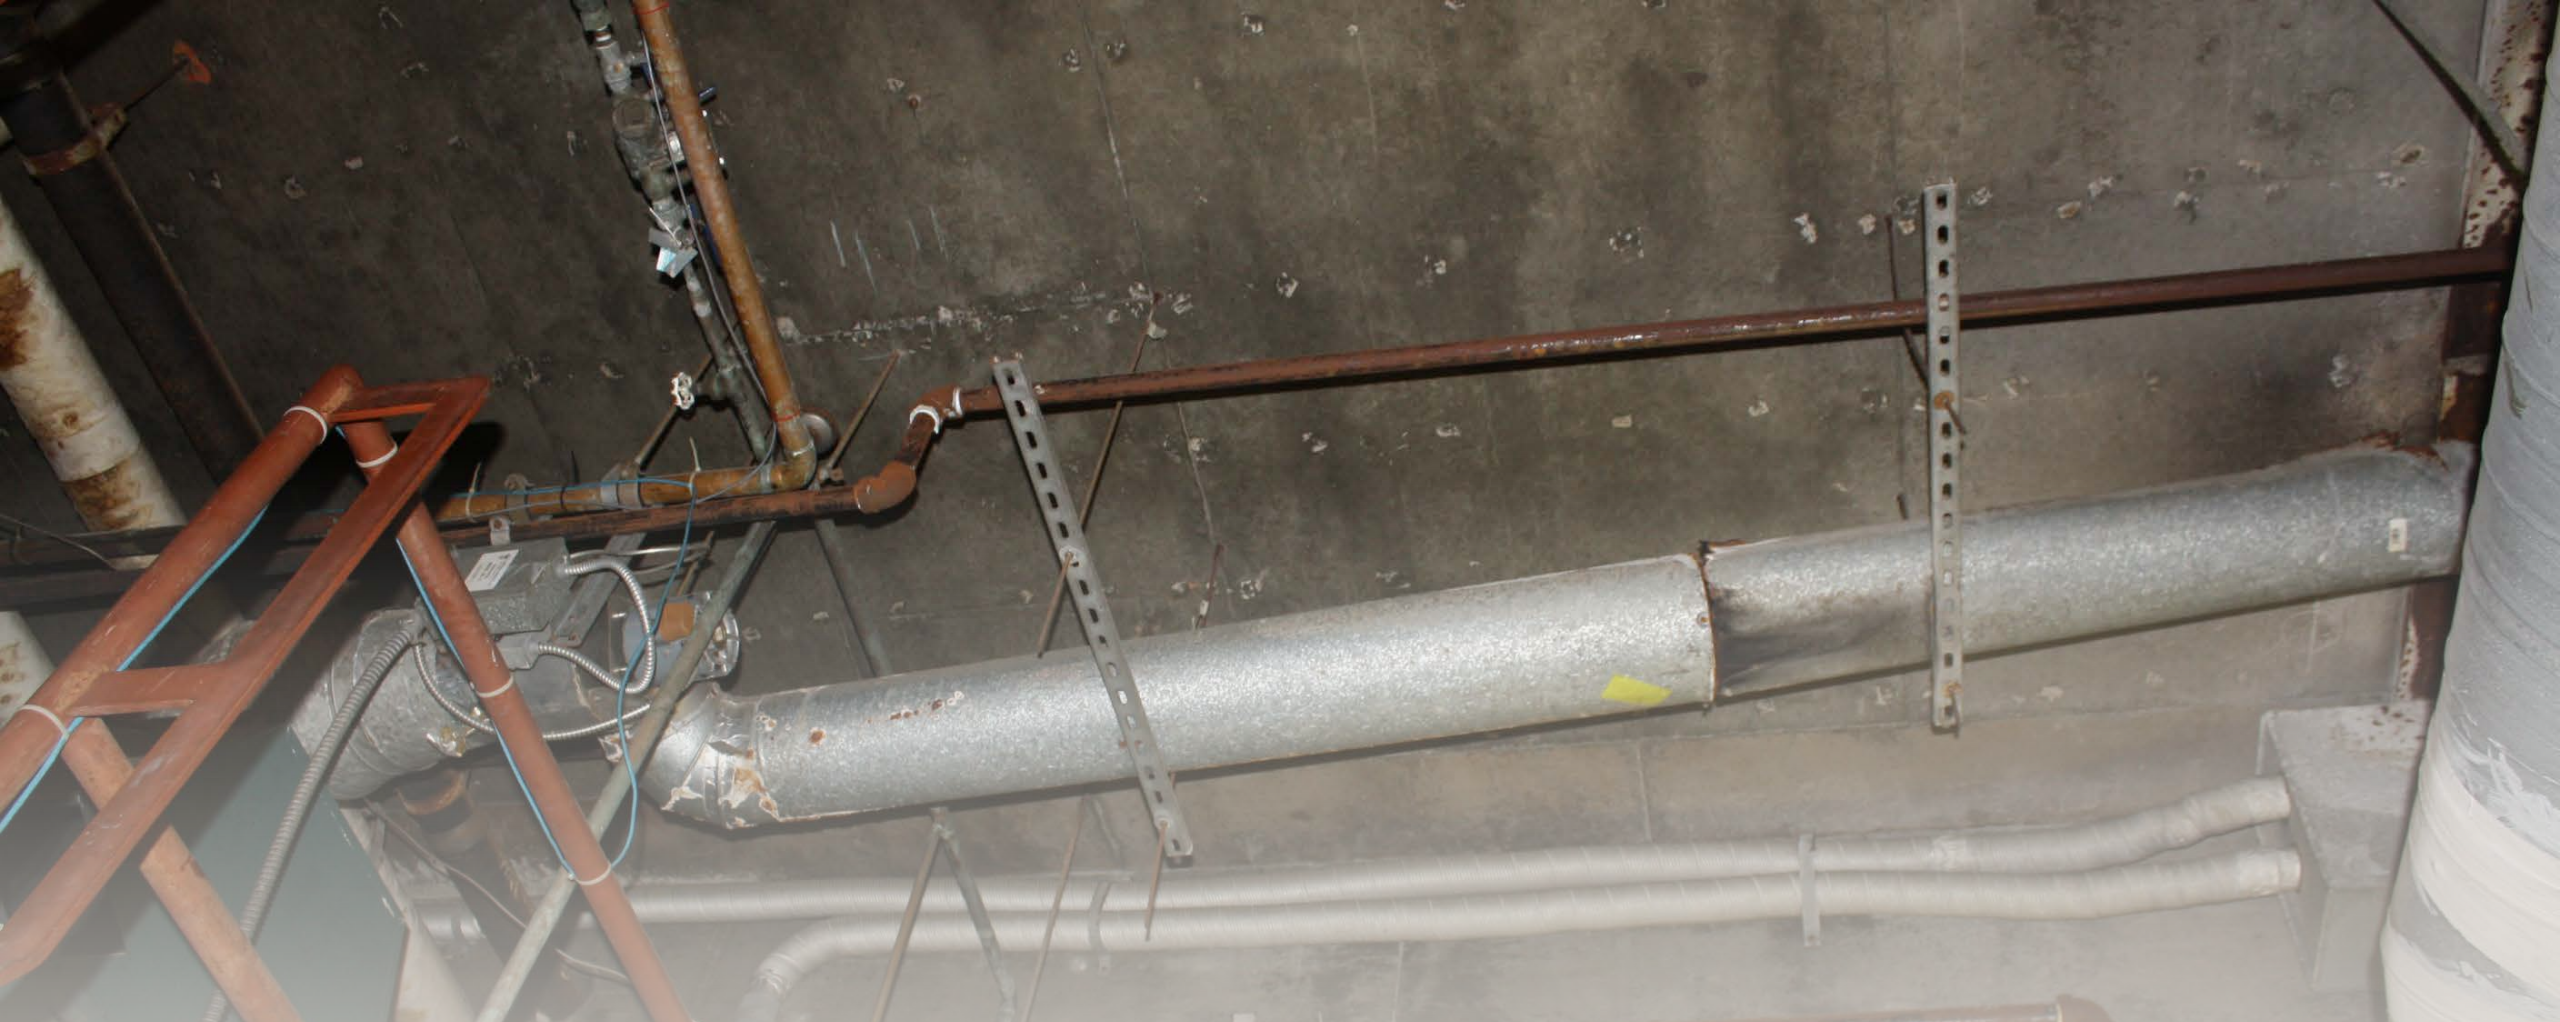
EXHAUST FLUE ACROSS EQUIPMENT ROOM

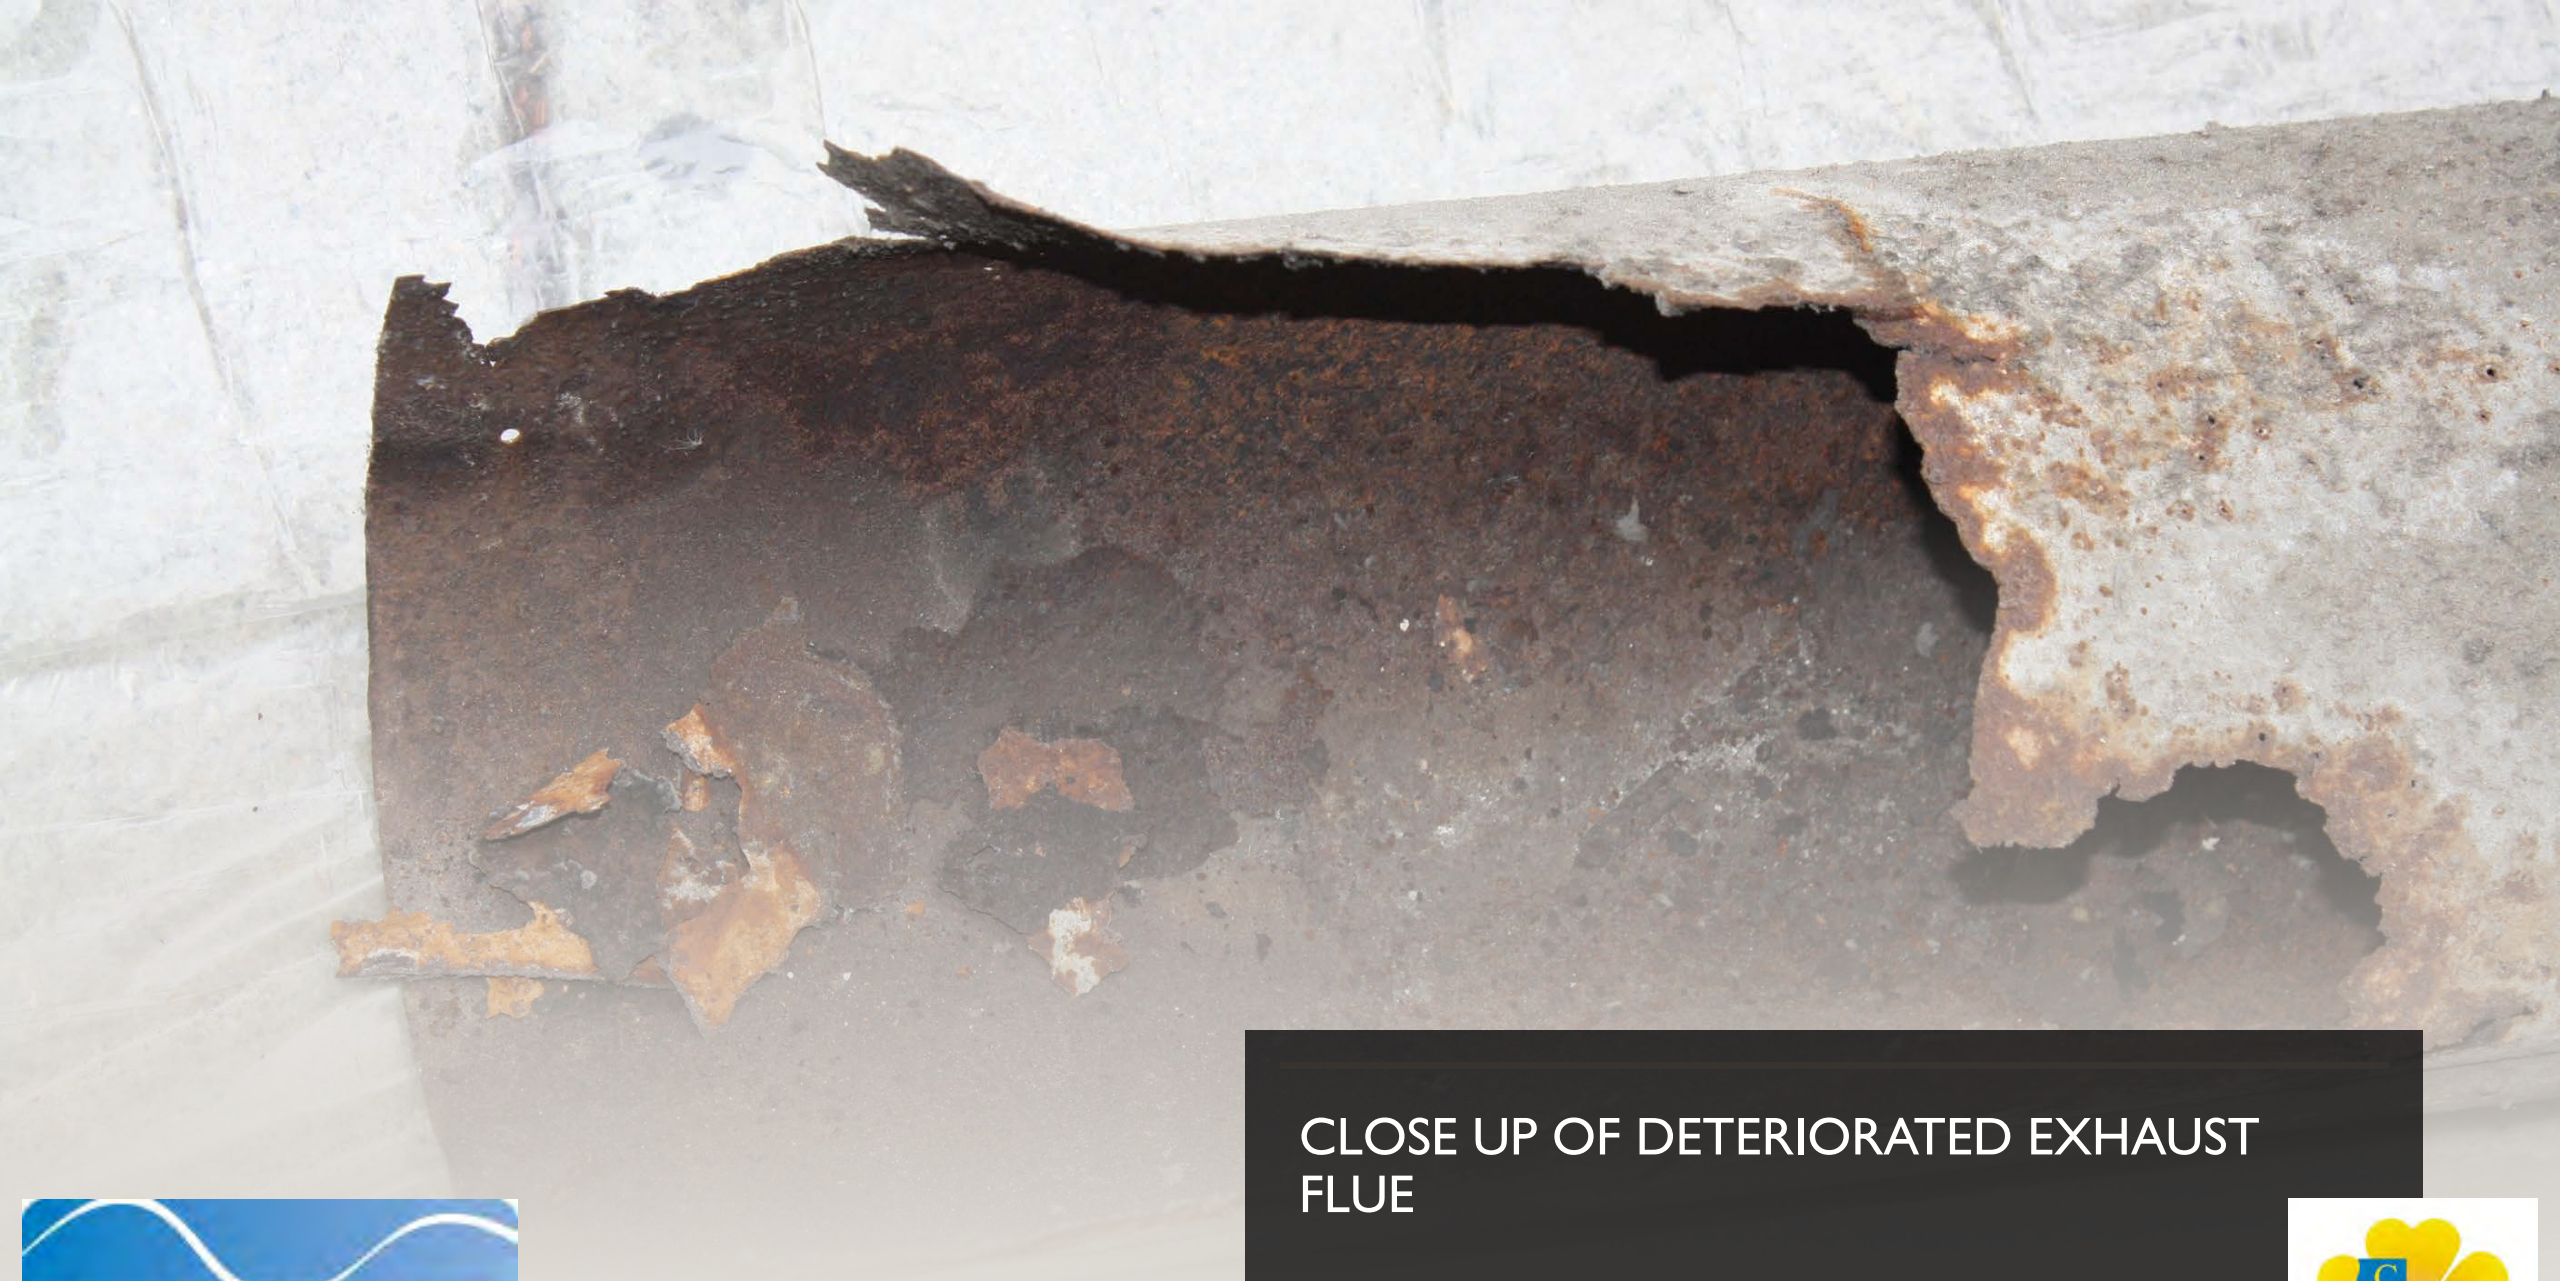
CLOSE UP OF DETERIORATED EXHAUST
FLUE
