TWO BOILERS AND A WATER HEATER

CALIFORNIA BOILER INSPECTORS
ASSOCIATION

OCTOBER 16, 2018

GEORGE WHITE, P.E.

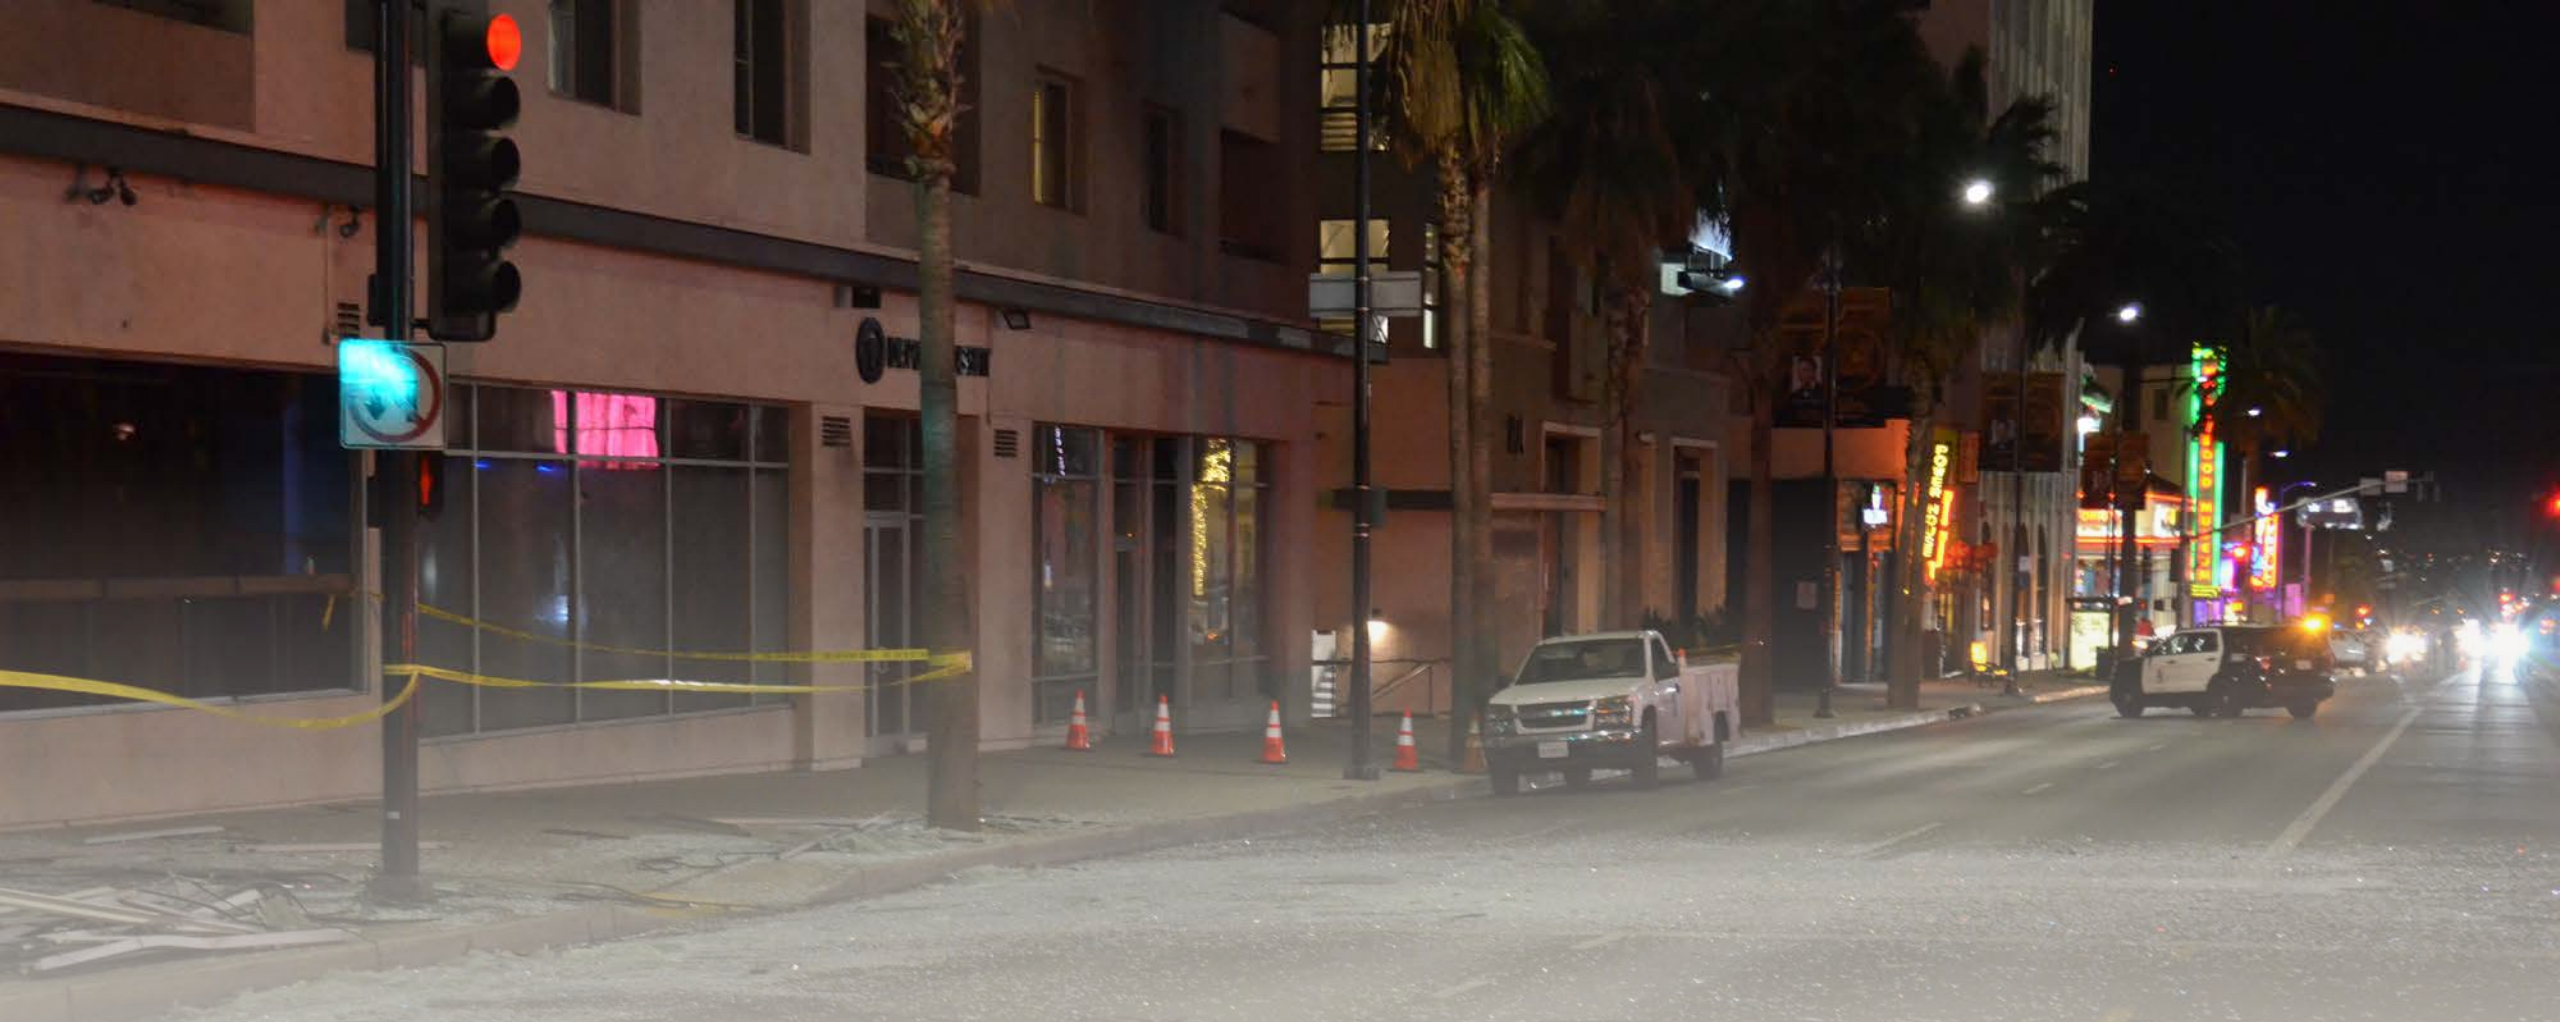
POLICE INITIALLY THOUGHT IT WAS A
TERRORIST BOMBING INCIDENT

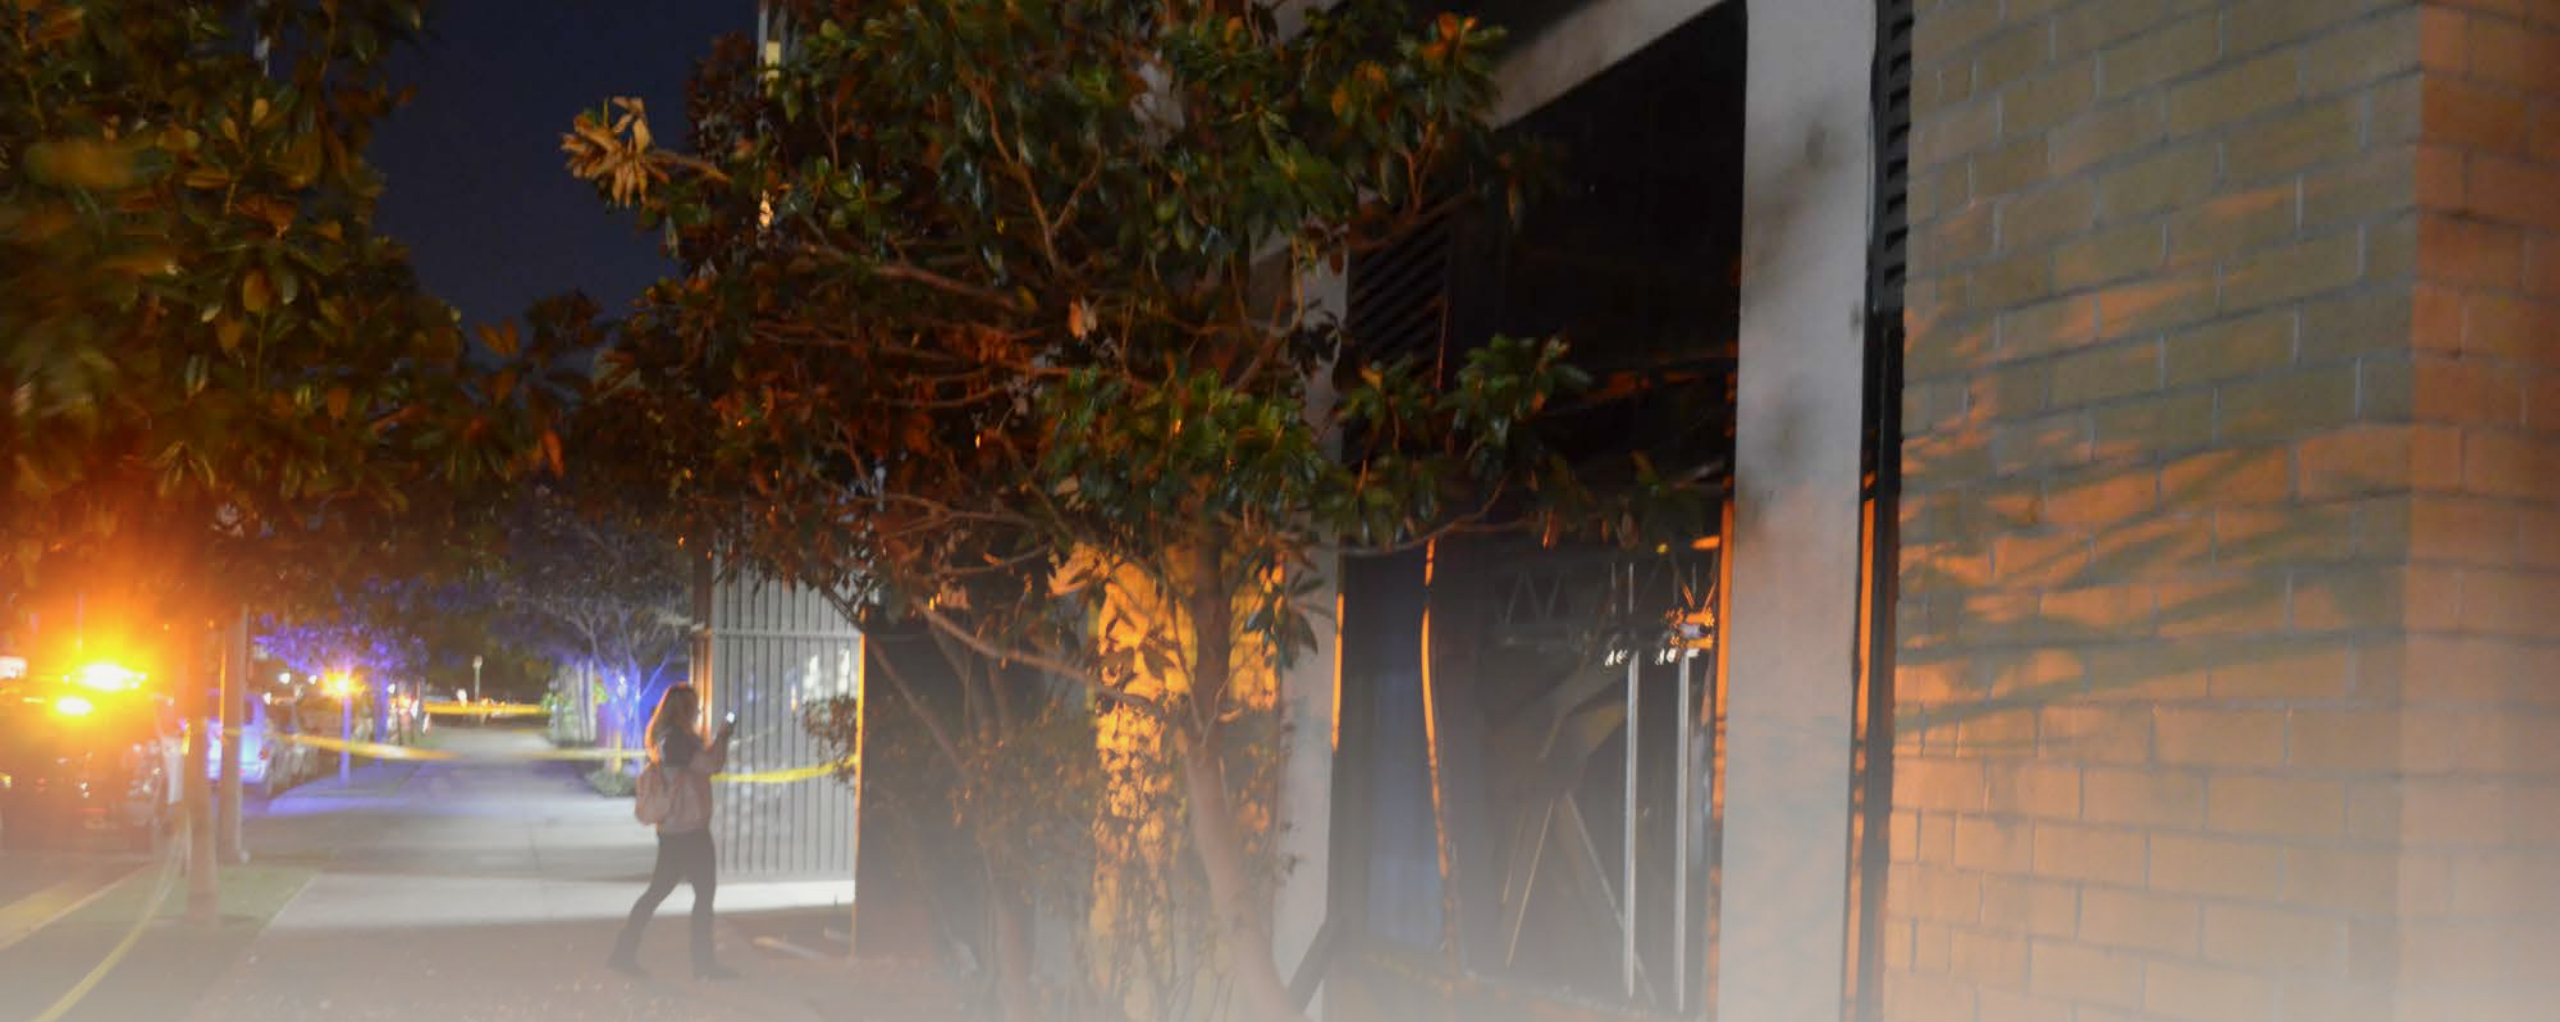
WINDOWS BLOWN OUT ON BOTH SIDES

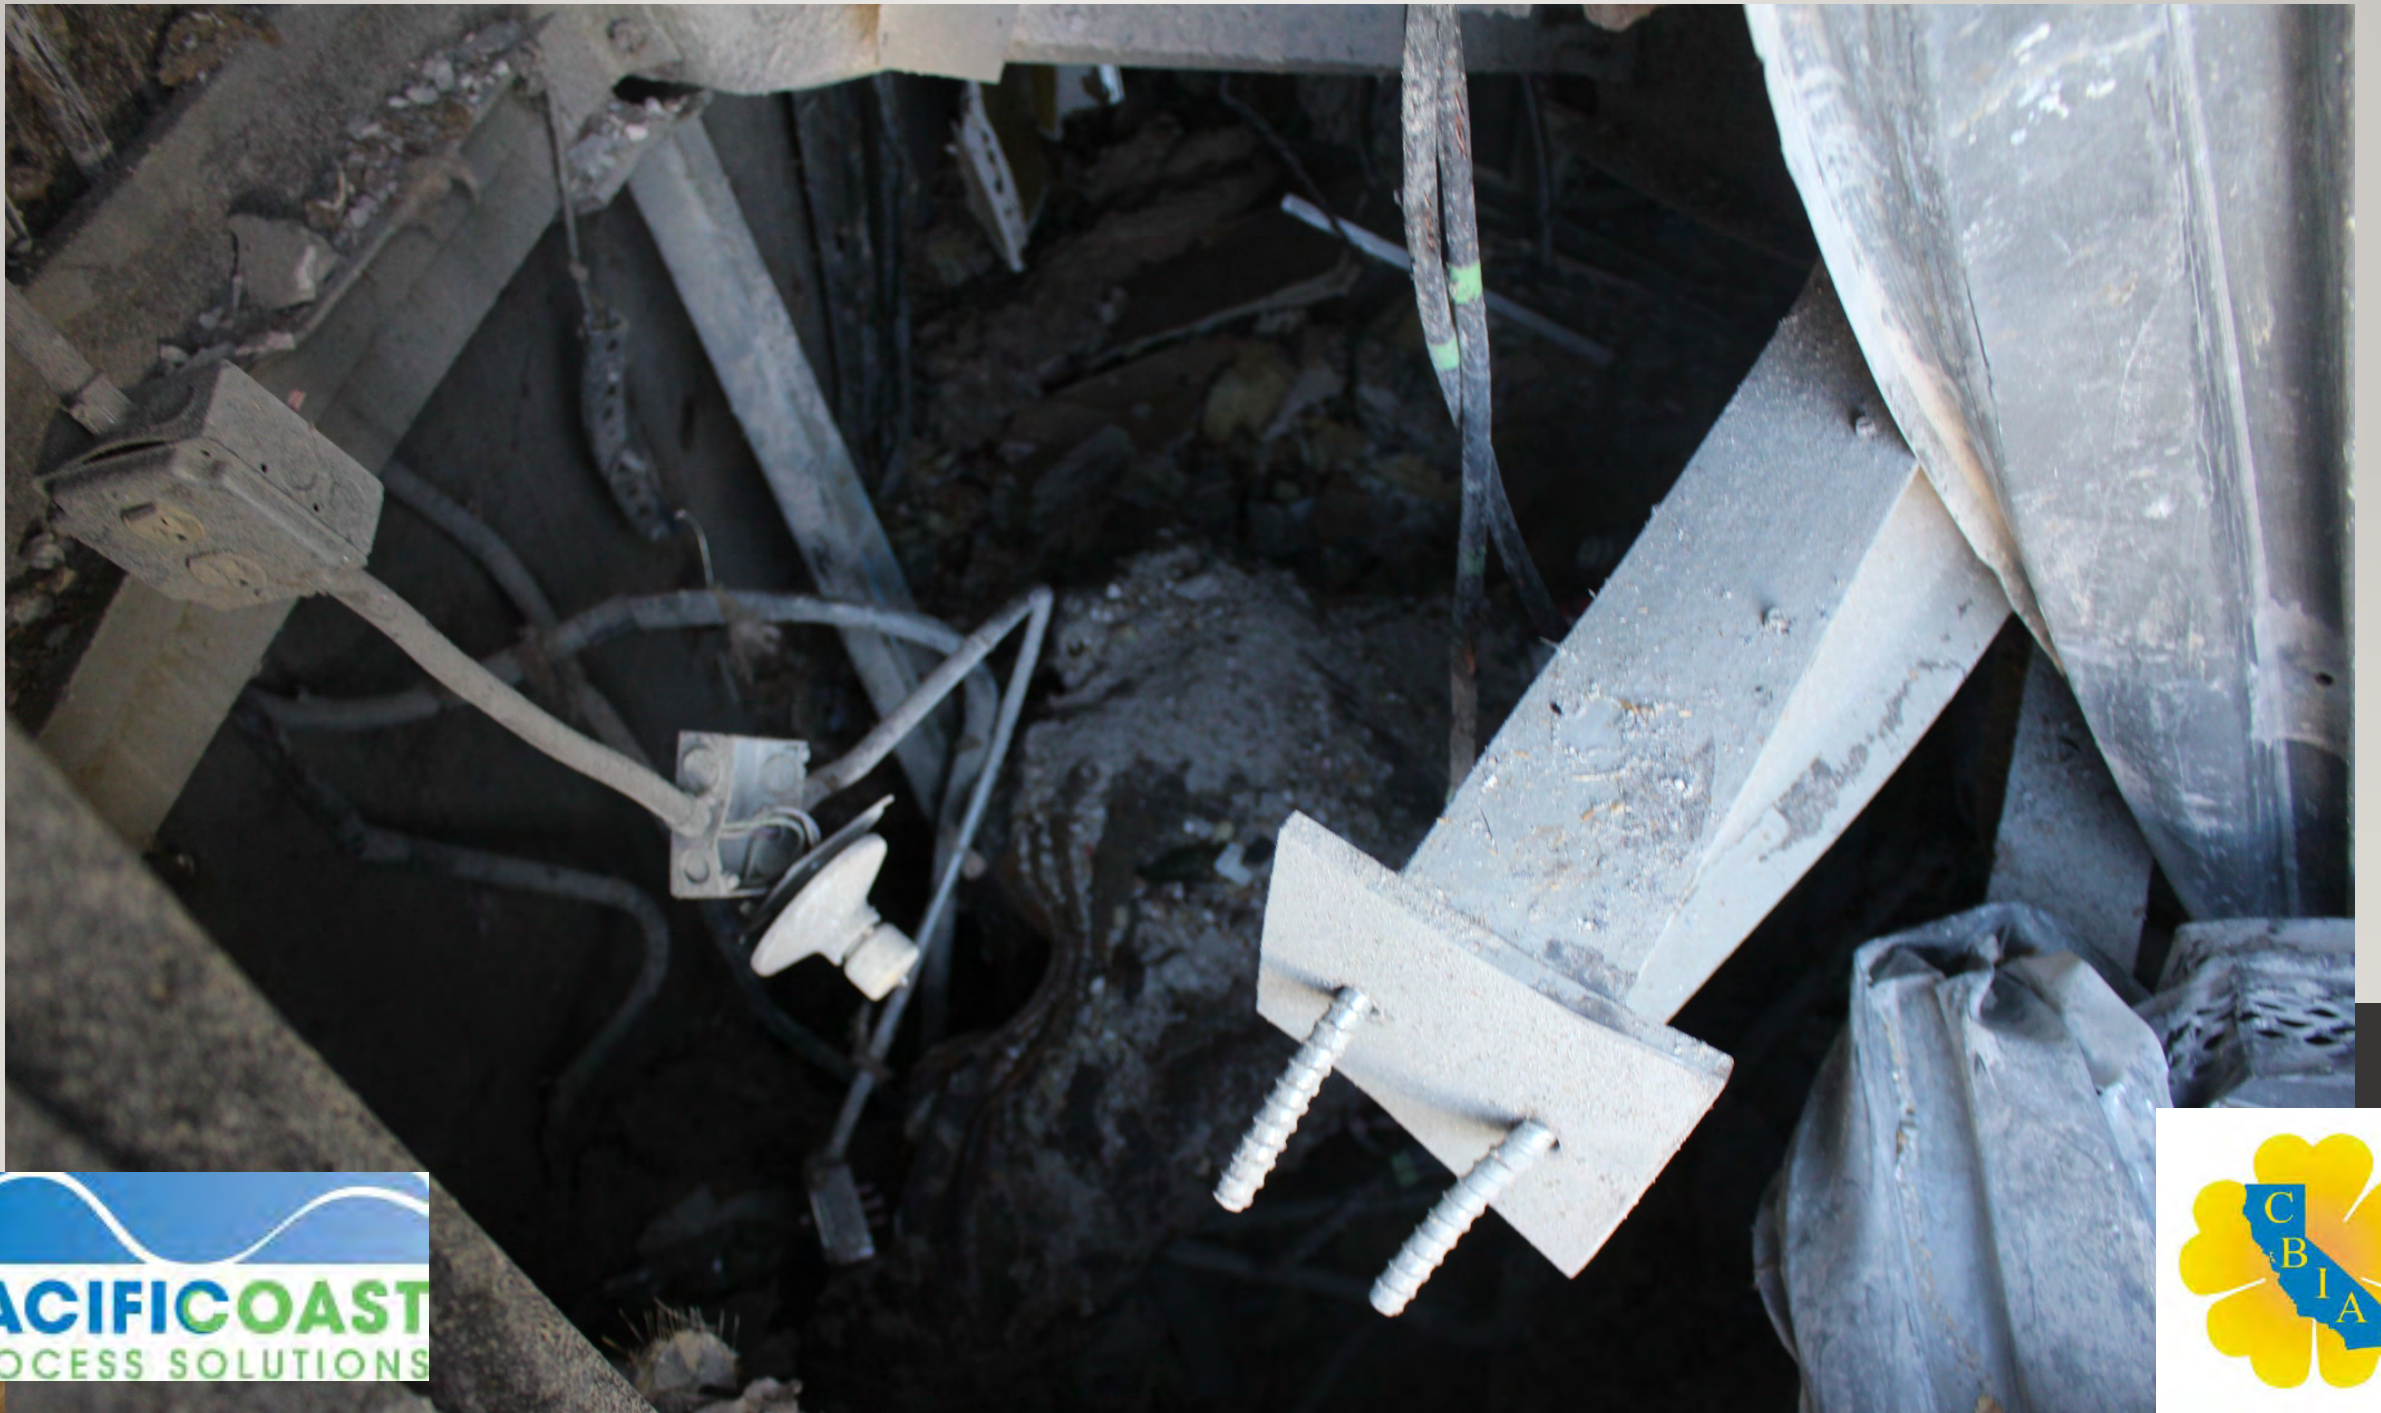
HEATING ELEMENTS NEAR BOTTOM OF WATER HEATER

- Arcing found on wire in heating element indicates that the water heater was on and operating at the time of the fire
- The 480-volt, 3-phase 90 amp circuit breaker that fed the water heater was in the tripped position, with soot and smoke coming out of the arc chutes
- Insulation on the hot water pipe was melted, indicating that the water heater was making steam at the time of this incident
- Further testing of the insulation will be required to determine its thermal characteristics
- The T & P valve was replaced. It comes with a Watts T & P valve, but the T & P at the time of this incident was manufactured by Wilkins.
- There were check valves installed on the hot water and cold water piping

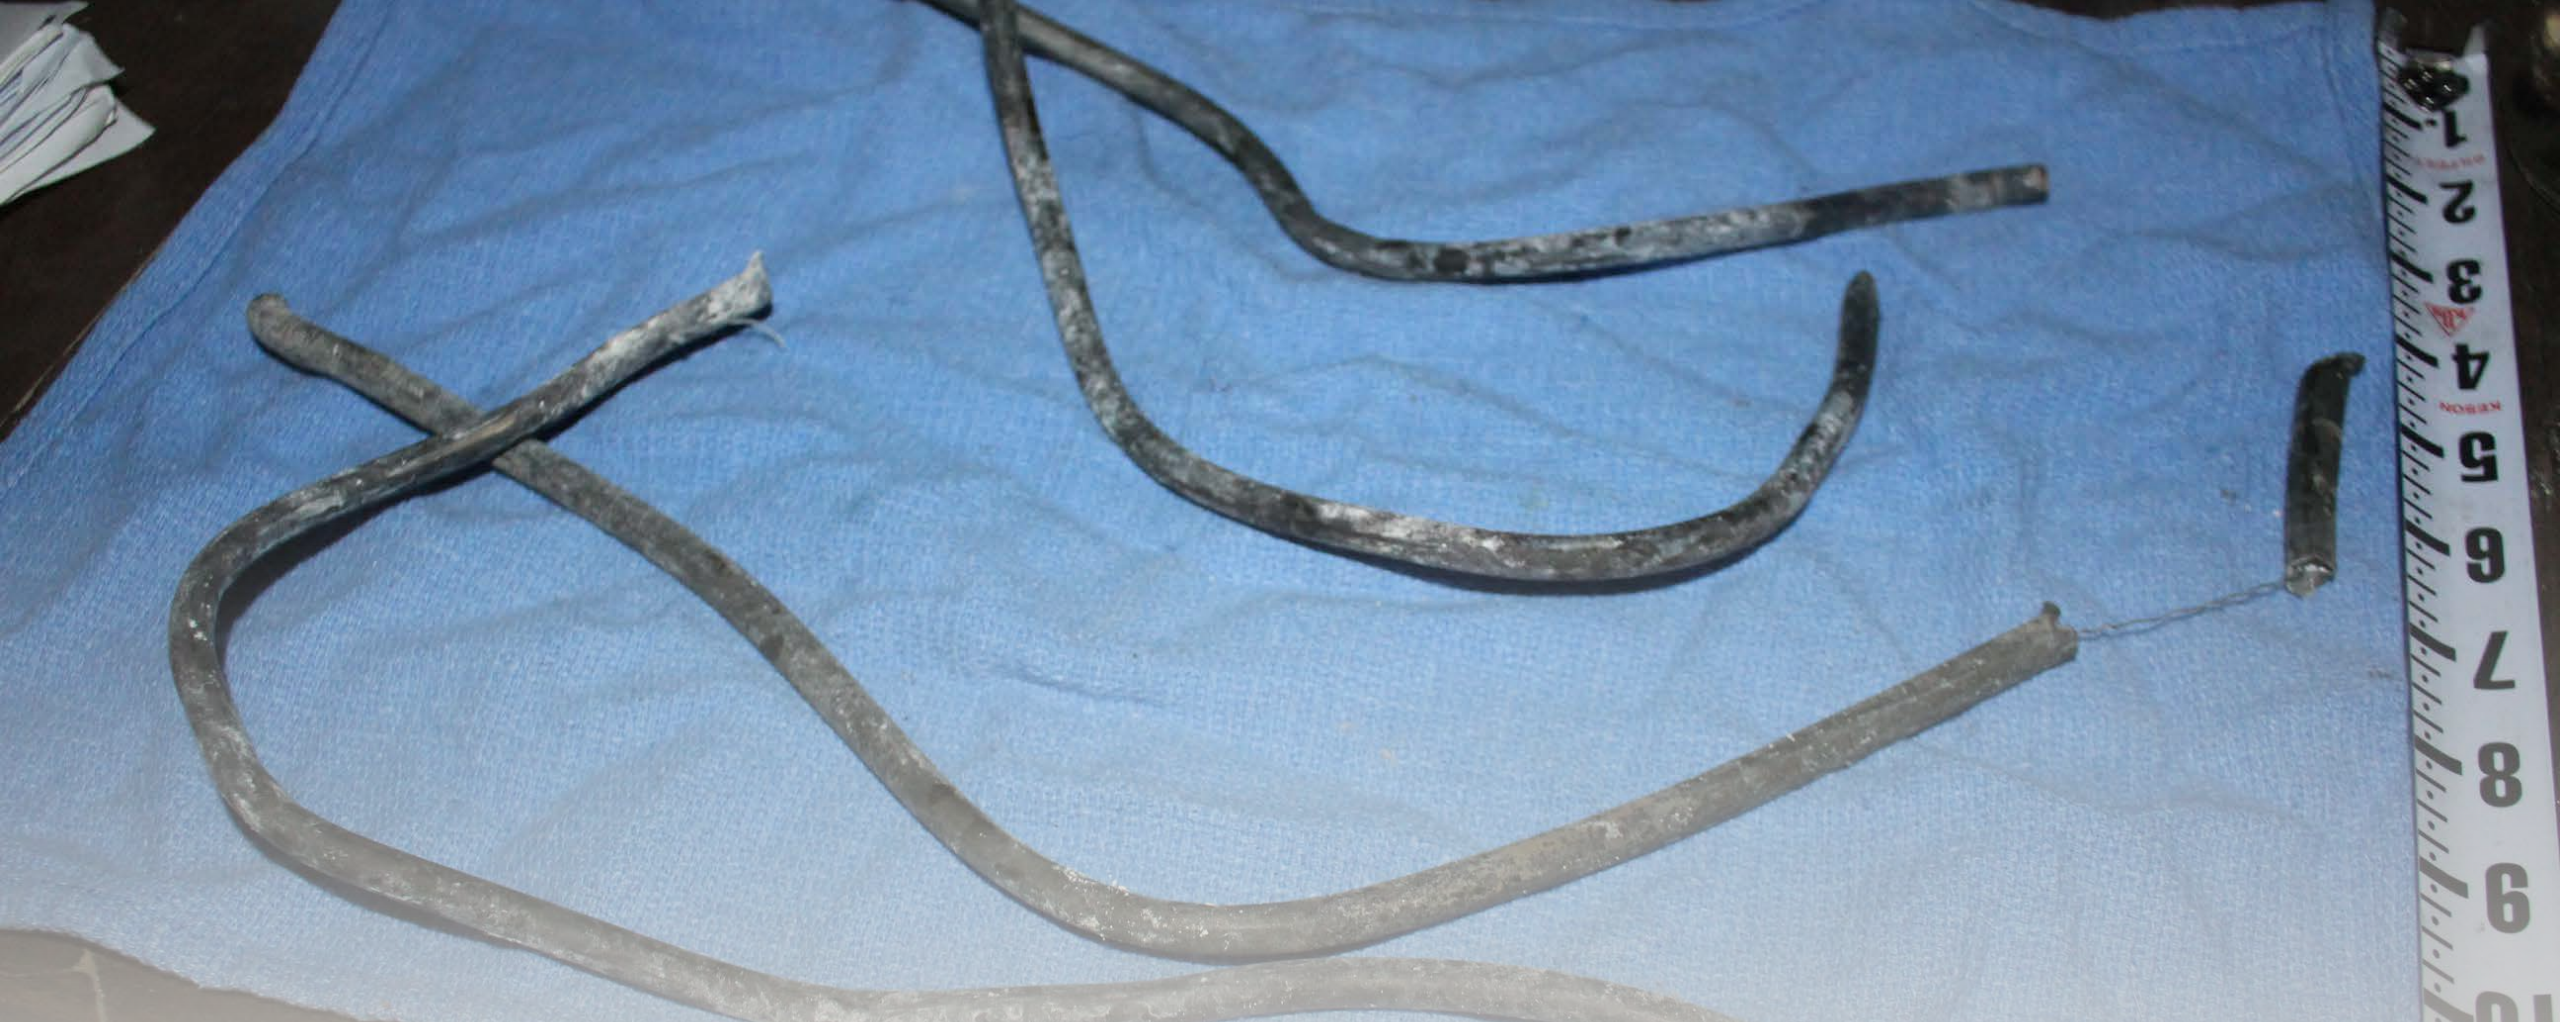
HEATING ELEMENT FRAGMENTS

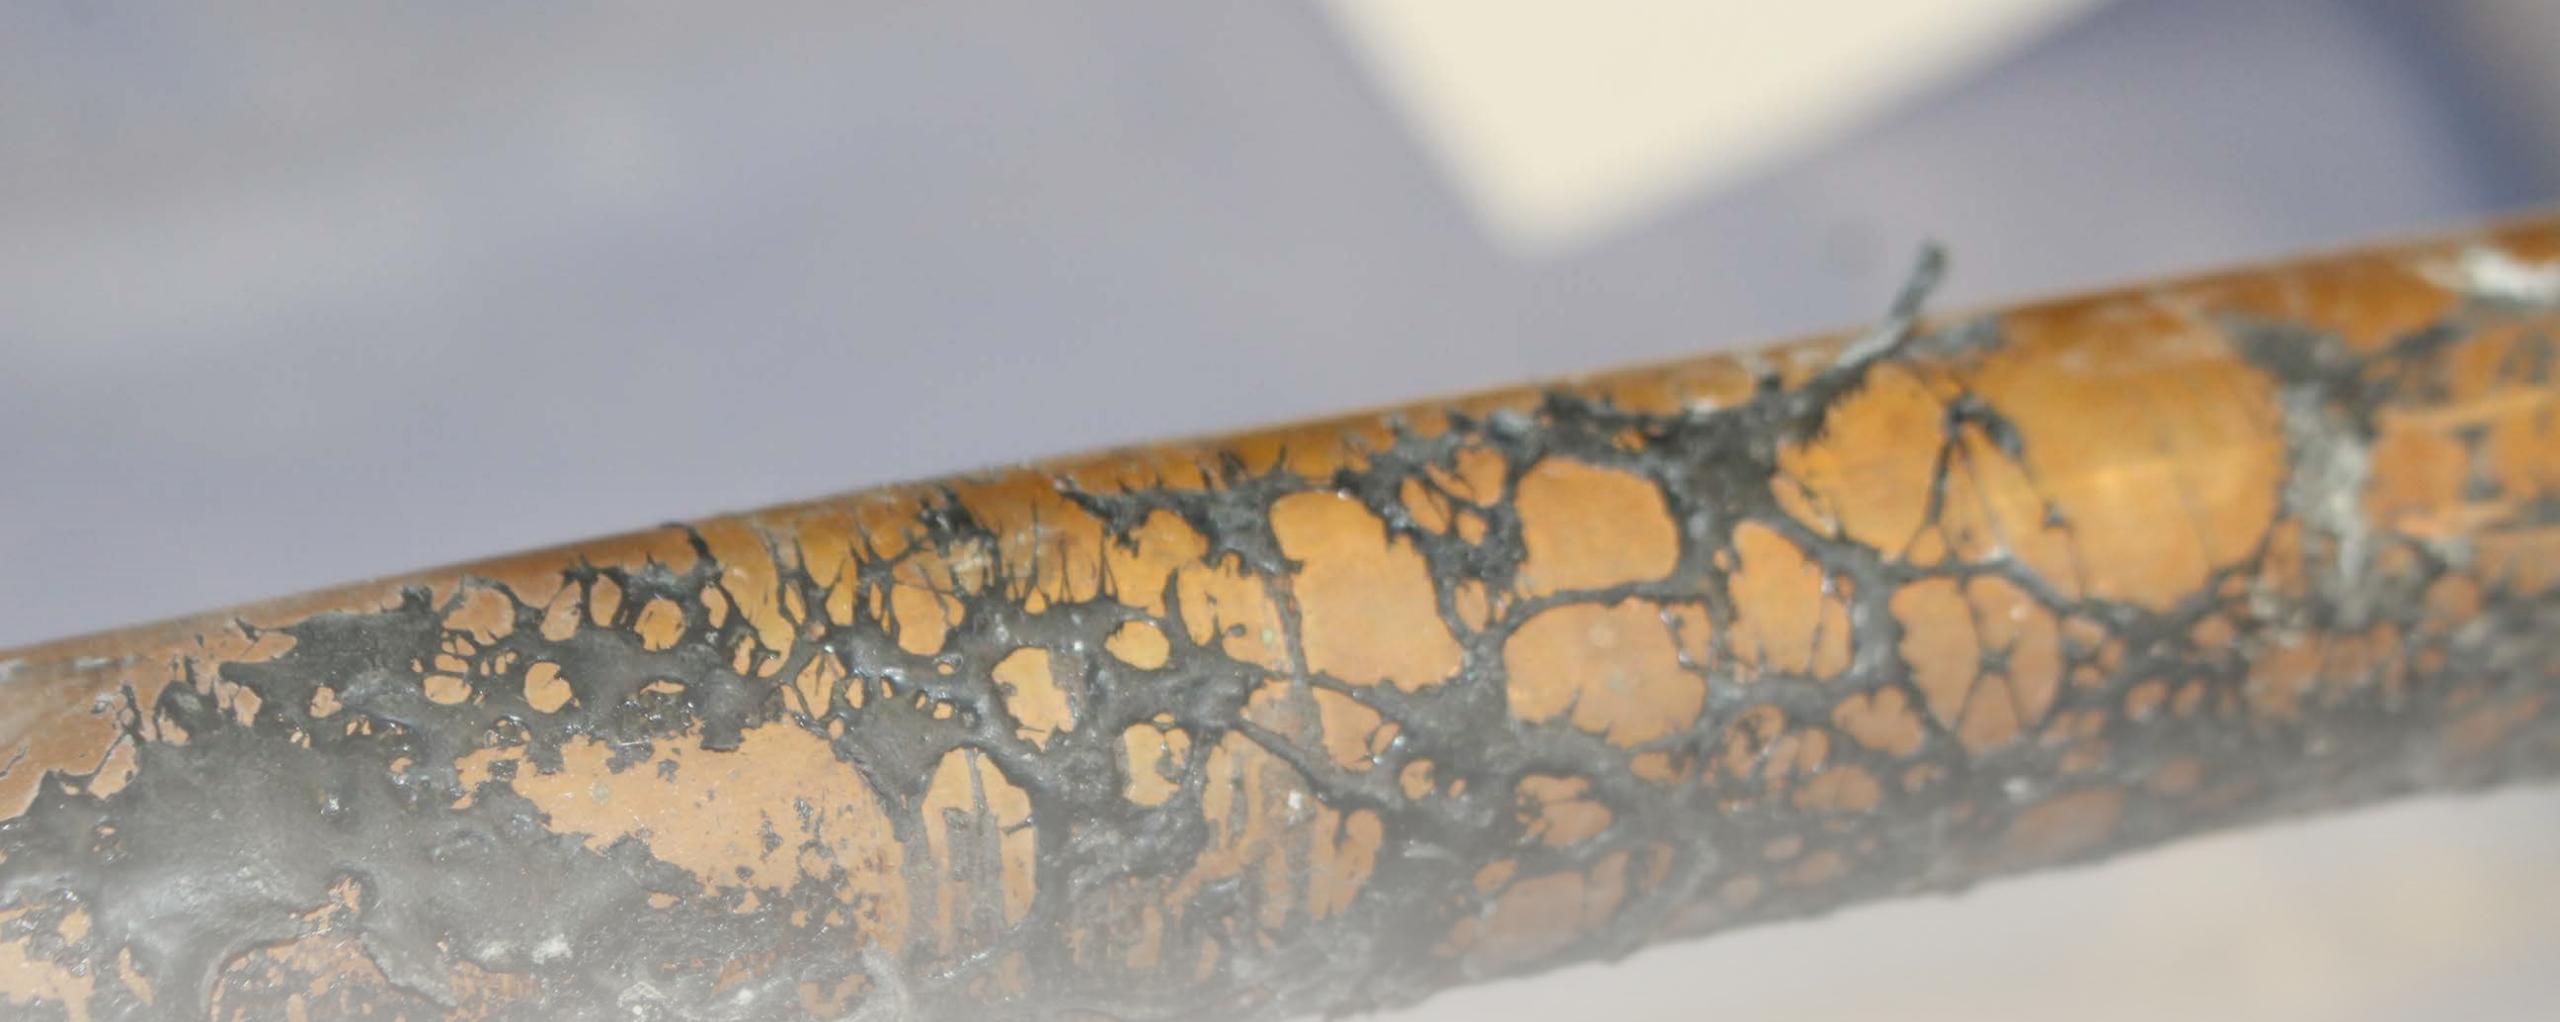
**INSULATION ON HOT WATER PIPE WAS
MELTED AND ESSENTIALLY COOKED!**
