MEDINA, OHIO

STEAM TRACTOR EXPLOSION
WITH FATALITIES AND MULTIPLE
INJURIES, MAIMING

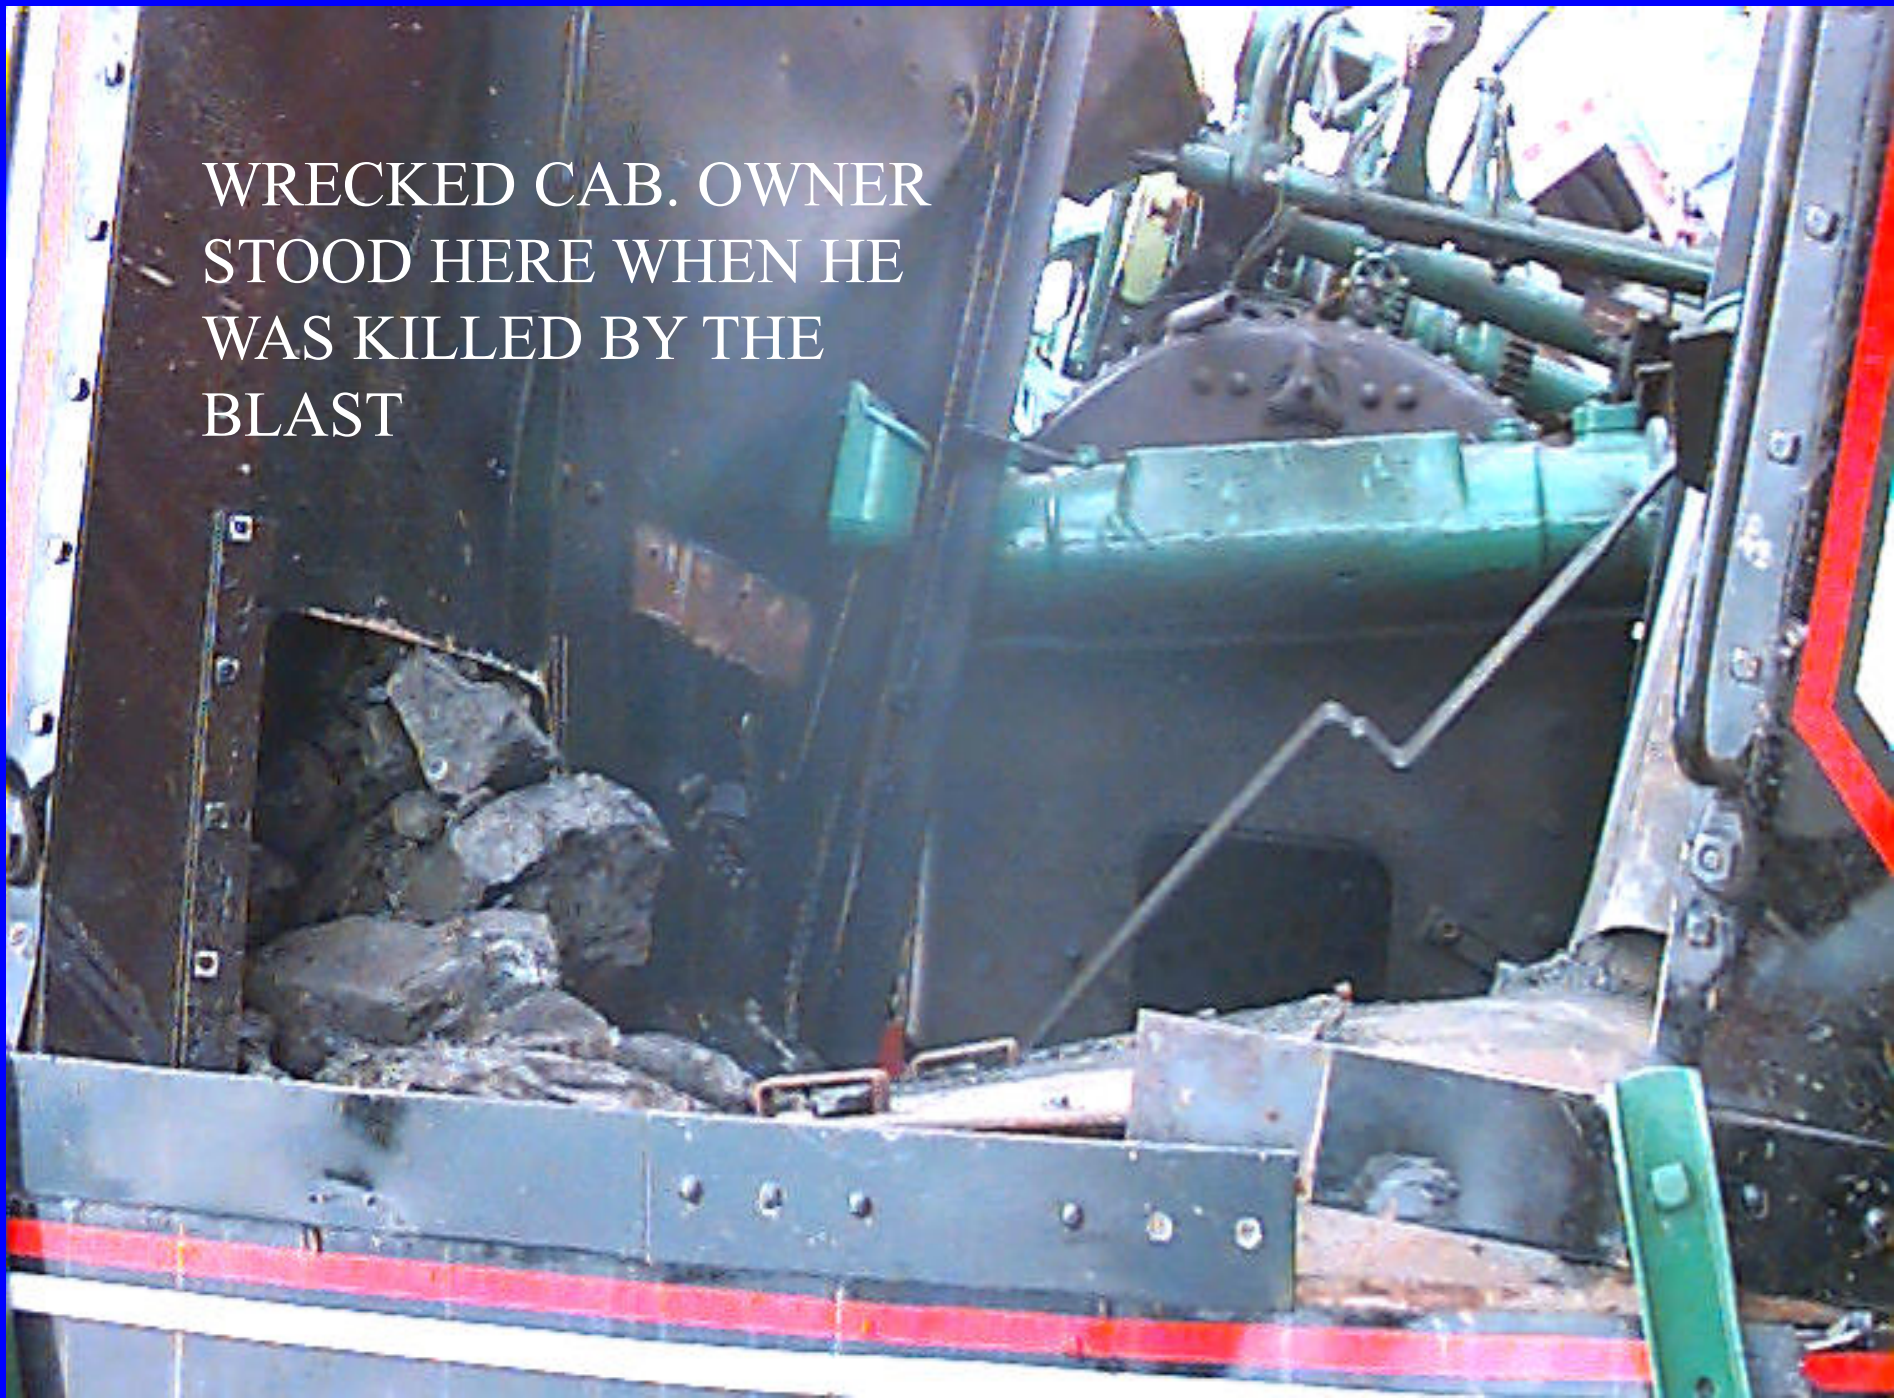
WRECKED CAB. OWNER
STOOD HERE WHEN HE
WAS KILLED BY THE
BLAST

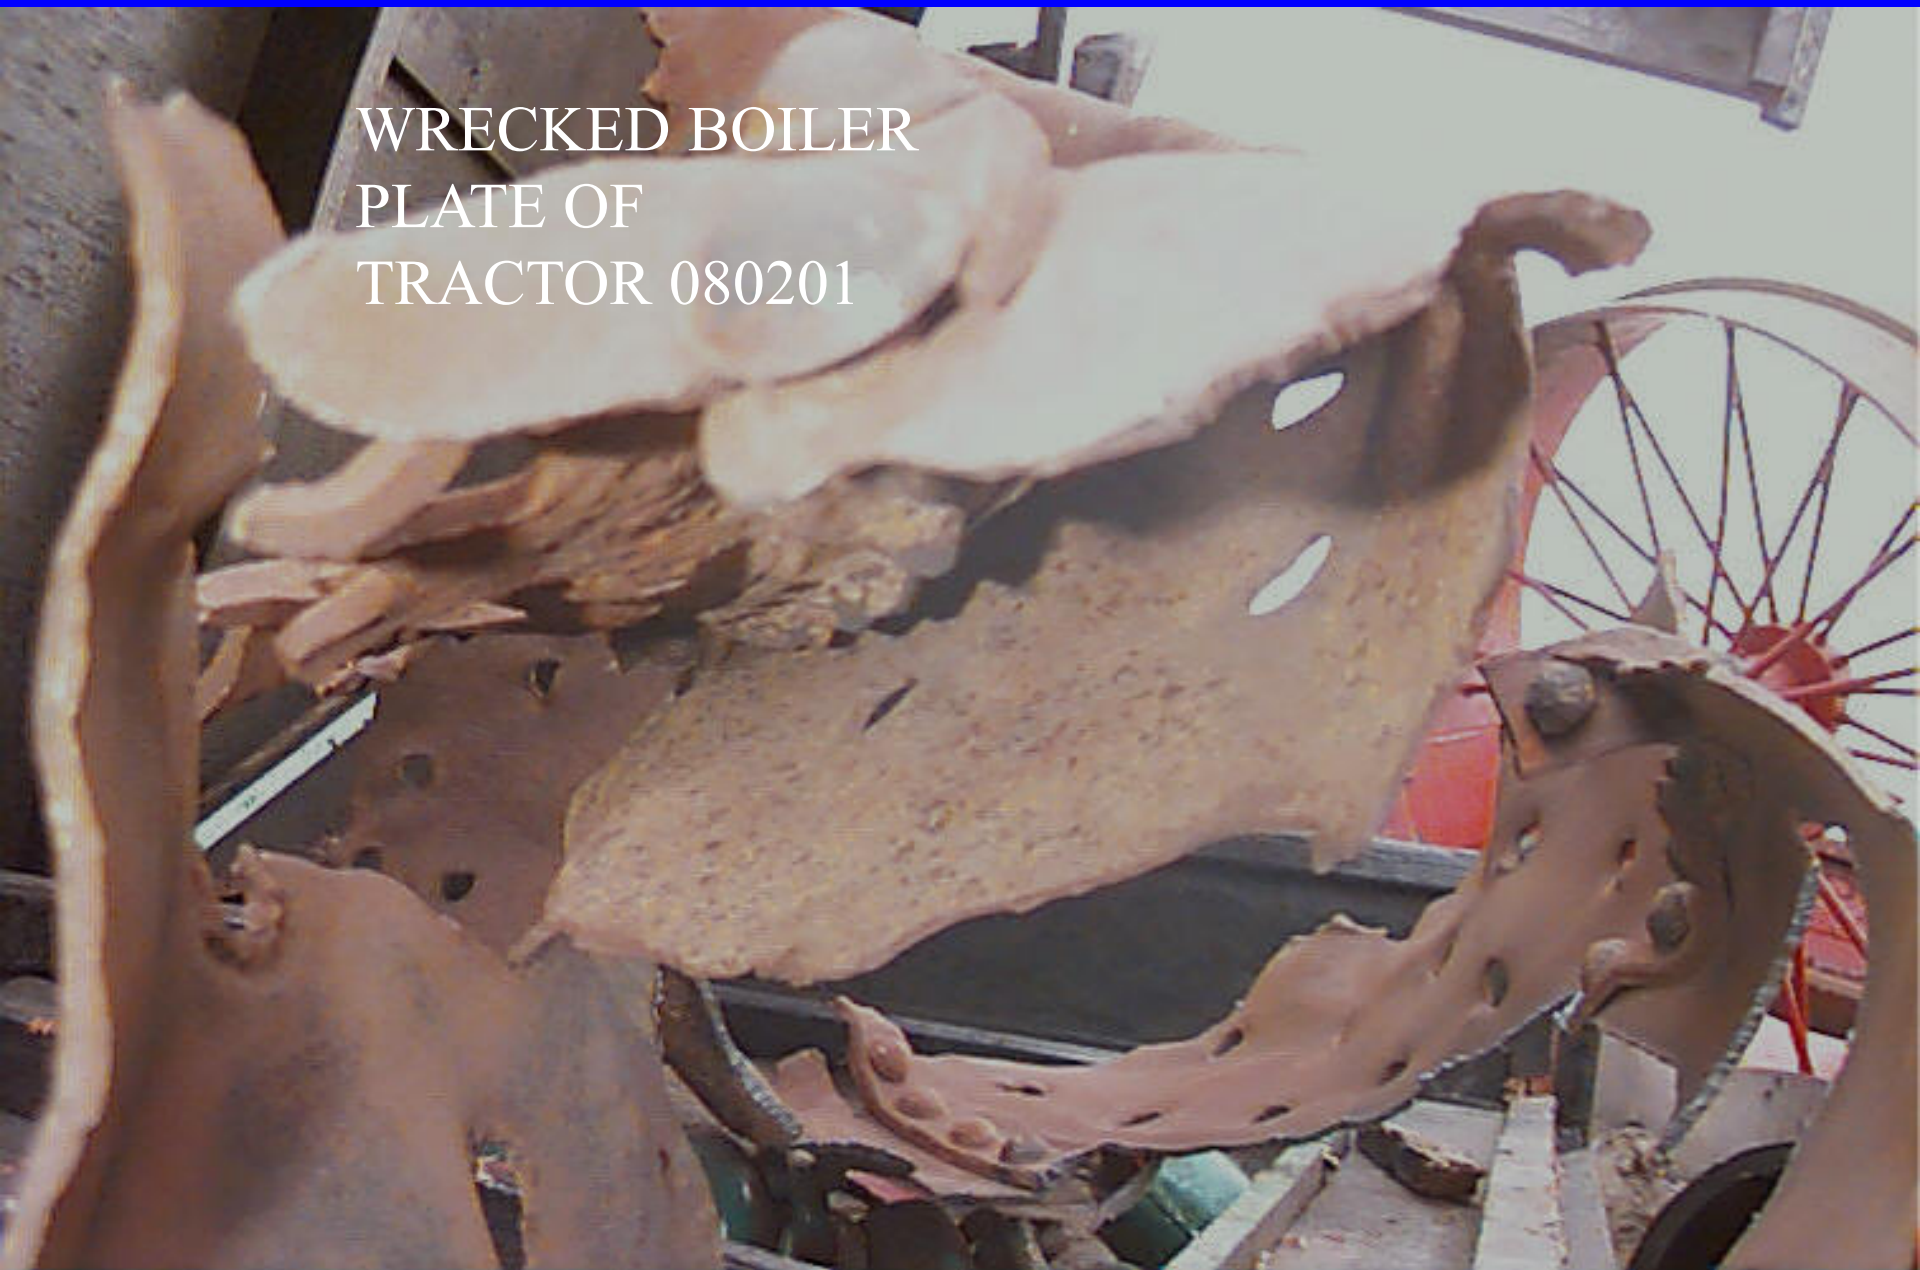
TEST SECTION HAS
BEEN REMOVED
FROM CROWN
SHEET

WRECKED BOILER
PLATE OF
TRACTOR 080201

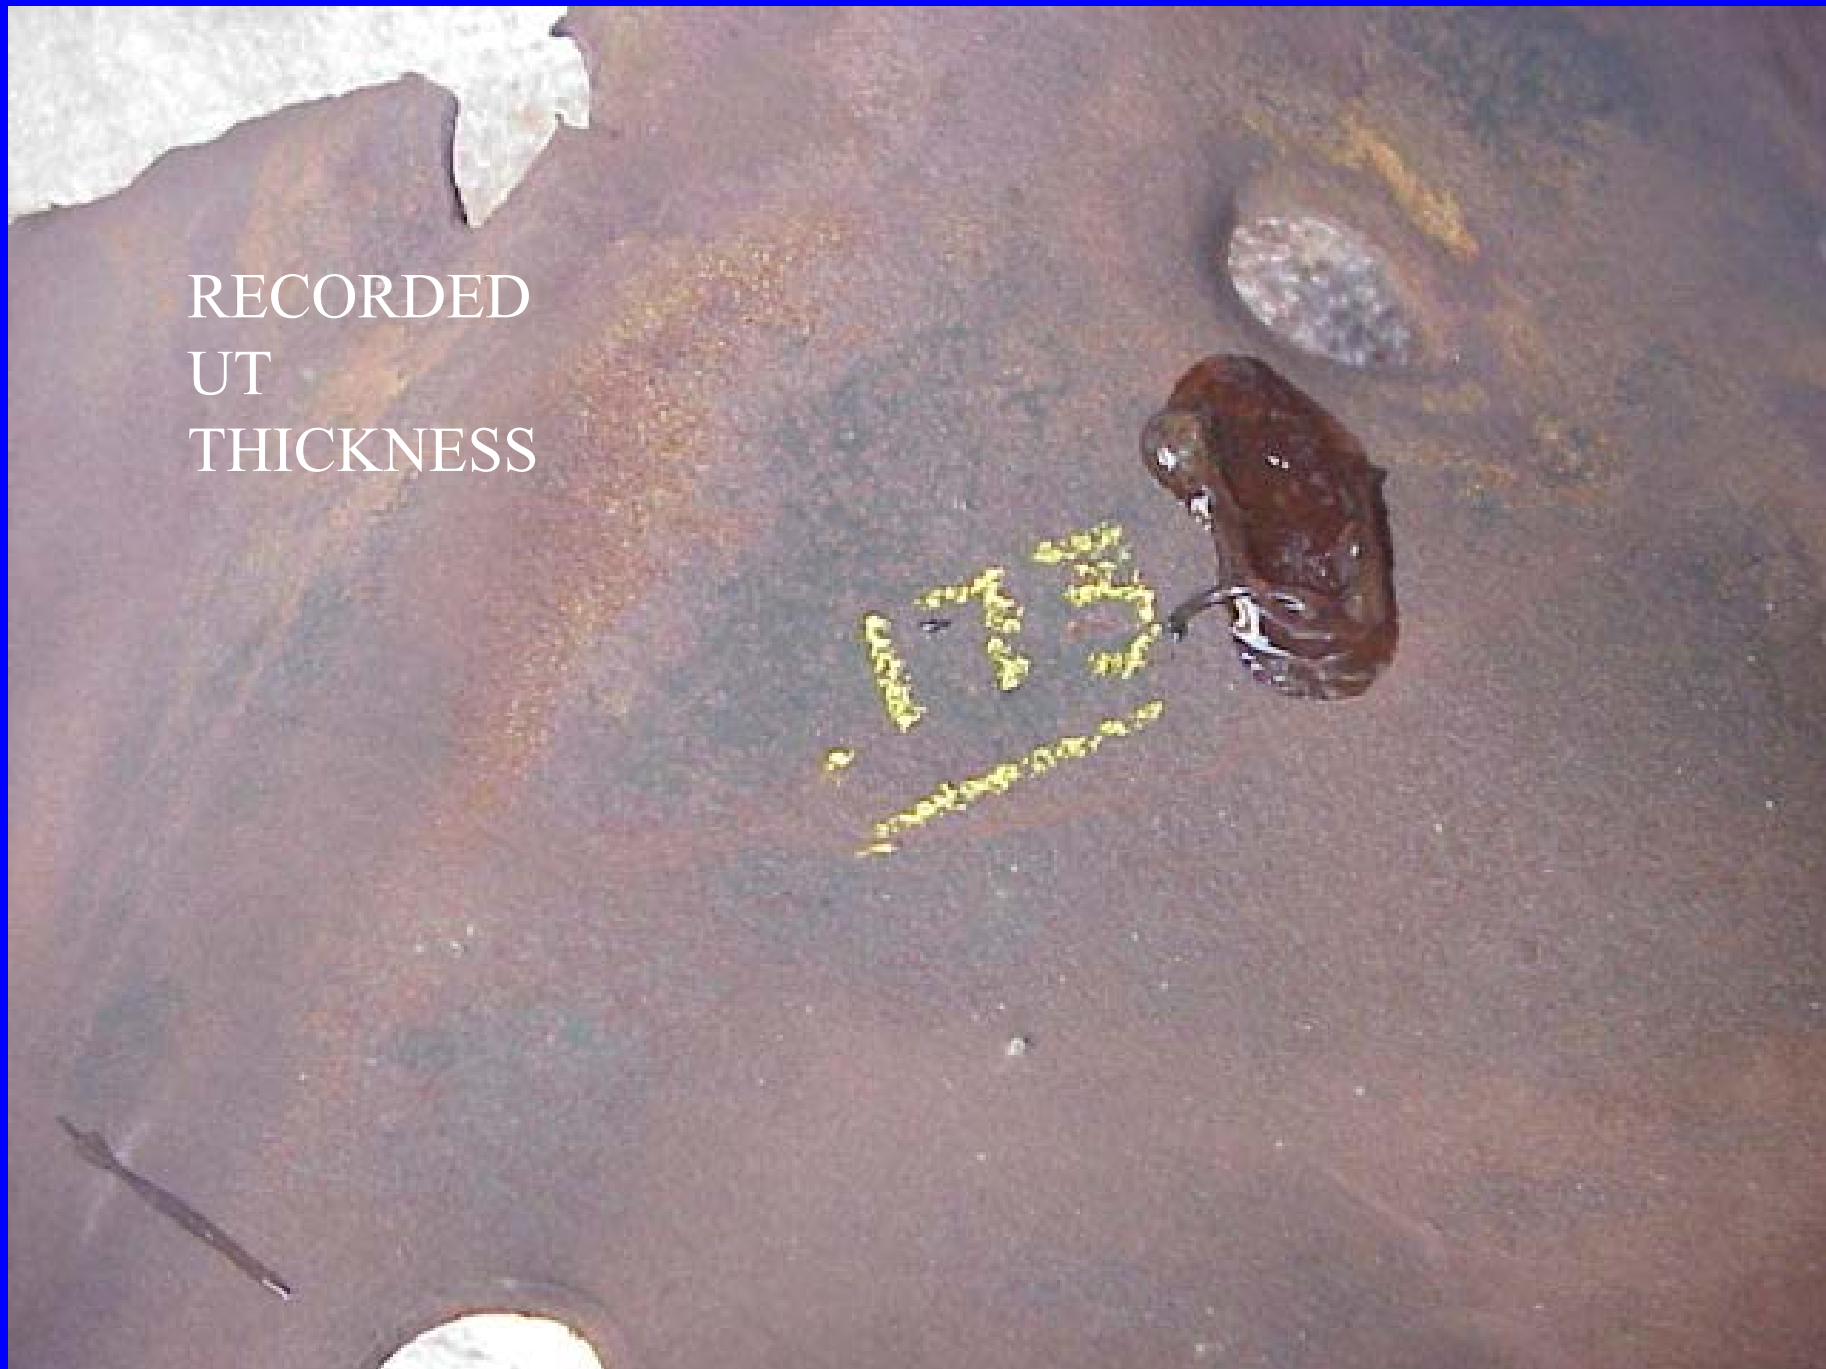
RECORDED
UT
THICKNESS

105

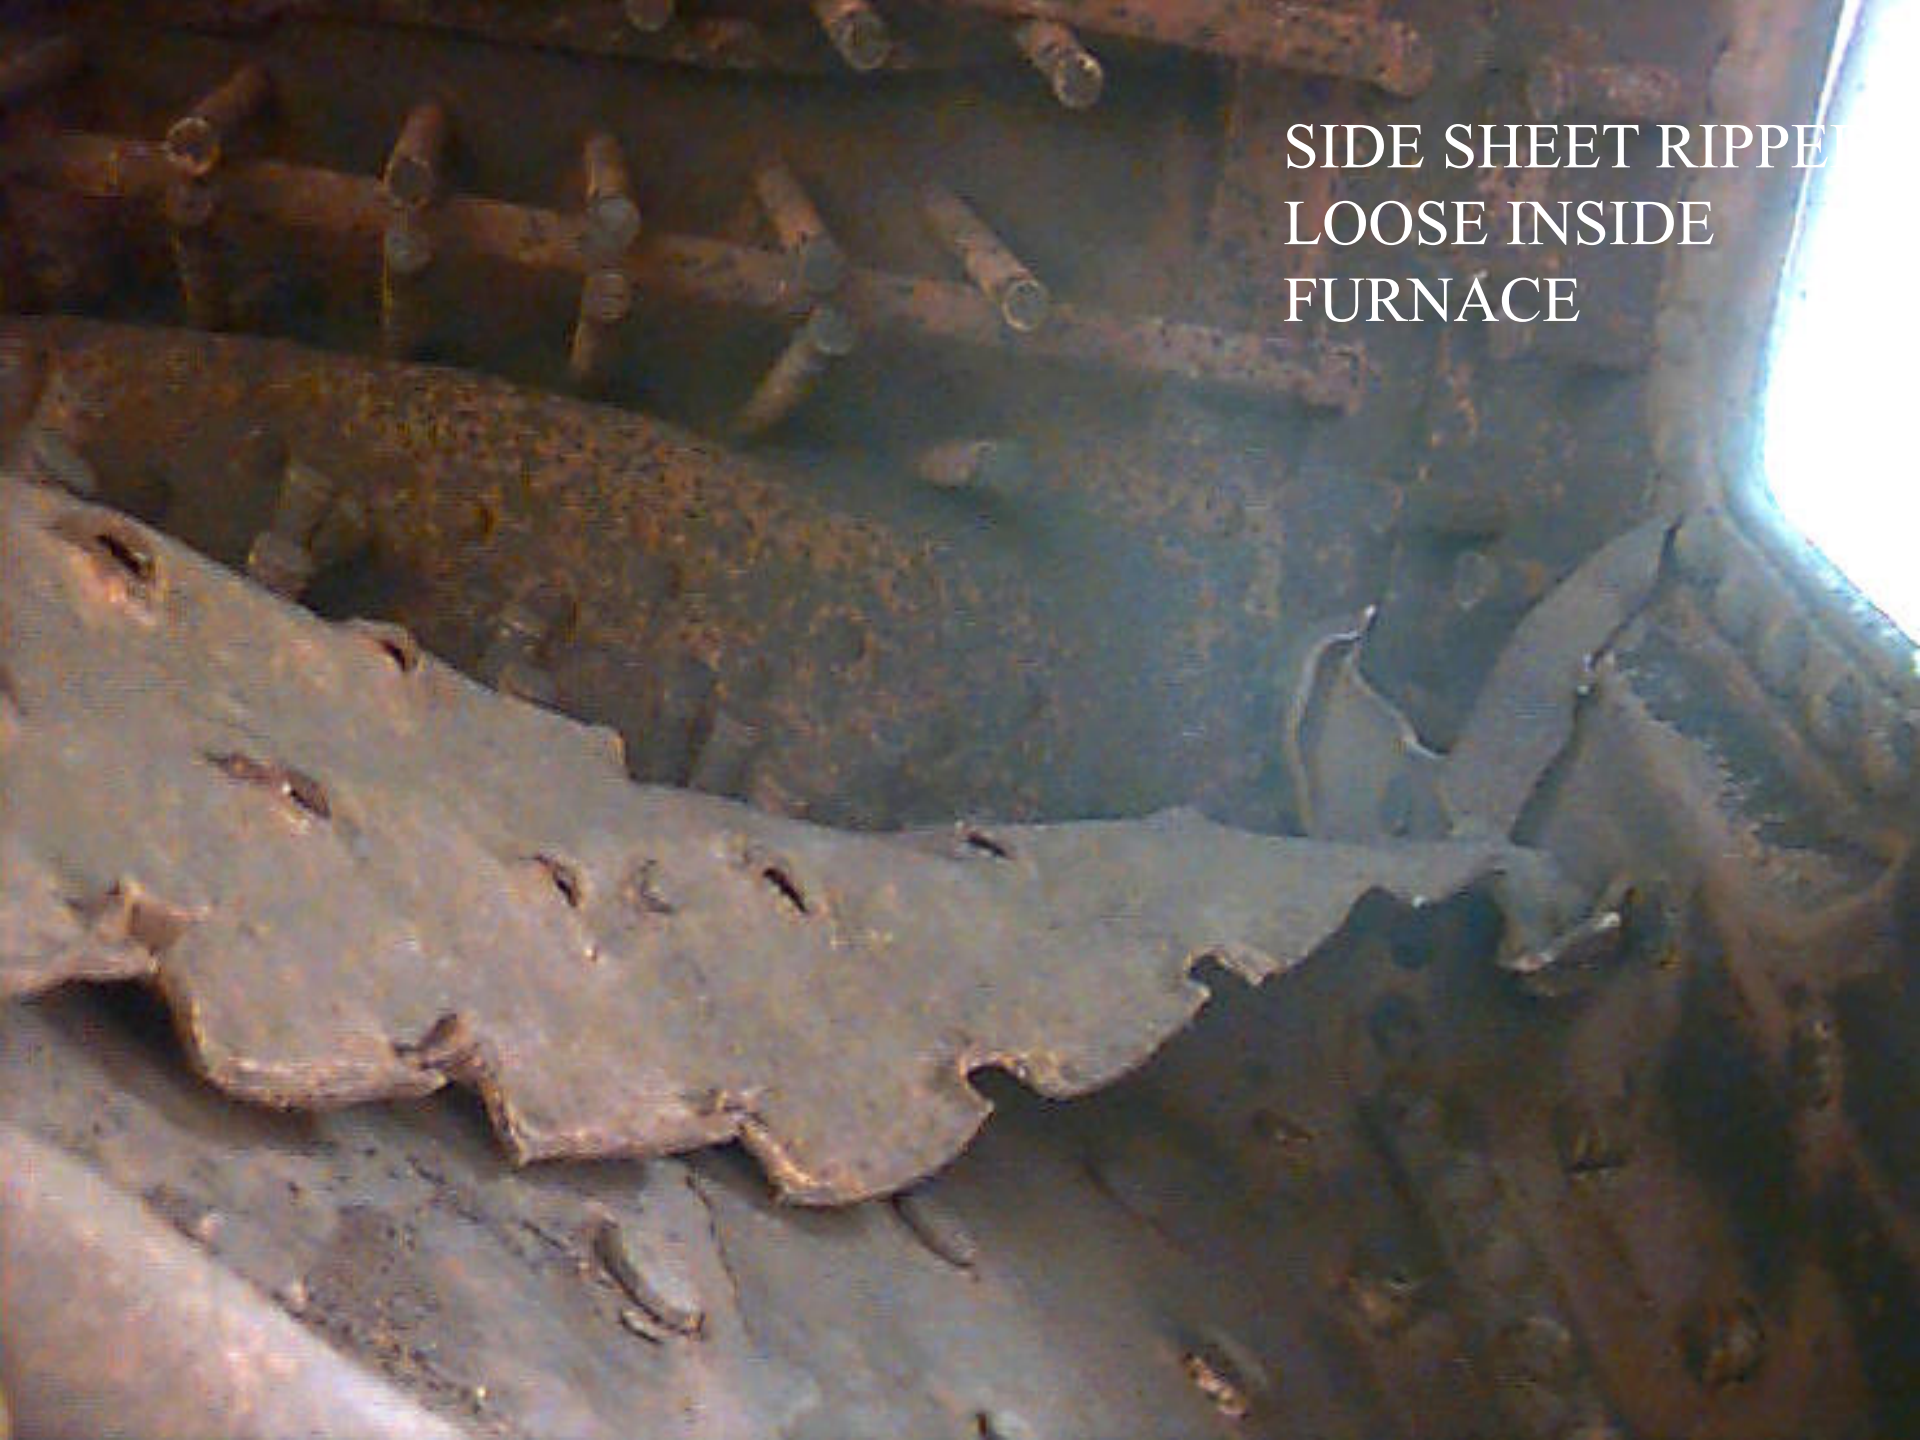
SIDE SHEET RIPPED
LOOSE INSIDE
FURNACE

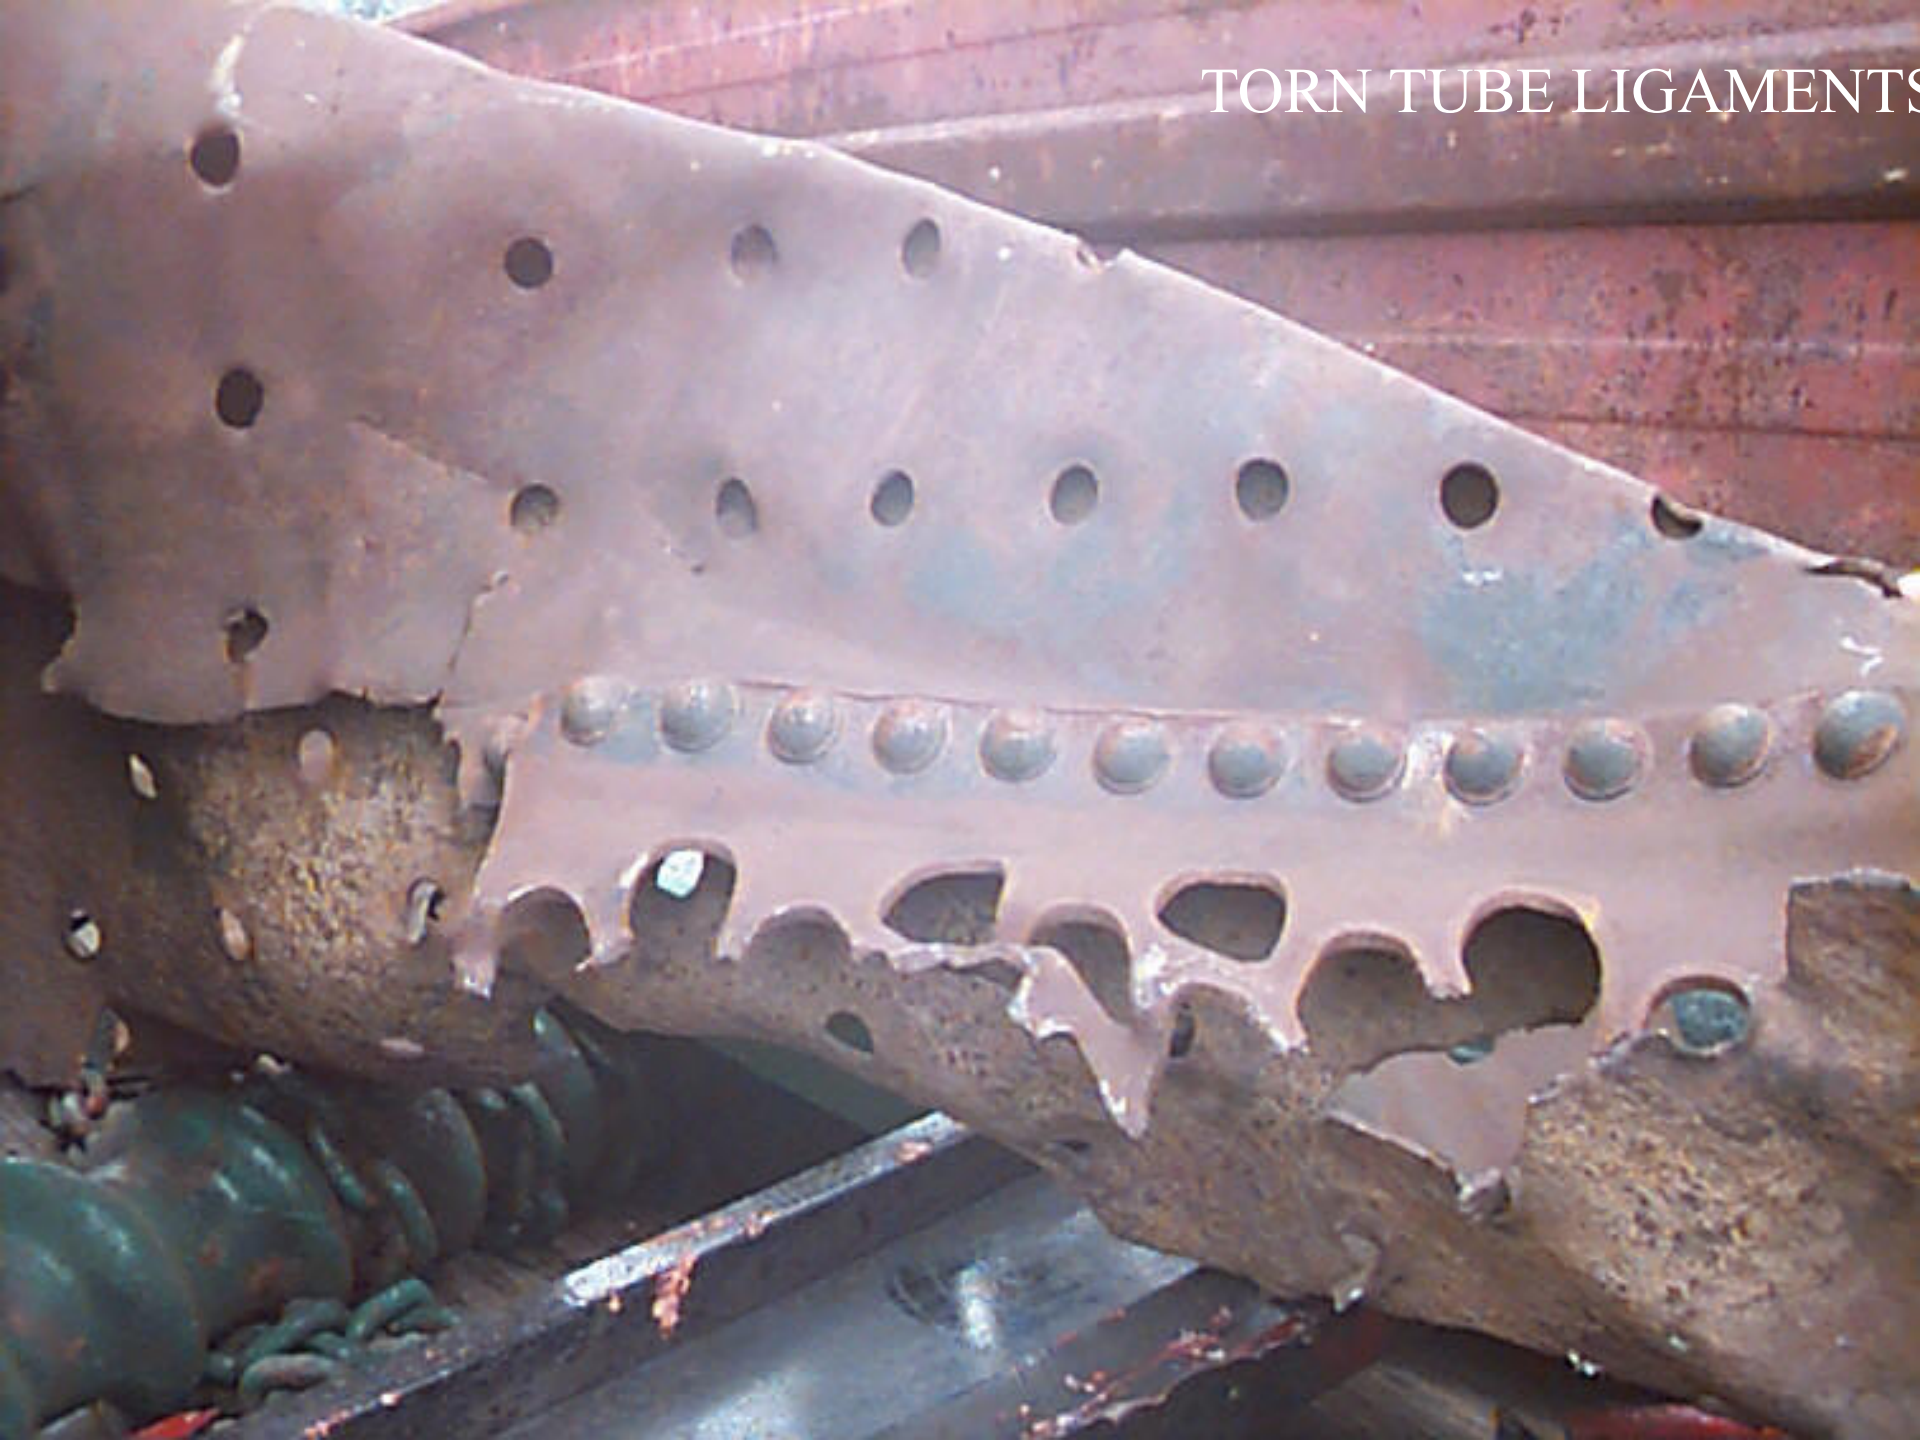
TORN TUBE LIGAMENTS

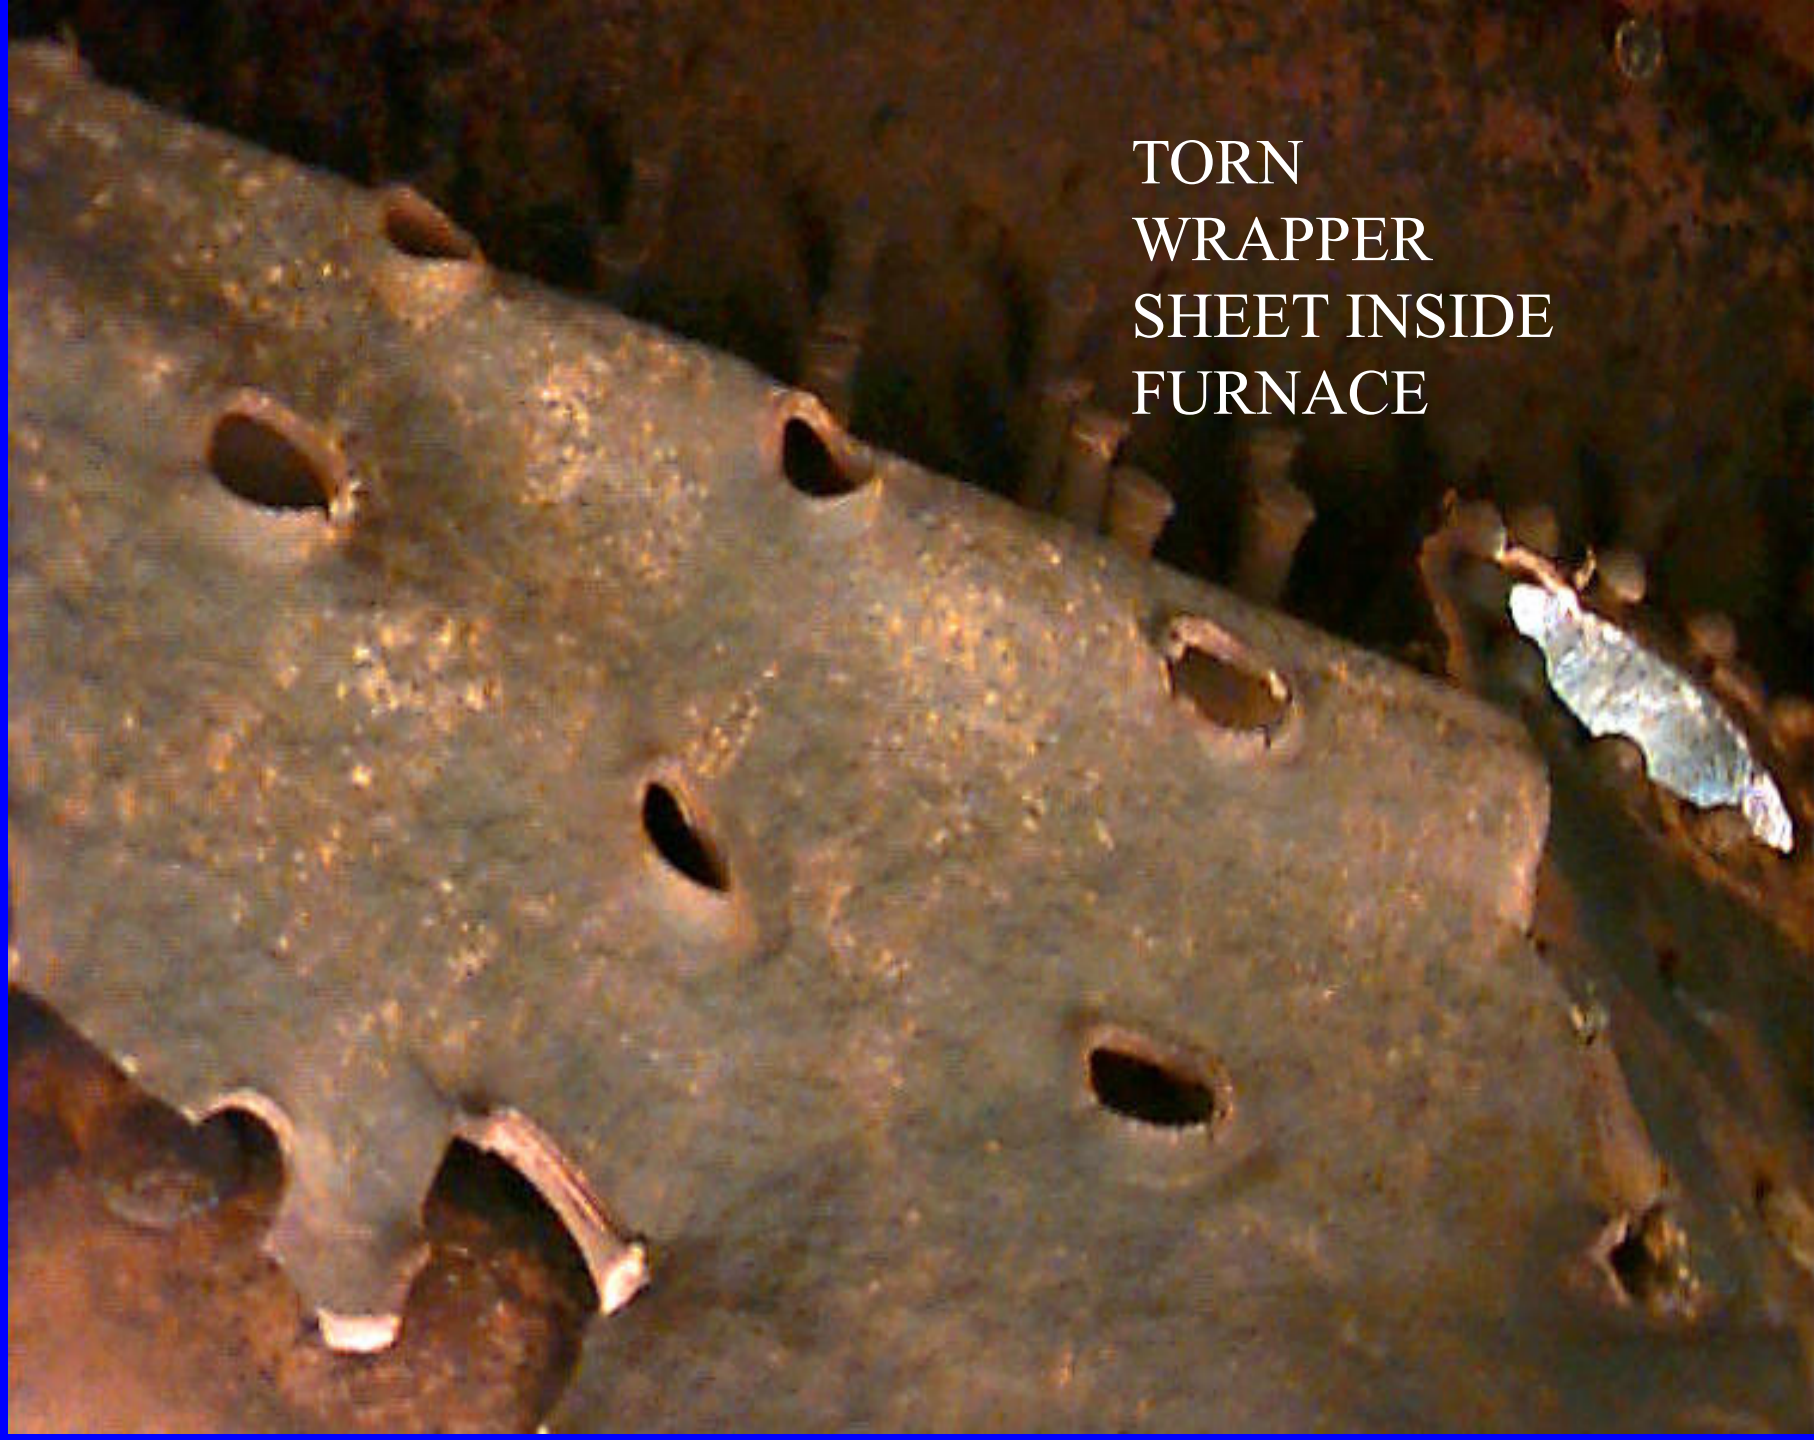
TORN
WRAPPER
SHEET INSIDE
FURNACE

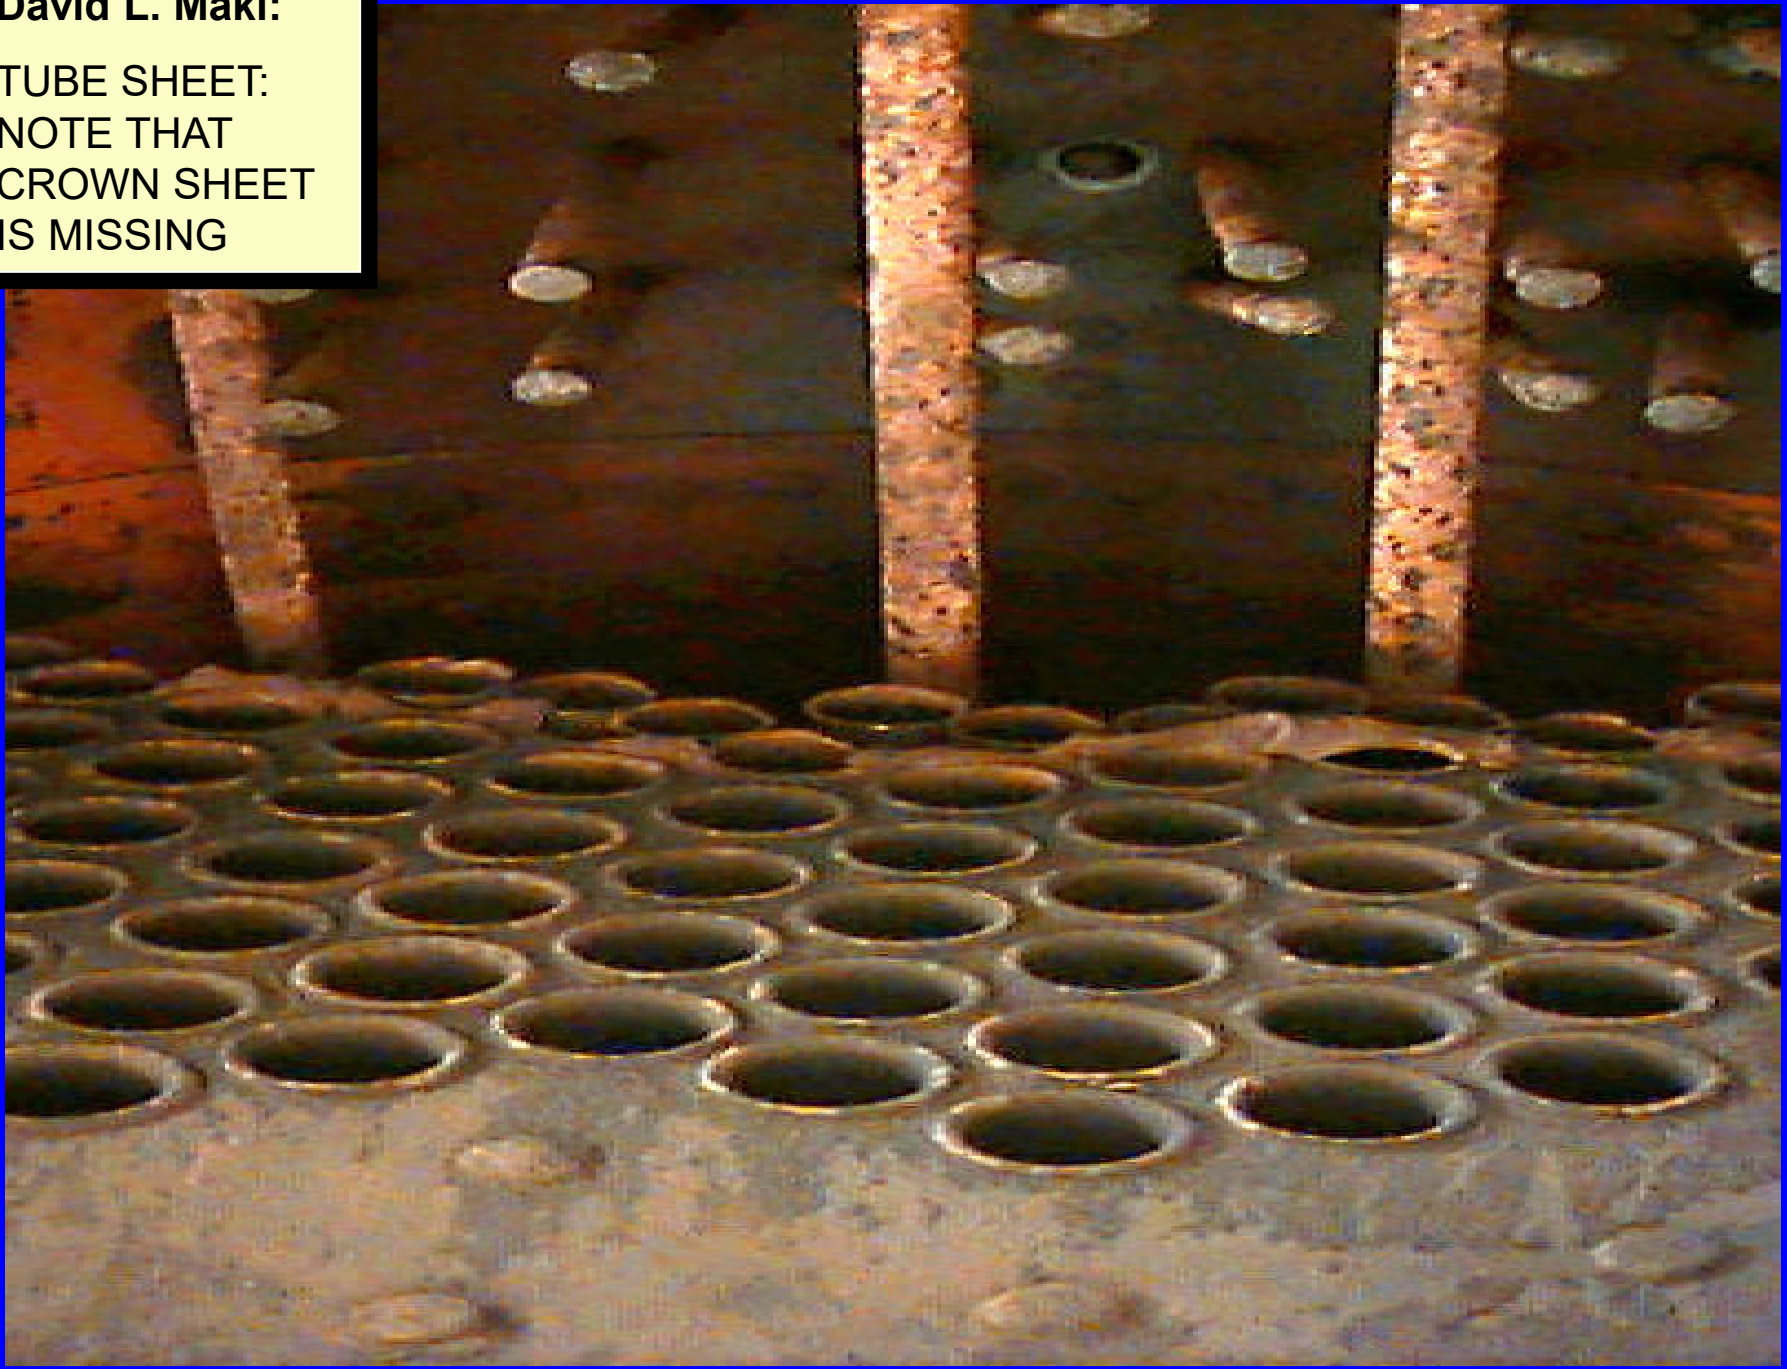
David L. Maki:
TUBE SHEET:
NOTE THAT
CROWN SHEET
IS MISSING
