# FINAL INVESTIGATION REPORT

## CHEVRON RICHMOND REFINERY PIPE RUPTURE AND FIRE

### CHEVRON RICHMOND REFINERY #4 CRUDE UNIT RICHMOND, CALIFORNIA

AUGUST 6, 2012

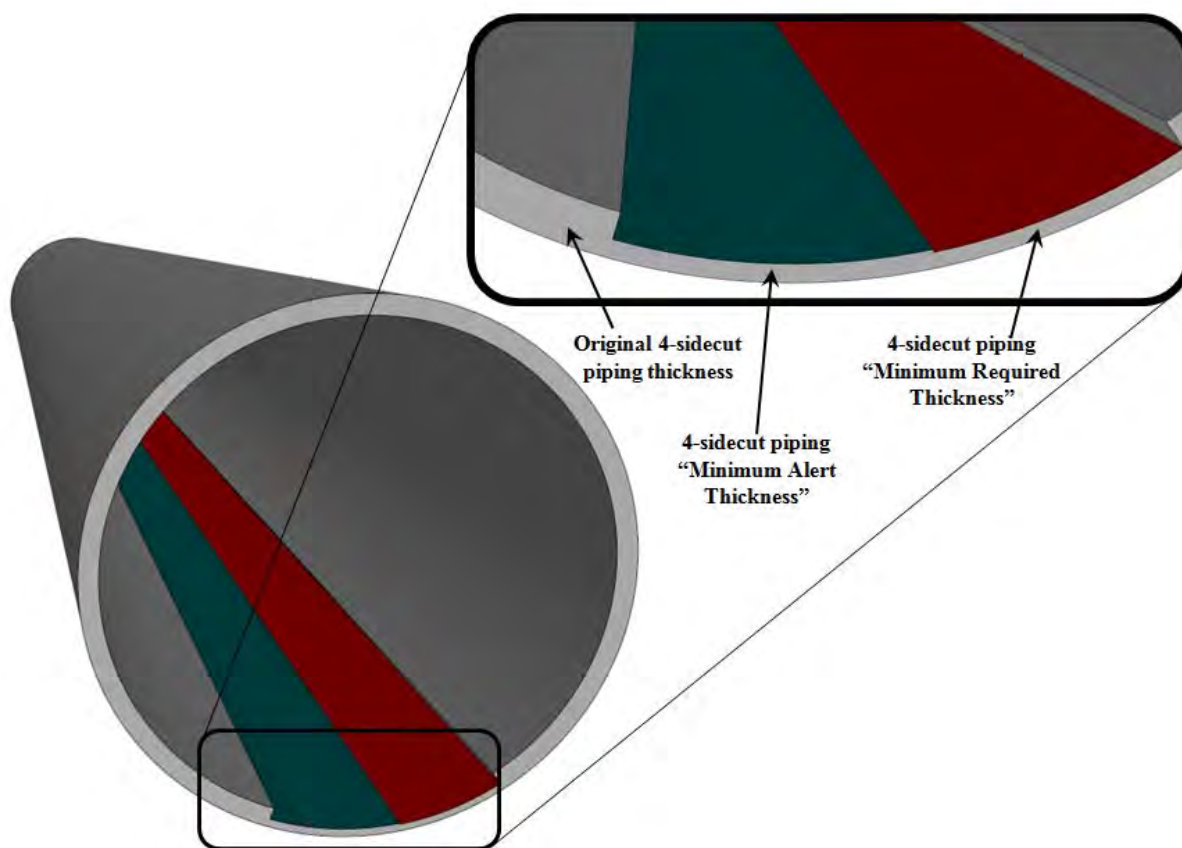
**Figure 1. To-scale schematic of 4-sidecut piping identifying key wall thickness values. These include the original wall thickness (0.322-inch), "Minimum Alert Thickness" (0.13-inch), and "Minimum Required Thickness" (0.11-inch) using *API RP 574* default values.**

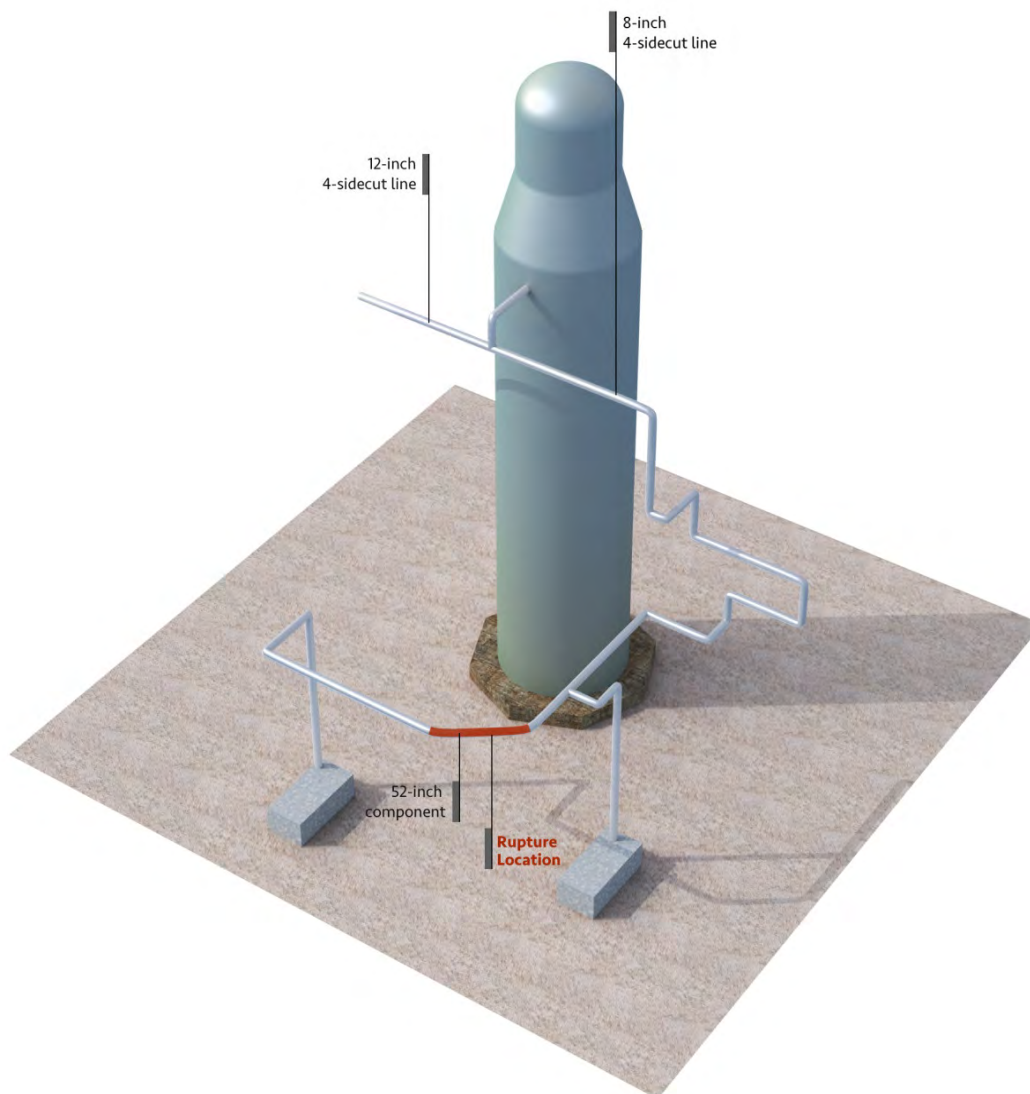
**Figure 4. 4-sidecut line configuration and rupture location.**

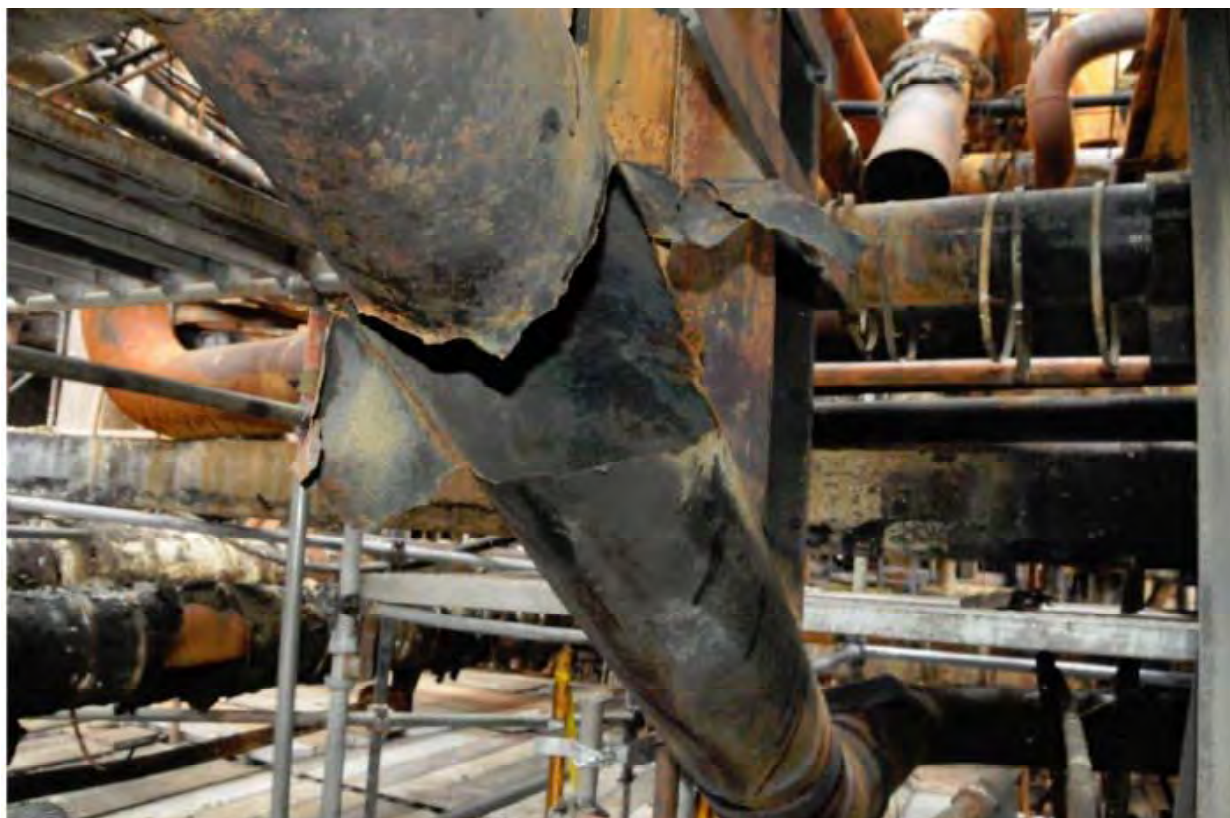
Figure 5. Photo of rupture on 4-sidecut 52-inch component.

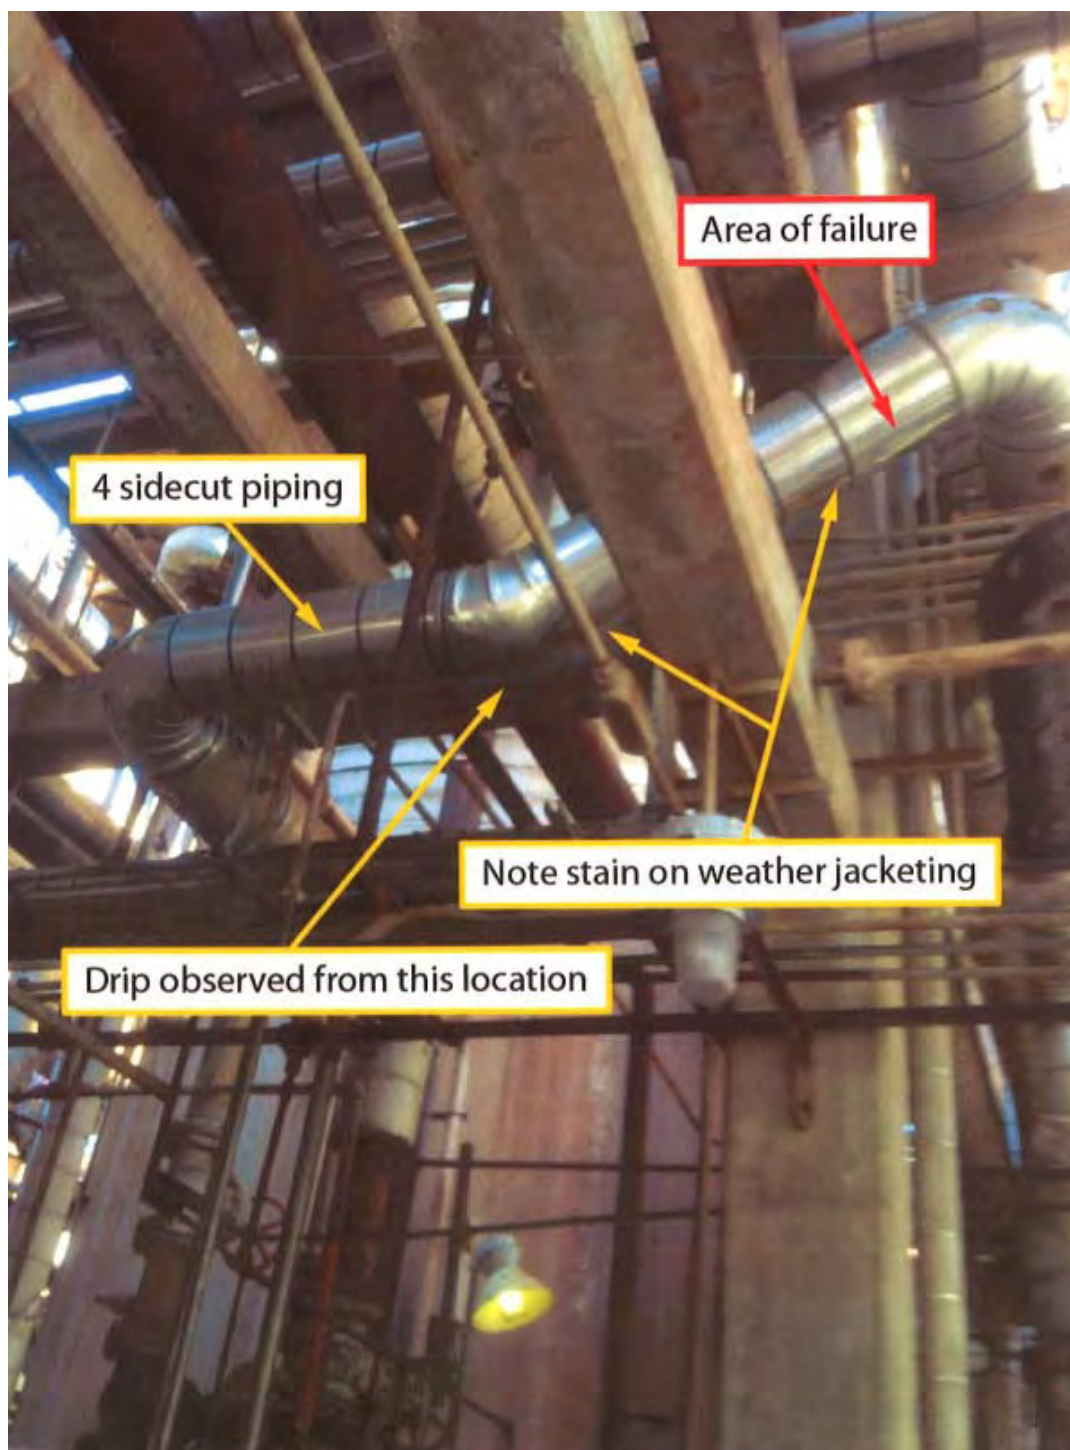
Figure 7. Photo taken of the leaking 4-sidecut pipe on August 6, 2012, at the Chevron Richmond Refinery.<sup>49</sup> Insulation obscured the actual leak location. Stain signifies where hydrocarbon process fluid was leaking from the 4-sidecut piping.

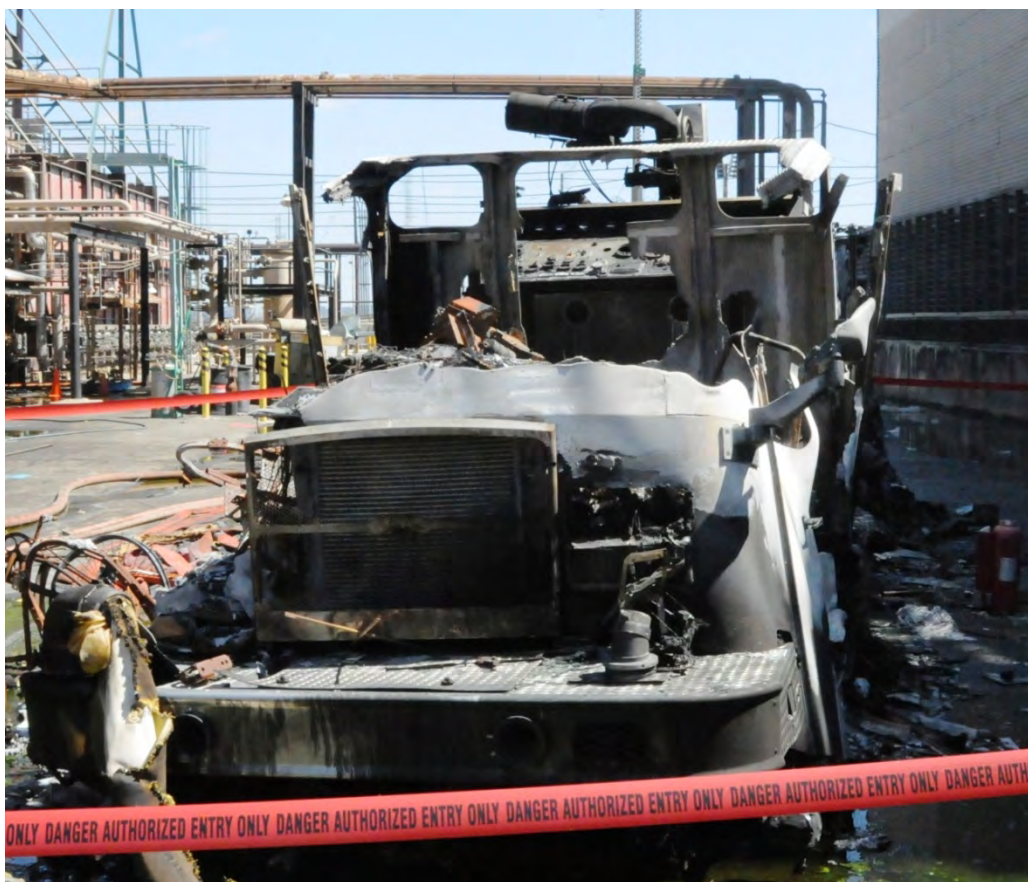
**Figure 14. Photo of the burned remains of the fire truck that was consumed by the fire. A firefighter was in the cab when the light gas oil ignited. The fire truck was positioned in the cold zone approximately 65 feet from the leak location.**

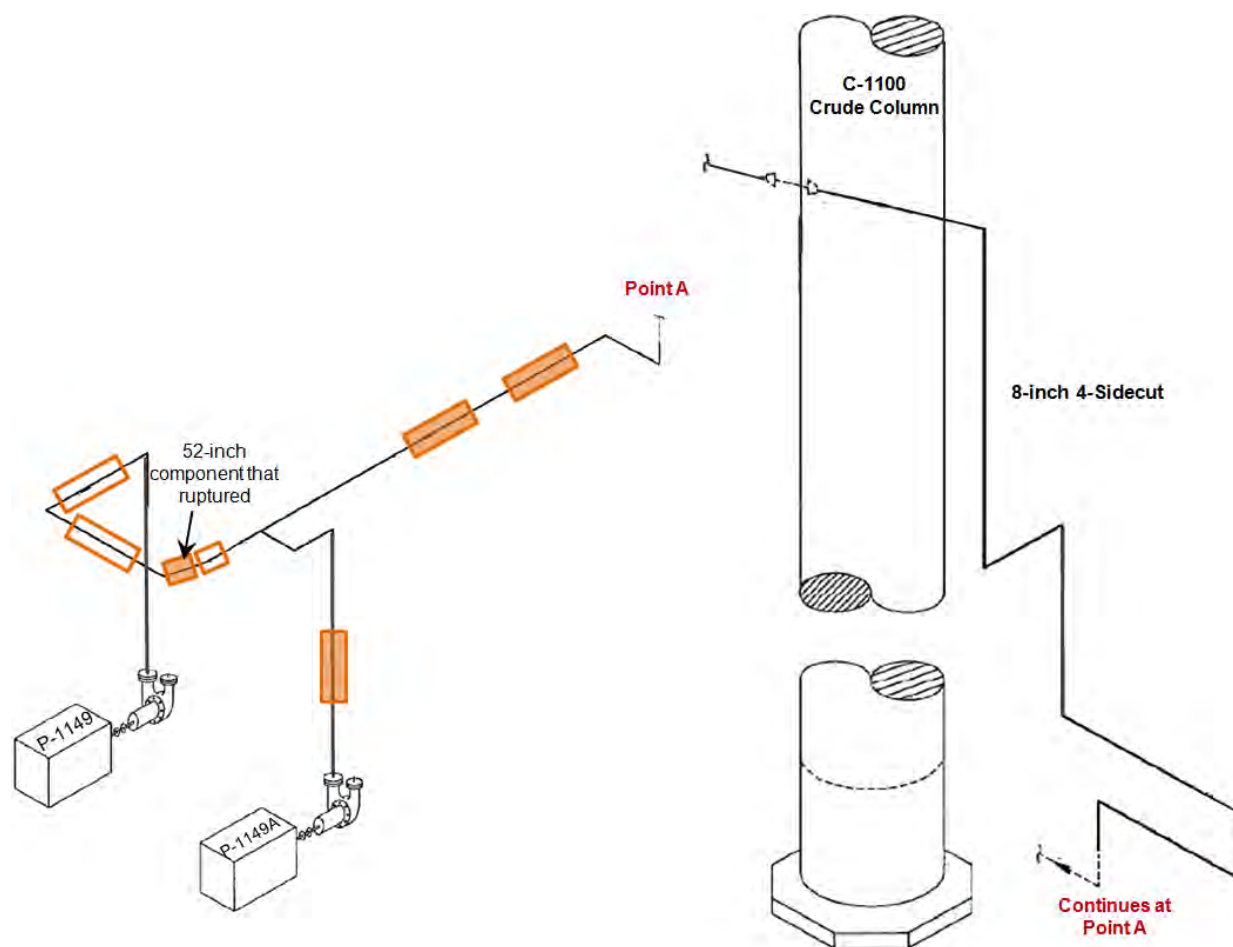
**Figure 18. Locations of metallurgical samples taken from 8-inch 4-sidecut piping post-incident. The seven samples taken are boxed in orange. Four of the seven components sampled (shown with an orange fill) were found to have a silicon content less than 0.10 weight percent.**

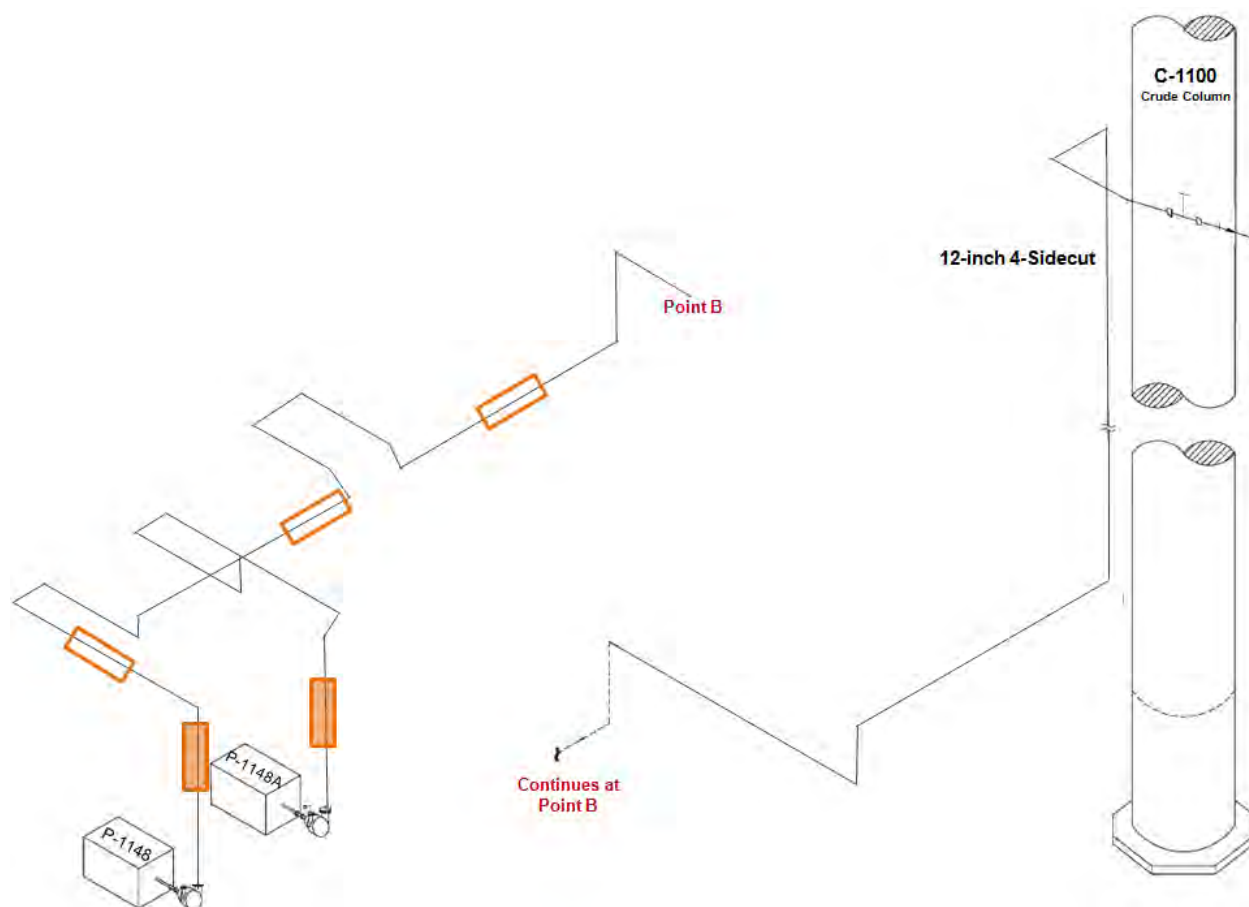
**Figure 19. Locations of metallurgical samples taken from 12-inch 4-sidecut piping post-incident. The five samples taken are boxed in orange. Two of the five components sampled (shown with an orange fill) were found to have a silicon content less than 0.10 weight percent.**

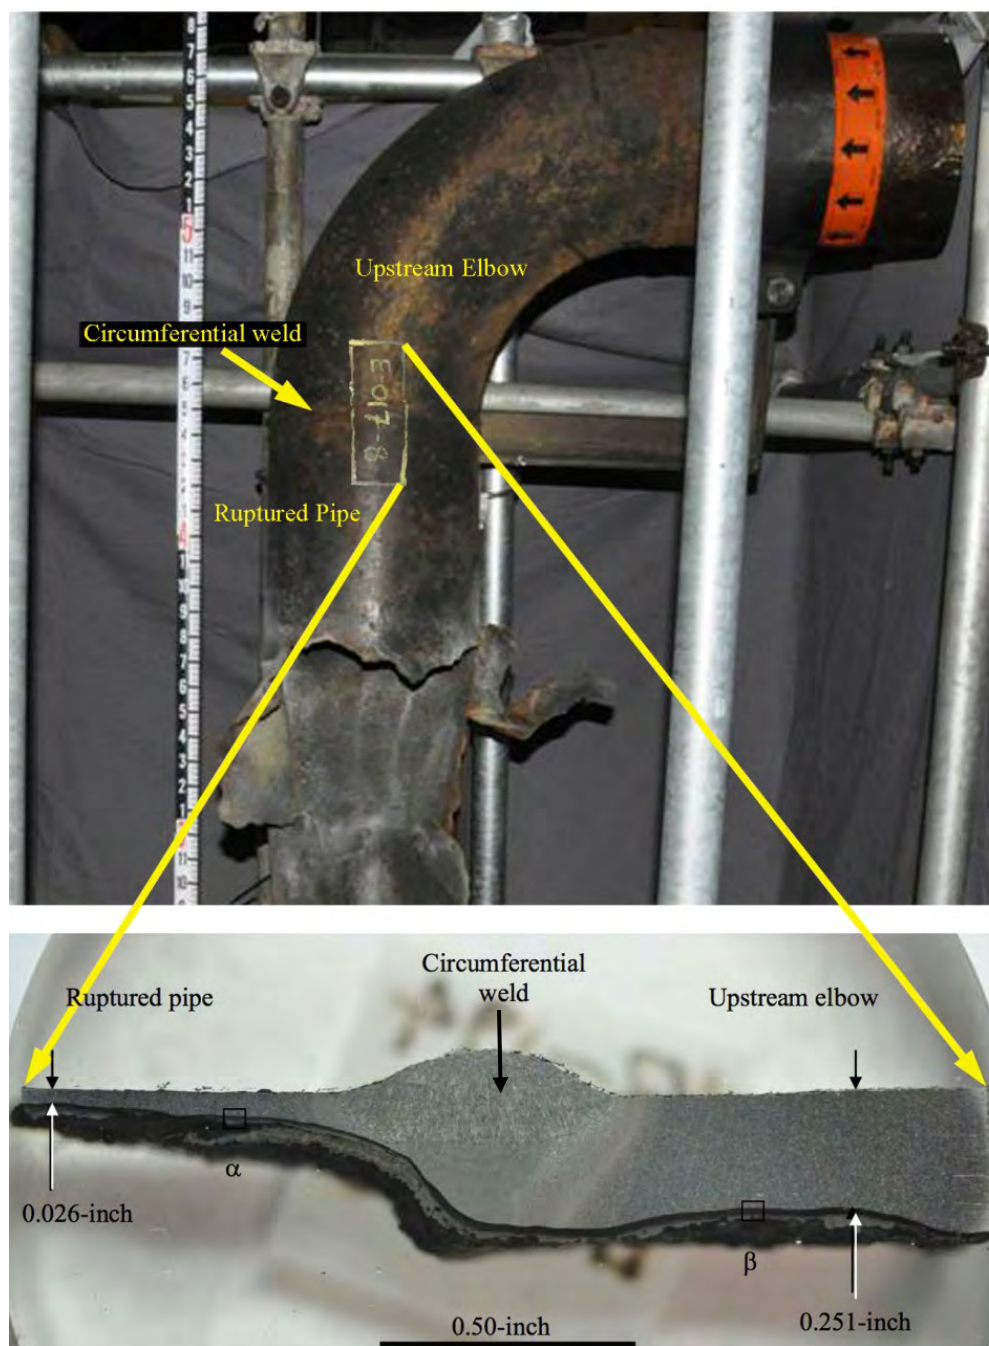
**Figure 20. 4-sidecut piping sample (E-017-8) analyzed by Anamet Labs showing the relative thickness of low silicon piping on the left and the high silicon piping on the right. The ruptured 52-inch pipe component (left) contained 0.01 weight percent silicon, and the upstream elbow component (right) contained 0.16 weight percent silicon.<sup>75</sup> The initial nominal thickness of this piping was 0.322-inch.**

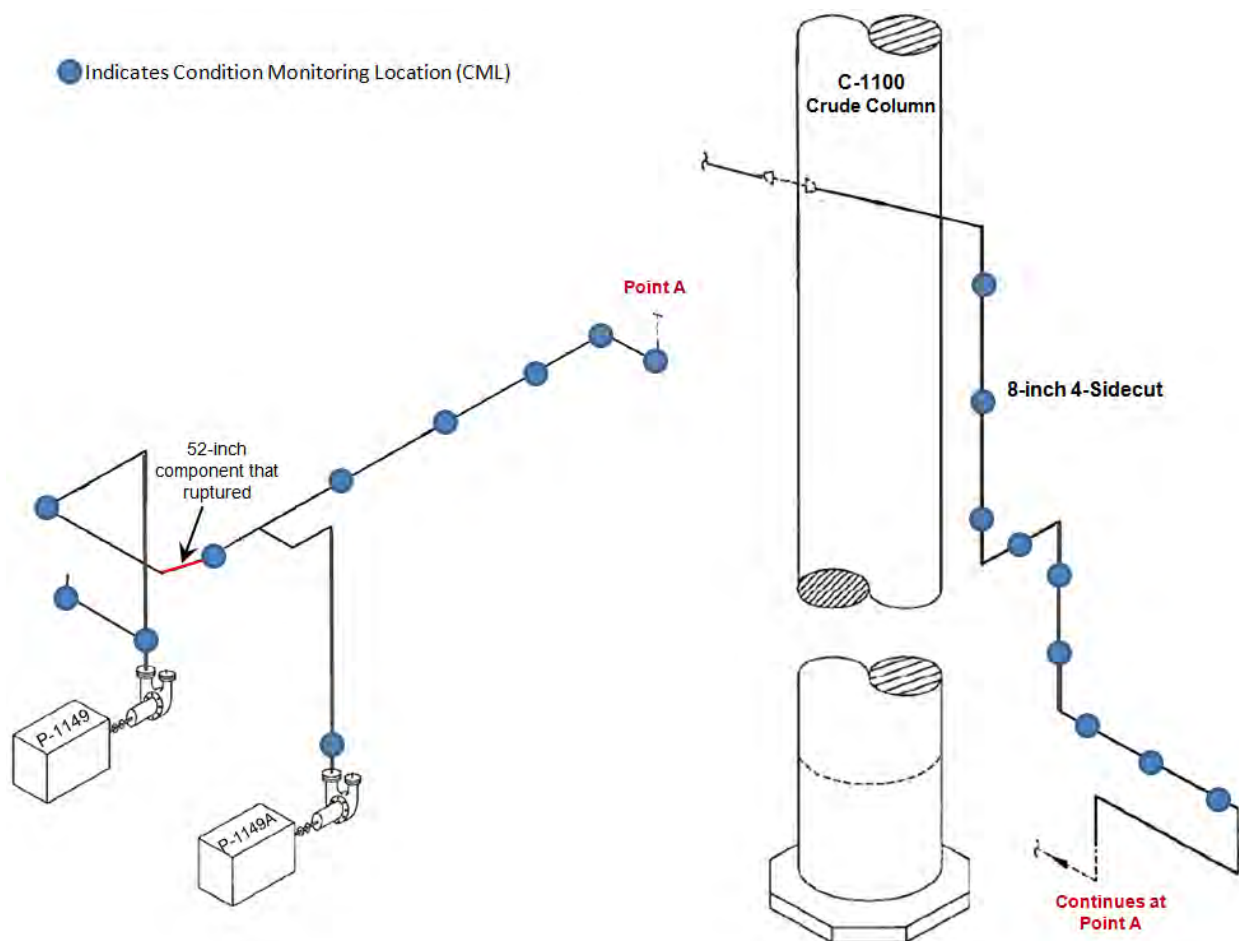
the 8-inch 4-sidecut piping circuit, although 100 percent component inspection was not performed. The CSB found that, although a CML was located on the adjacent upstream elbow, no CMLs were placed on the low silicon piping component that failed (Figure 21). Chevron identified corrosion in the 52-inch component during a supplemental 2002 inspection,<sup>87</sup> but the inspection results were not entered into the CML-tracking portion of the inspection database, and no new CML was required to be added to ensure future monitoring. As a result, the 52-inch component was never inspected again (Section 5.1.2.1.1).

**Figure 21. CML placement on 8-inch 4-sidecut piping. Nineteen CMLs were used to monitor corrosion rates in the 8-inch 4-sidecut piping. A CML was not placed on the 52-inch component that ultimately failed. A CML was placed, however, on the upstream elbow adjacent to the 52-inch component.**

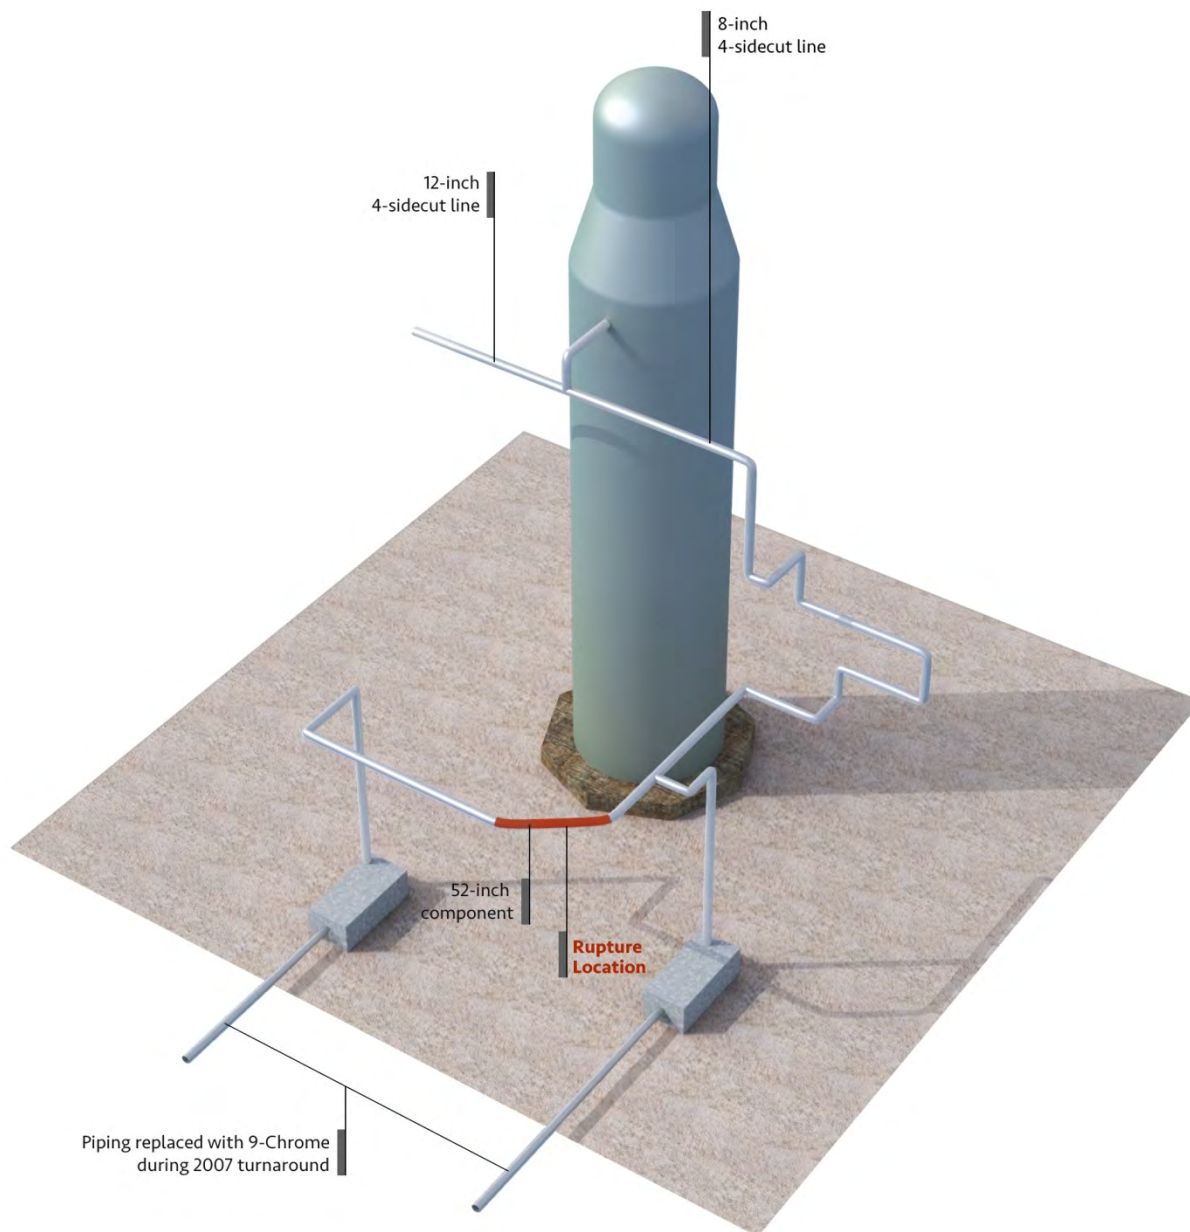
**Figure 33. Crude column schematic indicating the piping downstream of the 4-sidecut pumps that was replaced during the 2007 Crude Unit turnaround. The portion of the carbon steel line containing the component that failed on August 6, 2012 was not replaced.**

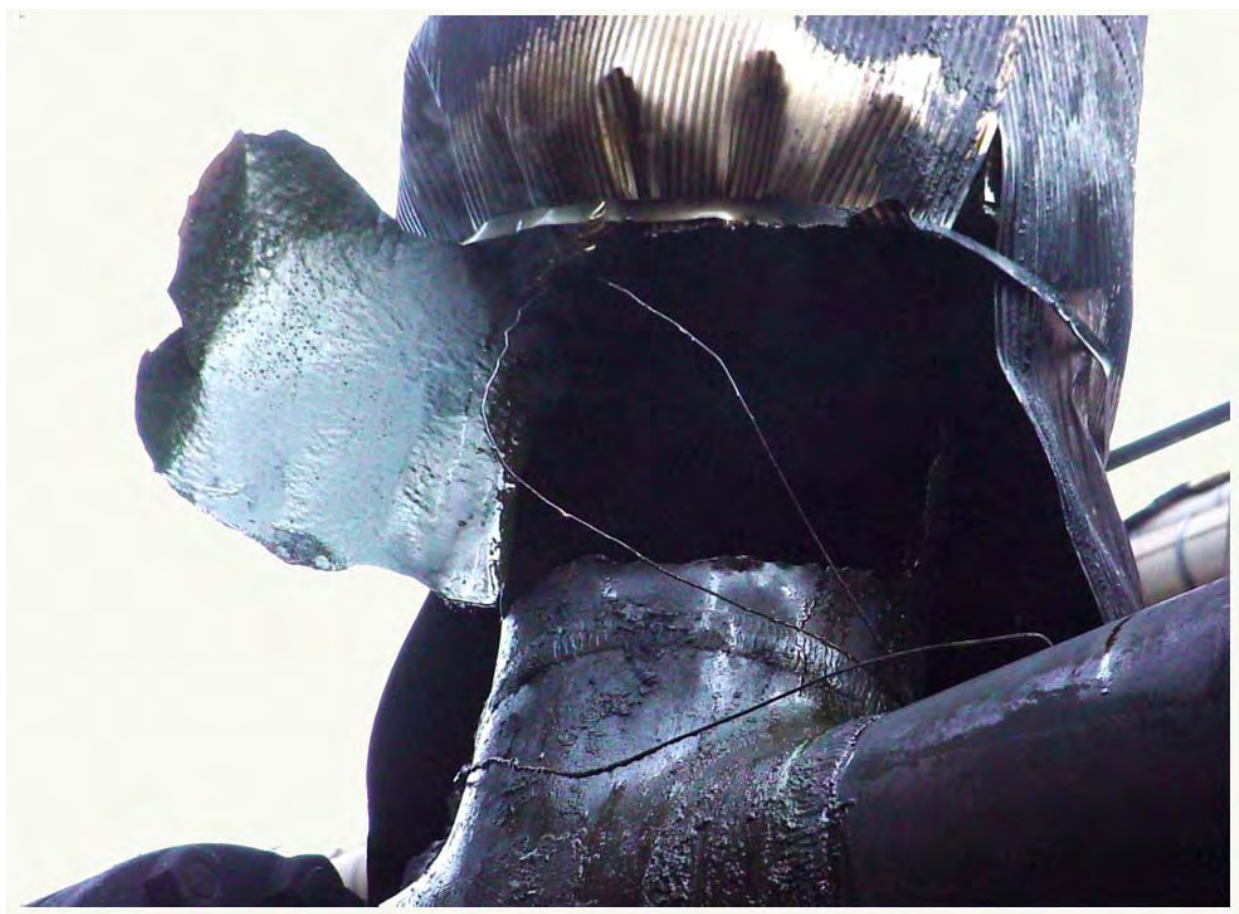
**Figure 38. Photo from API RP 939-C of a low-silicon pup piece that ruptured at a BP refinery. The surrounding piping had higher silicon content, and the pup piece’s accelerated corrosion rate was unmonitored.**

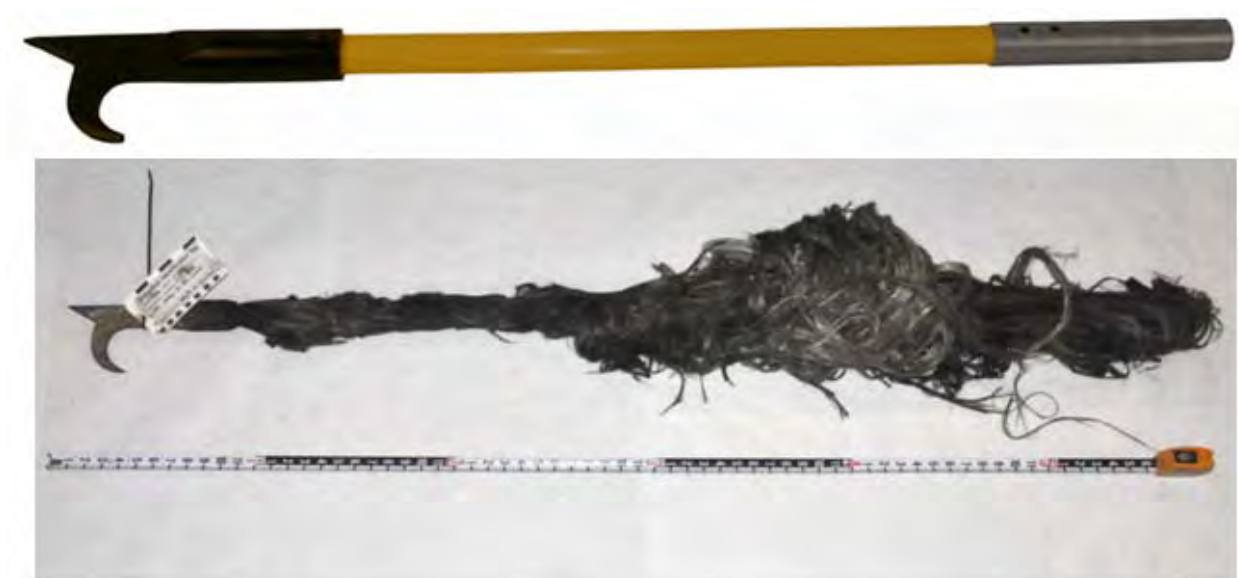
Figure 40. Photo of undamaged<sup>179</sup> (top) and burned during incident (bottom) pike pole used in early attempts to remove 4-sidecut insulation.

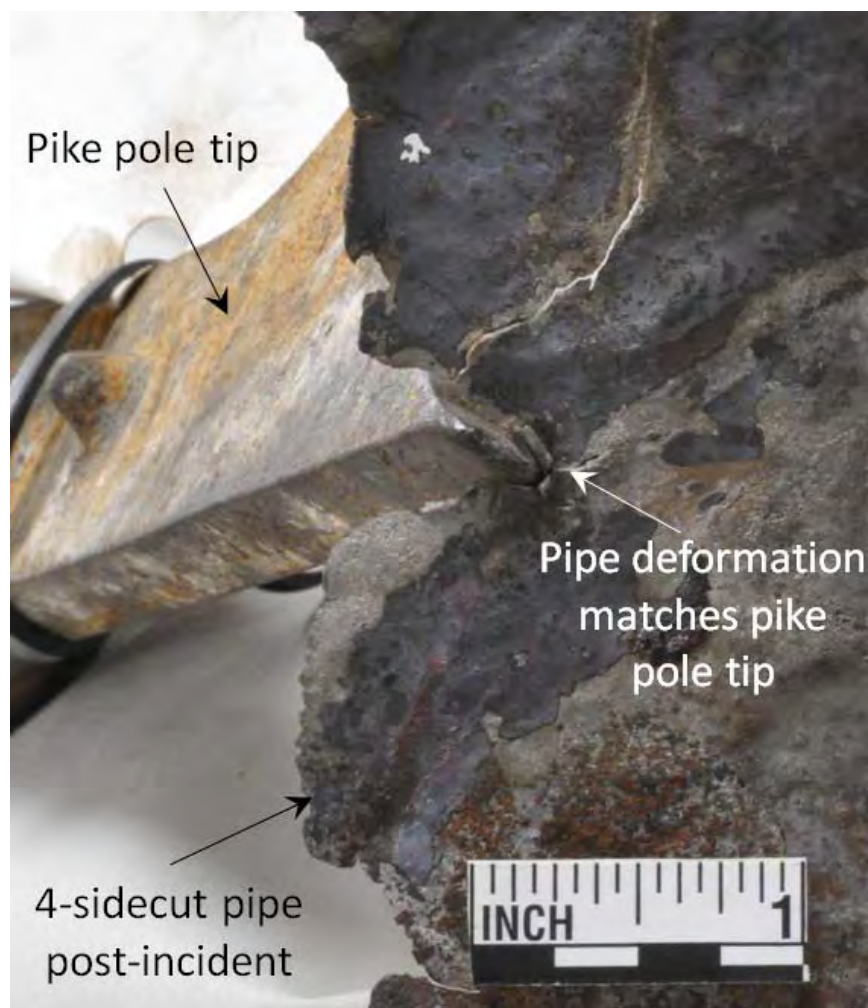
**Figure 41. Photo showing that tip of fire pole matches apparent puncture location in failed 52-inch component of 4-sidecut piping.**
