# FINAL INVESTIGATION REPORT

## CHEVRON RICHMOND REFINERY PIPE RUPTURE AND FIRE

### CHEVRON RICHMOND REFINERY #4 CRUDE UNIT RICHMOND, CALIFORNIA

AUGUST 6, 2012

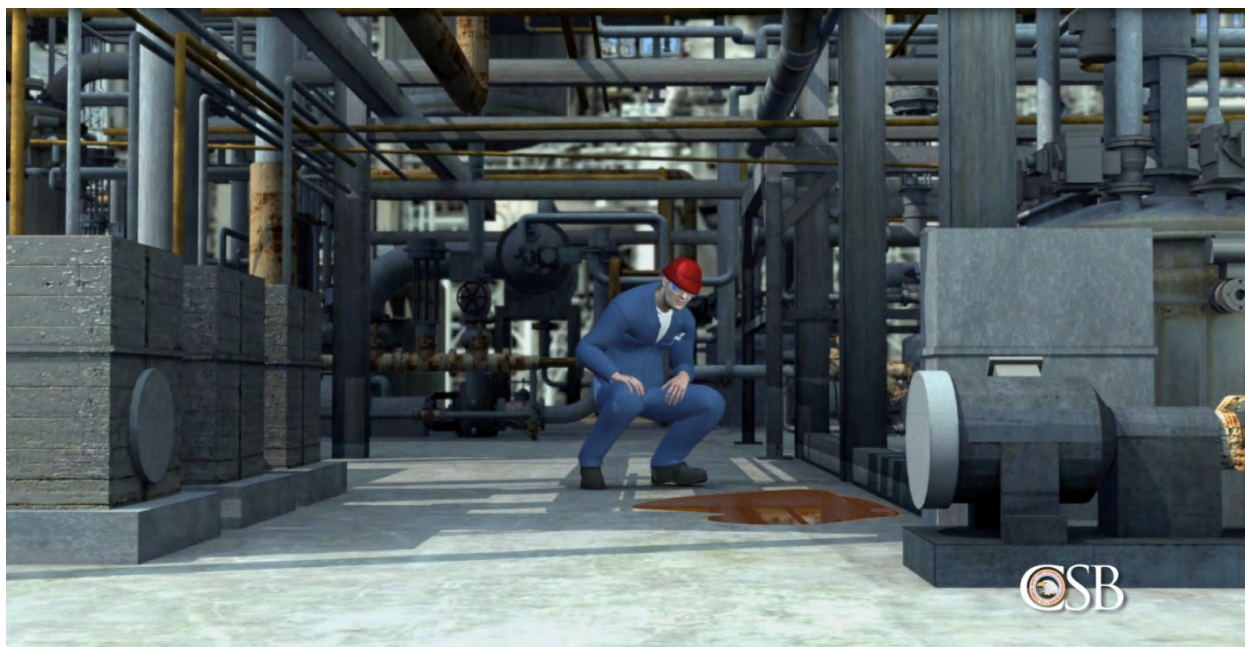
At approximately 3:50 p.m. on August 6, 2012, an outside operator performing routine checks of piping and equipment found an 18-inch puddle of what appeared to be a diesel-like material on the refinery concrete pad (Figure 6). Identifying that the leak was occurring from overhead, the operator observed intermittent drips as they accumulated on the underside of an insulated pipe 14 feet above ground level. The leaking pipe was identified to be a portion of the 4-sidecut piping that originated on the Crude Column. Visually analyzing the piping, the operator determined that the line could not be isolated from the process.

**Figure 6. CSB animation depicting operator identifying the leaking 4-sidecut pipe.**

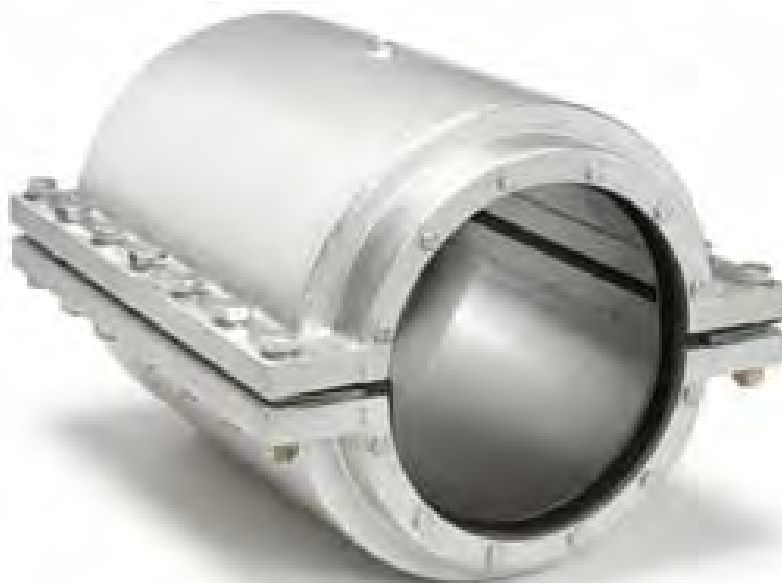
**Figure 9. Example leak repair clamp for piping.<sup>50</sup> It is installed over the leak location to prevent process fluid leakage to the atmosphere.**

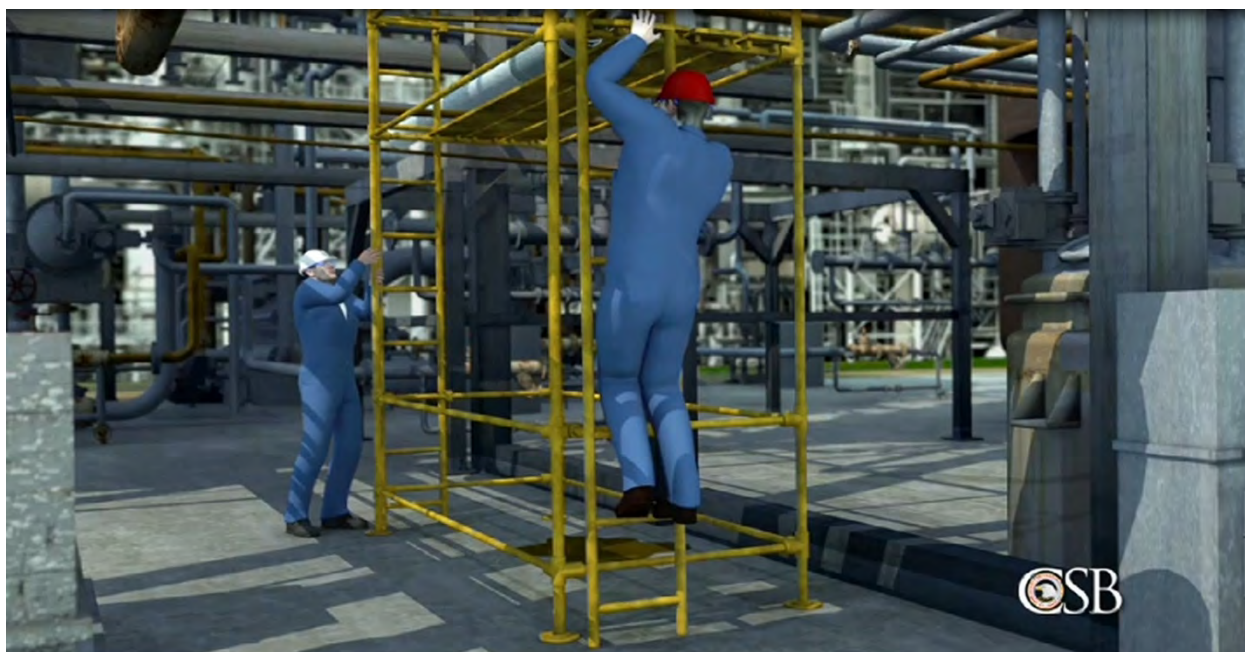
Contractors arrived at the scene to build the scaffold (Figure 10). During a pre-response safety meeting consisting of the Incident Commander, a safety officer, firefighters, and key operations personnel, one group of firefighters operating a hose was directed to spray the scaffold builders should an incident occur, and the other group of firefighters operating the second hose was directed to spray the pipe if needed. Three scaffold contractors then built the scaffold beneath the leaking 4-sidecut pipe.

**Figure 10. CSB animation of contractors erecting scaffolding beneath the leak location.**

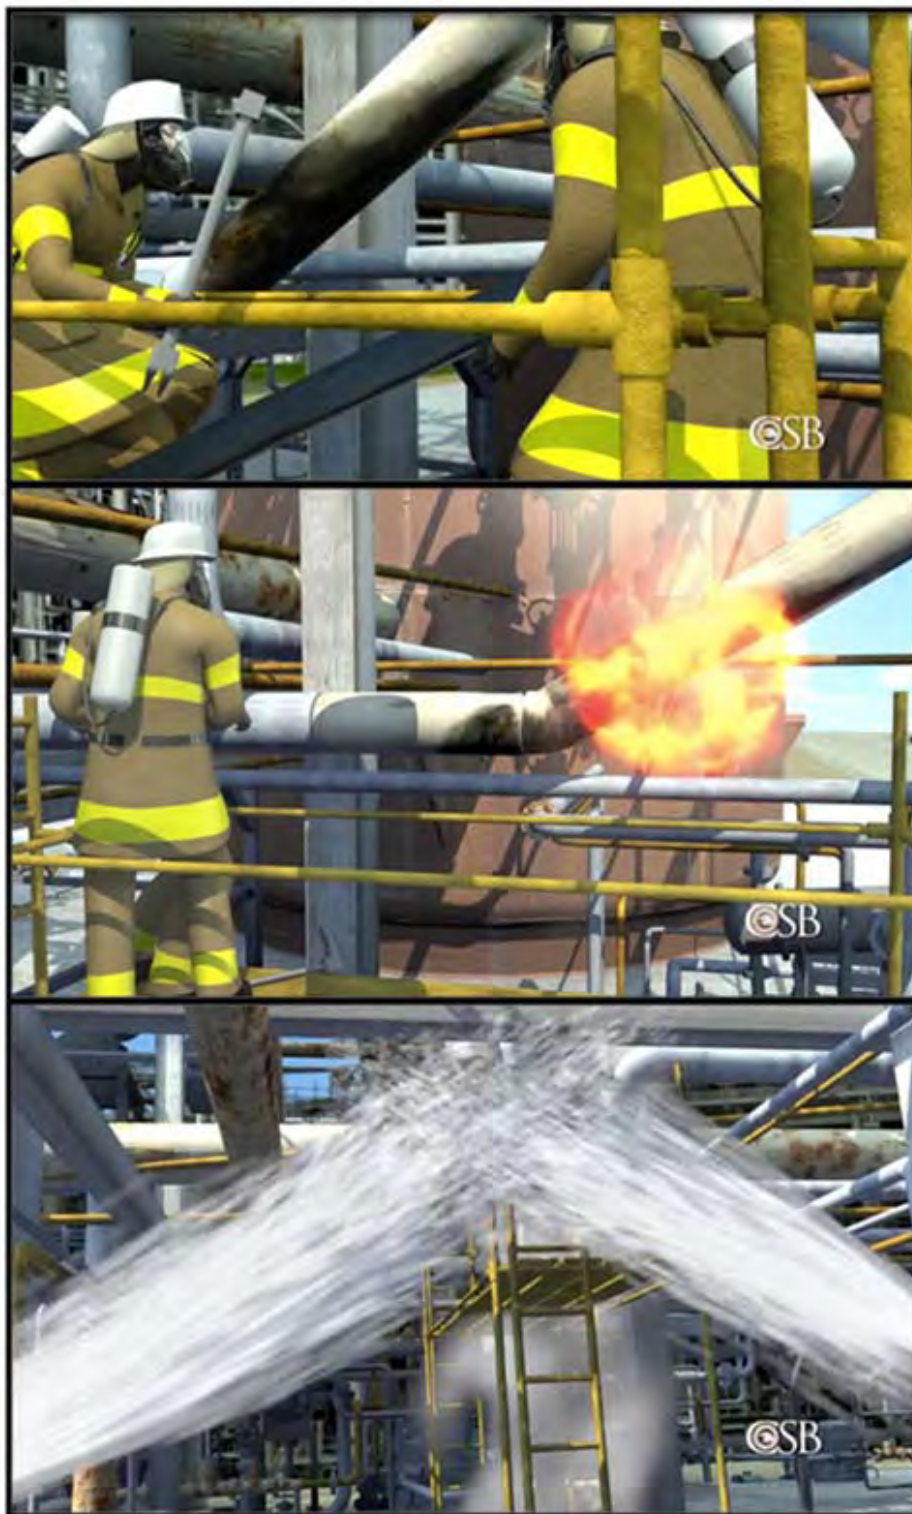
As the firefighters were removing the sheathing of the 4-sidecut line (shown in Figure 7), white hydrocarbon vapor visibly began to emerge from under the now-exposed insulation material. The firefighters continued to remove the sheathing despite the formation of hydrocarbon vapor. During the continued sheathing removal, insulation that was soaked with hot 4-sidecut hydrocarbon autoignited once exposed to oxygen—only feet from the firefighters. The hose teams immediately put out the fire, and both firefighters quickly came down from the scaffold (Figure 11).

Figure 11. CSB animation of firefighters attempting to remove the 4-sidecut insulation, the resulting fire, and fire extinguishing.

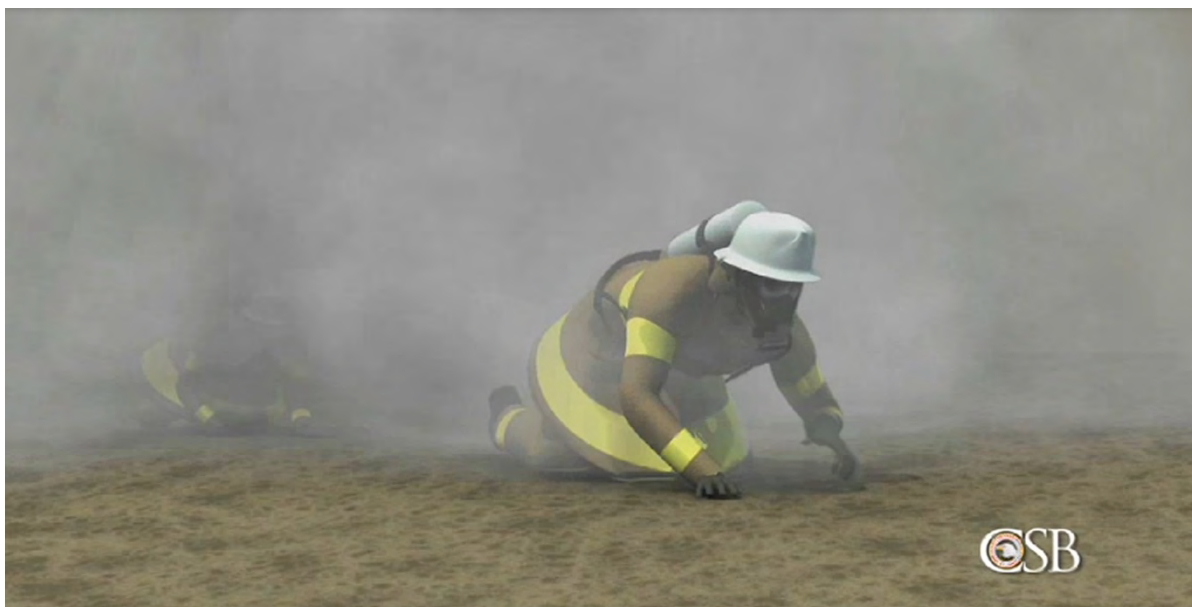
Each person engulfed in the cloud began working their way out of the vapor cloud. Several of the firefighters operating the two hoses dropped to their hands and knees to follow their hose lines to safety, feeling their way out of the cloud (Figure 12).

**Figure 12. CSB animation of firefighters who dropped to their hands and knees to escape the vapor cloud.**

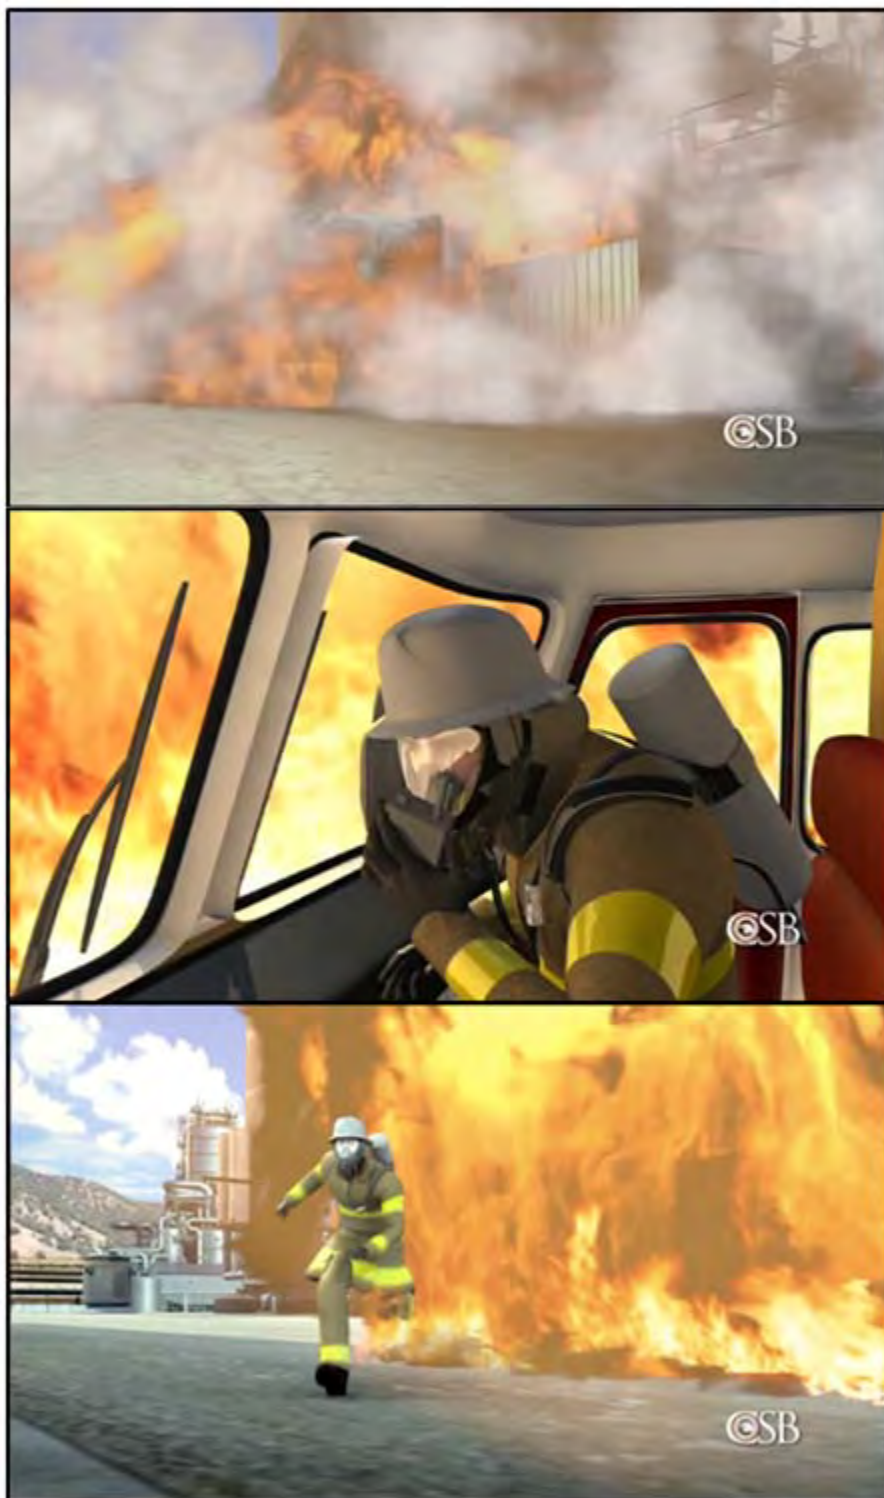
At approximately 6:30 p.m., two minutes after the large vapor cloud formed, the light gas oil ignited.<sup>53</sup> Eighteen employees safely escaped from the cloud just before ignition. One employee, a firefighter, was inside a fire engine that was engulfed in the fireball when the light gas oil ignited (Figure 13 and Figure

Figure 13. CSB animation of firefighter who was inside the fire engine when the light gas oil ignited.

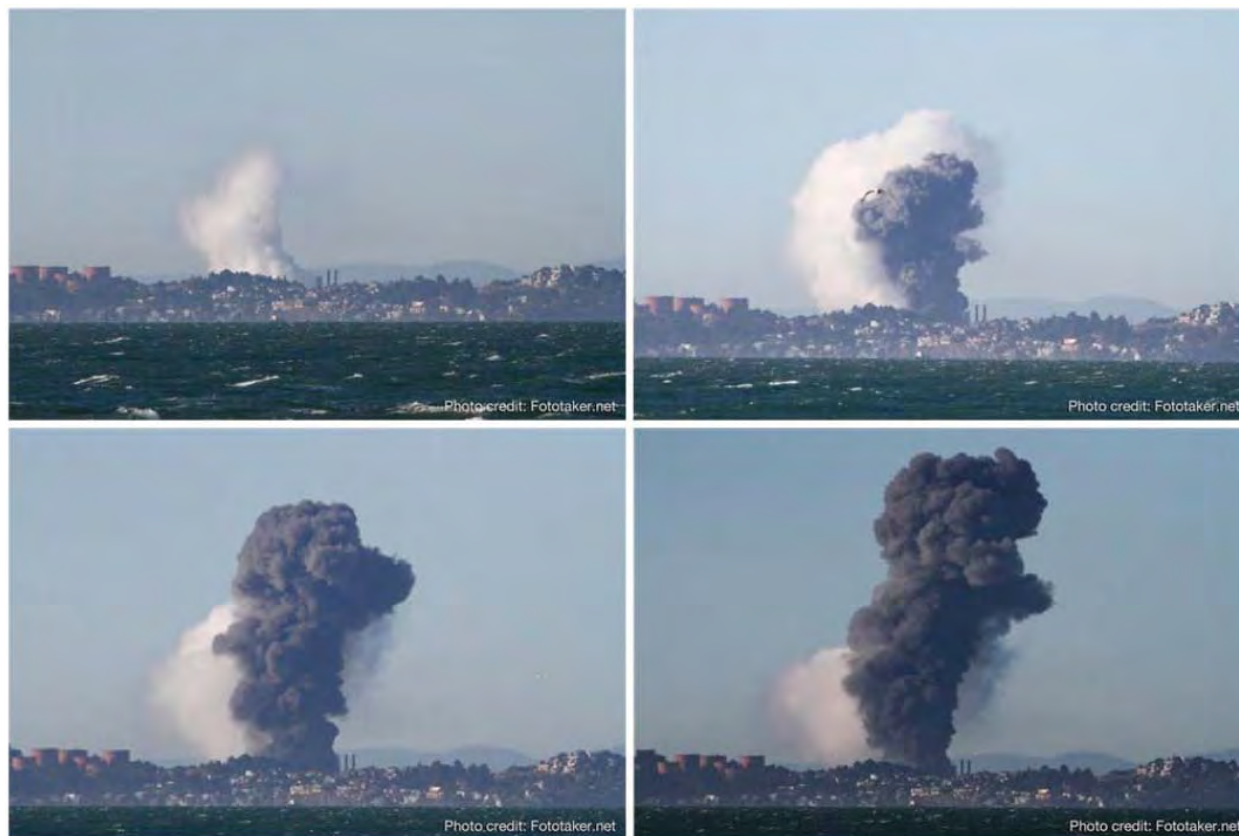
The leak resulted in a large plume of vapor which traveled across the surrounding area. The ignition and subsequent burning of the hydrocarbon process fluid created a large black cloud of smoke, which also swept across the surrounding area (Figure 15). This situation resulted in a Community Warning System (CWS) Level 3 alert,<sup>54</sup> and a shelter-in-place<sup>55</sup> advisory (SIP) was issued at 6:38 p.m.<sup>56</sup> for Richmond, San Pablo, and North Richmond. It was lifted later that night at 11:12 p.m. after the fire was fully under control. In the weeks following the incident, nearby medical facilities received over 15,000 members of the public seeking treatment for ailments including breathing problems, chest pain, shortness of breath,

**Figure 15. Initial vapor cloud formation (white cloud) and subsequent ignition (black smoke) as seen from a pier in San Francisco, California.<sup>57</sup>**

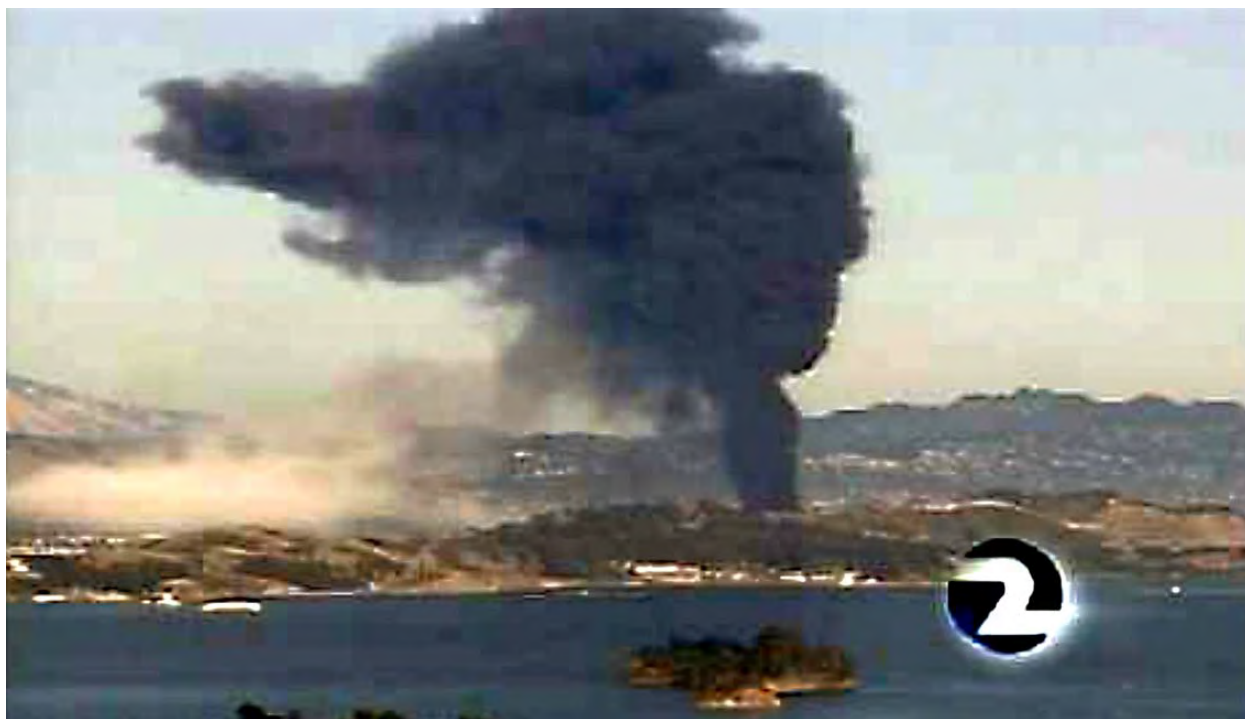
Figure 16. Vapor cloud and ignition seen from Marin County.<sup>58</sup>

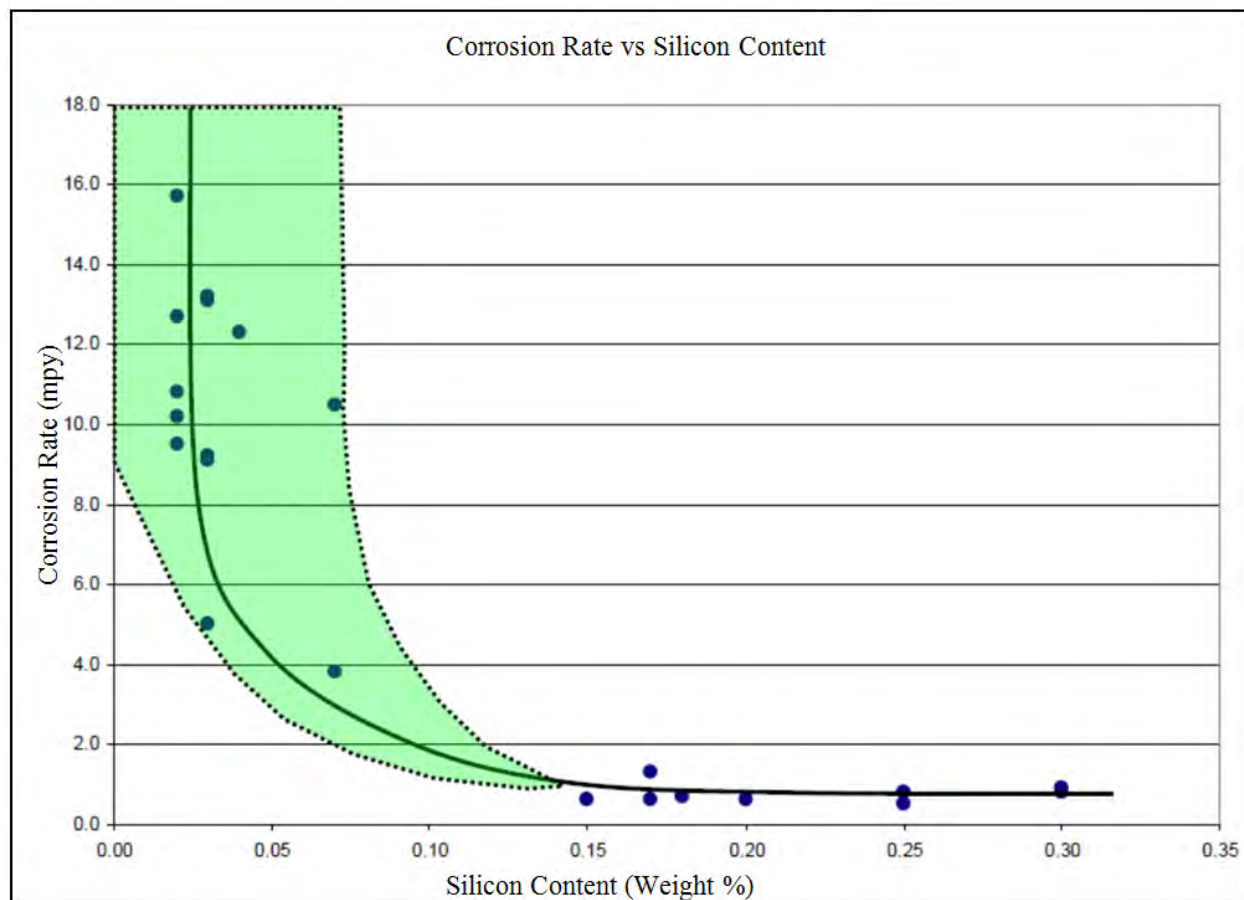
Sulfidation corrodes carbon steel at a much faster rate in comparison with its effect on other materials of construction, such as steels with a higher chromium content. This issue is discussed in depth in the CSB's Interim Investigation Report of the August 6, 2012, Chevron incident.<sup>65</sup> In addition to its naturally faster rate of sulfidation corrosion when compared with higher chromium steels, carbon steel can also experience significant variation in corrosion rates due to variances in silicon content, a component used in the steel manufacturing process. Carbon steel piping containing silicon content less than 0.10 weight percent can corrode at accelerated rates,<sup>66</sup> up to 16 times faster than carbon steel piping containing higher percentages of silicon. Figure 17 shows how carbon steel corrosion rates can greatly vary depending on silicon content.

**Figure 17. Graph of sulfidation corrosion rates with respect to silicon content in carbon steel. This graph shows how corrosion rates increase in carbon steel containing decreasing percentages of silicon. This information can be found in Annex C of API RP 939-C.<sup>67</sup>**

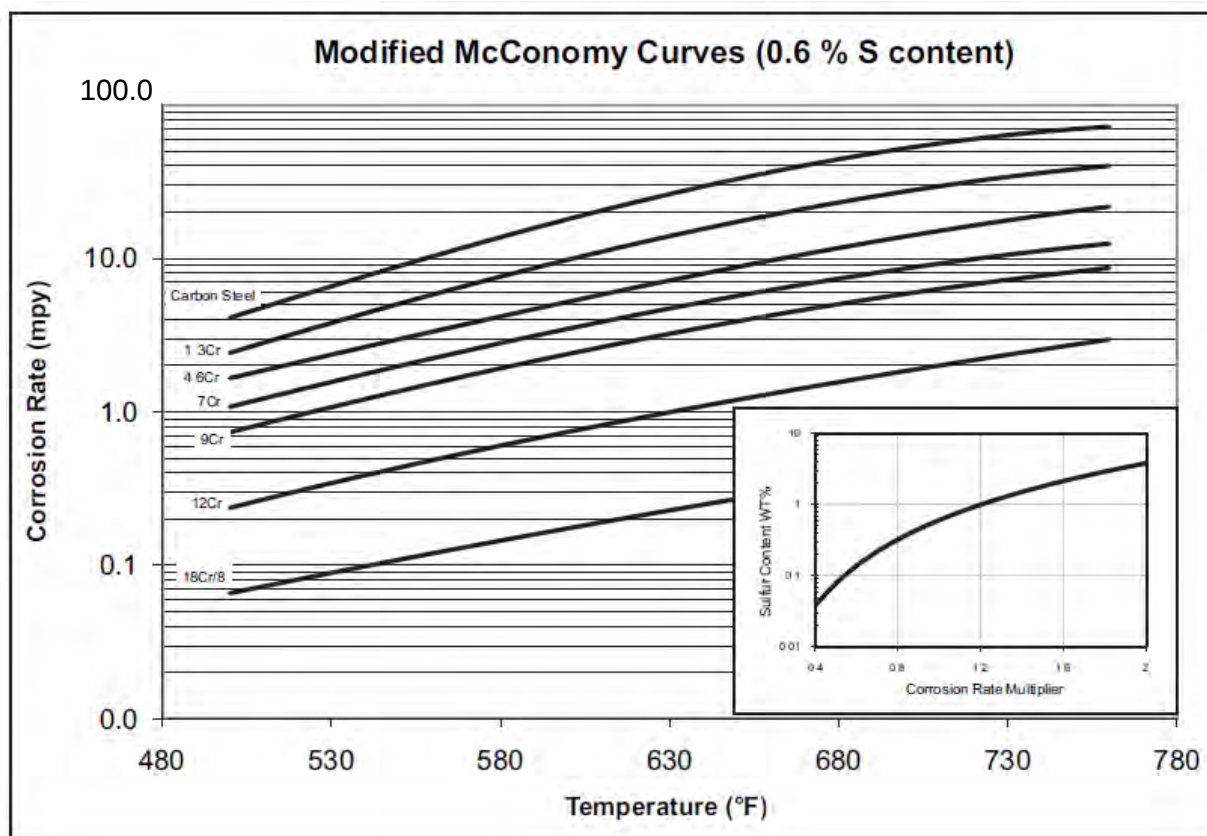
greatly reduced. Carbon steel<sup>99</sup> corrodes approximately nine times faster than 9-Chrome steel, which contains 9 percent chromium, and carbon steel corrodes approximately 120 times faster than stainless steel, which contains 18 percent chromium.<sup>100,101</sup>

Figure 22. Modified McConey Curves from API RP 939-C.

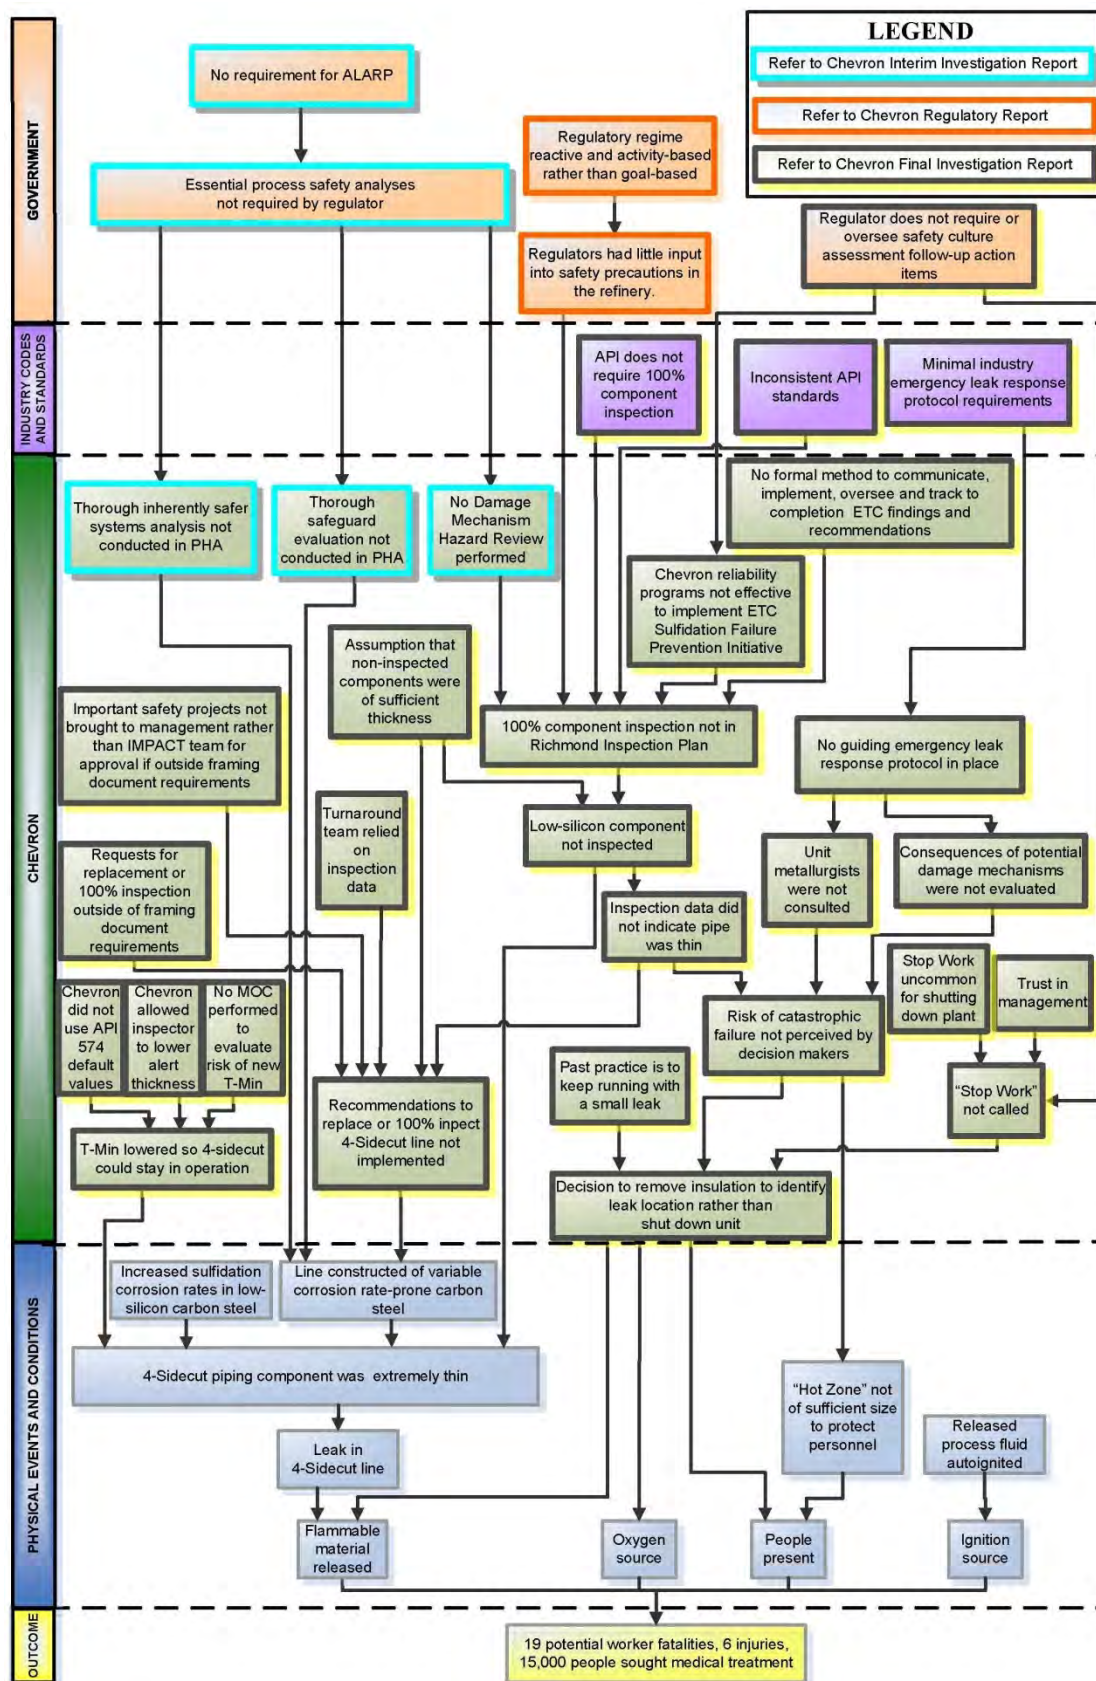
The CSB investigation team developed an accident map (AcciMap)<sup>114</sup> for the Chevron investigation (Figure 24). The AcciMap is a multilayered causal diagram that depicts immediate causes<sup>115</sup> as well as higher level contributing causes at the corporate, governmental, and regulatory levels. This diagram includes five levels:

Figure 24. Acci-Map of August 6, 2012, Chevron Refinery Fire.

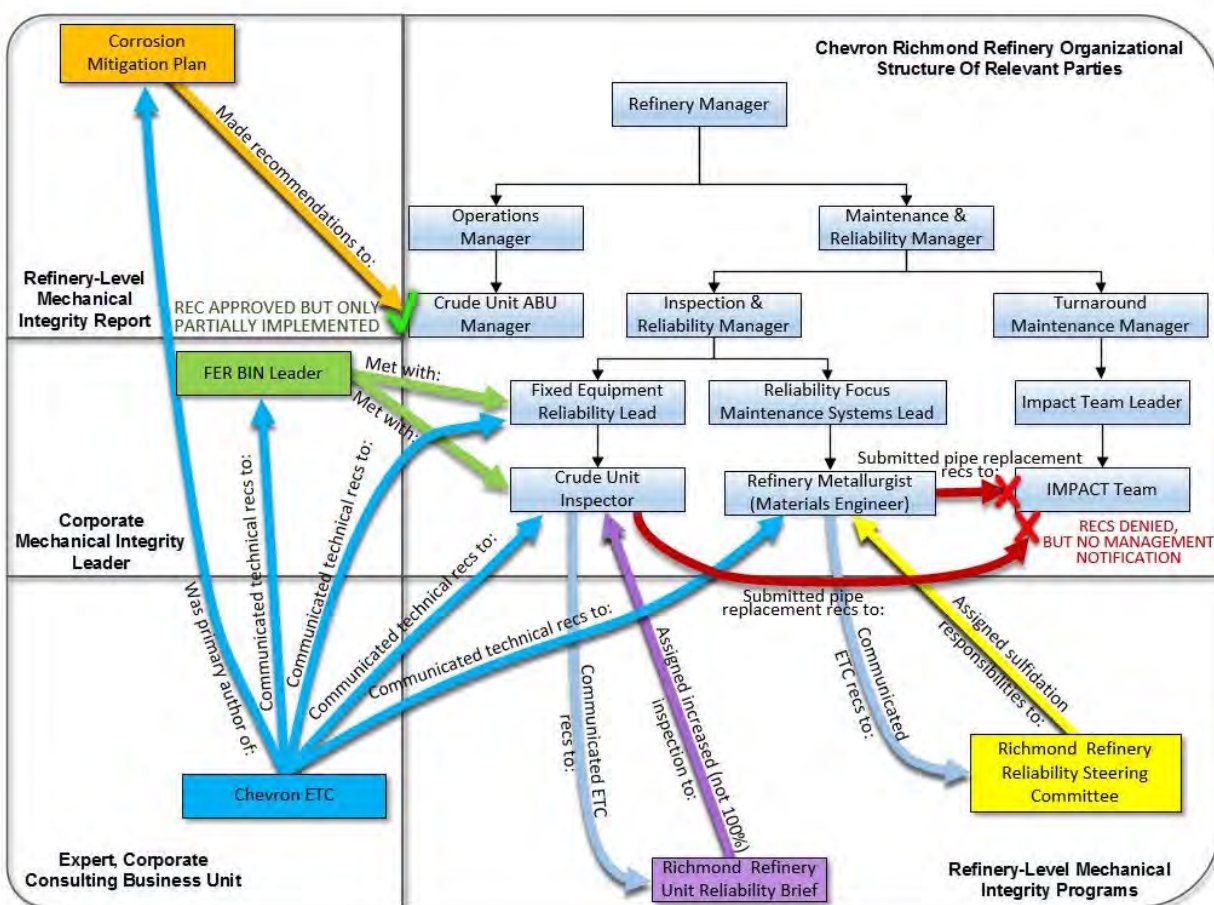
In the ten years prior to the incident, a small number of Chevron personnel with knowledge and understanding of sulfidation corrosion made recommendations to increase inspections or upgrade the material of construction in the 4-sidecut piping. Their recommendations were not effectively implemented. The process to implement important, safety-critical projects within the Chevron Richmond Refinery was not fully effective. As discussed in the following sections and depicted in Figure 25, a combination of (1) reliance on a turnaround management program that depended on only a fraction of necessary data to make important process safety decisions, (2) an unsuccessful bottom-up approach—with no management oversight or accountability—for implementing a crucial safety program, and (3) no formal method to track to completion the Chevron expert group's findings and recommendations ultimately caused these recommendations to not be implemented.

**Figure 25. Organizational decision-making schematic showing attempts to have carbon steel 4-sidecut piping 100 percent component inspected or replaced with a higher chromium steel alloy. Attempts failed due to lack of accountability and lack of authority to ensure recommendation implementation, and a rigid turnaround planning process that could not approve the 4-sidecut piping replacement recommendations.**

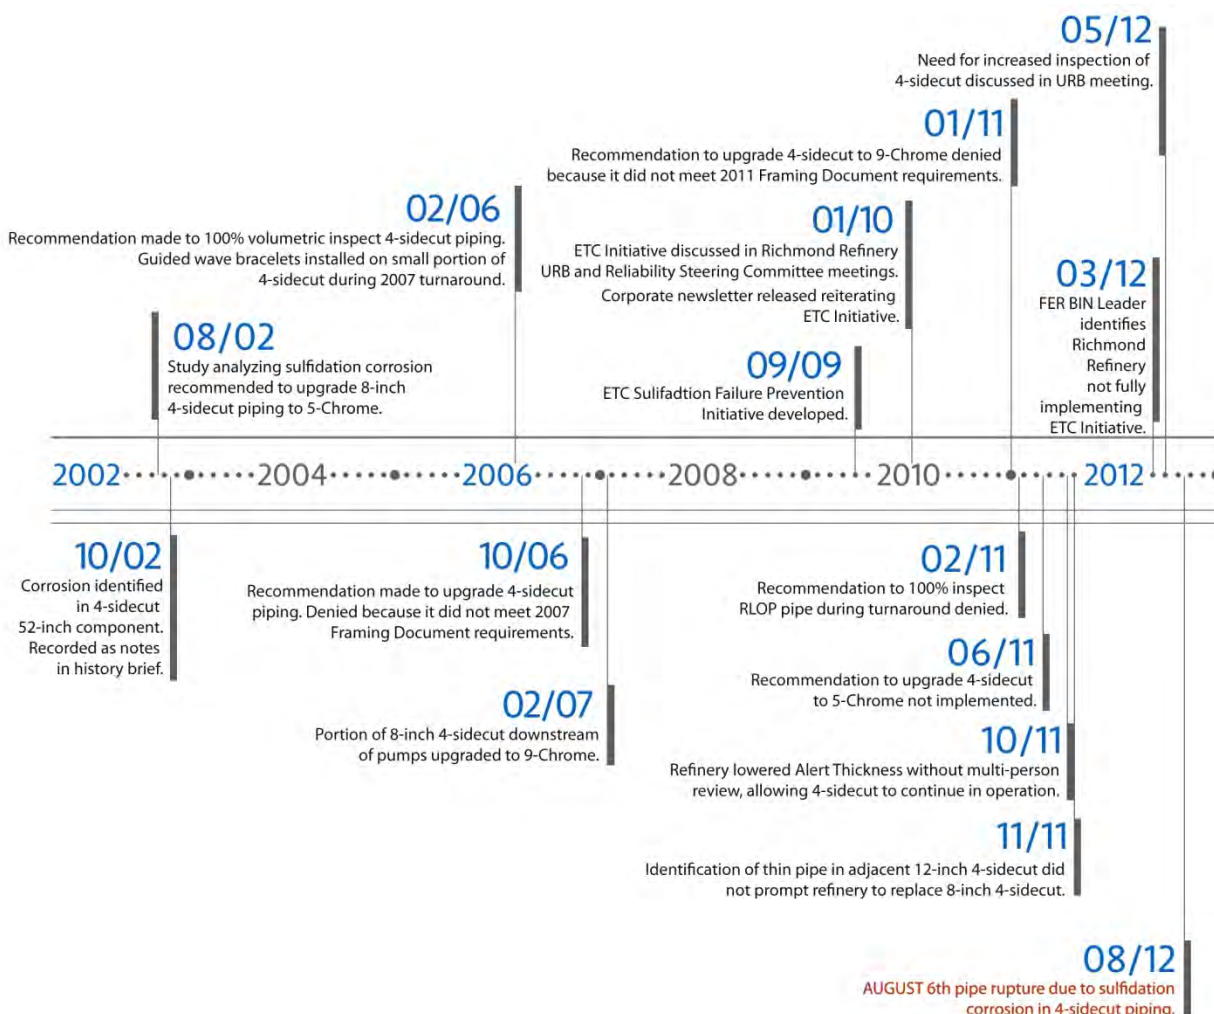
Figure 26 shows the sequence of sulfidation corrosion-related recommendations and events within Chevron Corporation and the Chevron Richmond Refinery between 2002 and the day of the incident. These events are discussed in subsequent sections of this report.

**Figure 26. Key events at the Richmond refinery between 2002 and 2012.**

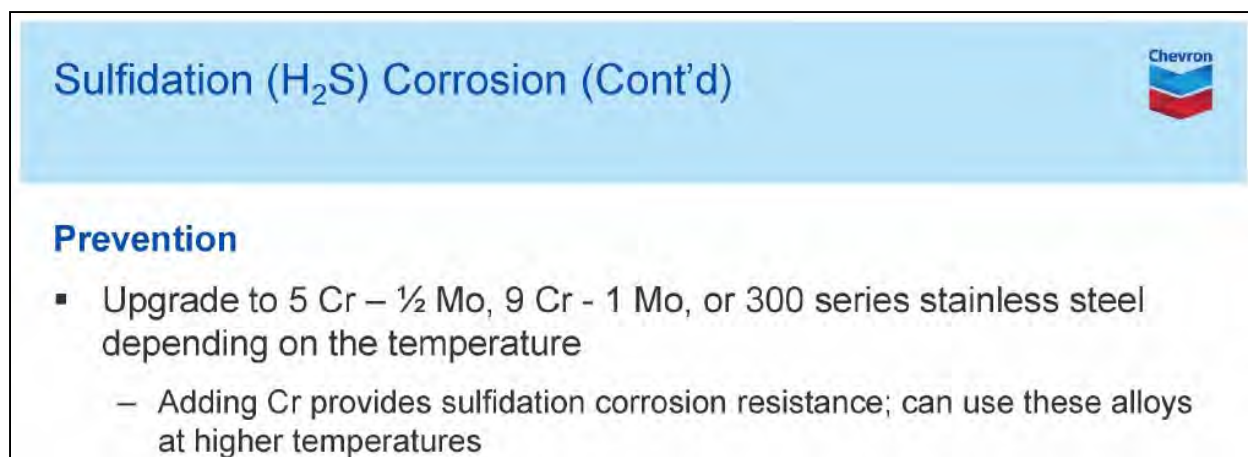
**Figure 30. Presentation slide of ETC training course that guided refinery staff on ways to reduce risk from sulfidation corrosion.**

<sup>118</sup> Shown in Figure 30, ETC's senior inspector and analysis training taught inspectors that sulfidation corrosion resistance could be improved by upgrading susceptible piping circuits to steels containing higher percentages of chromium.

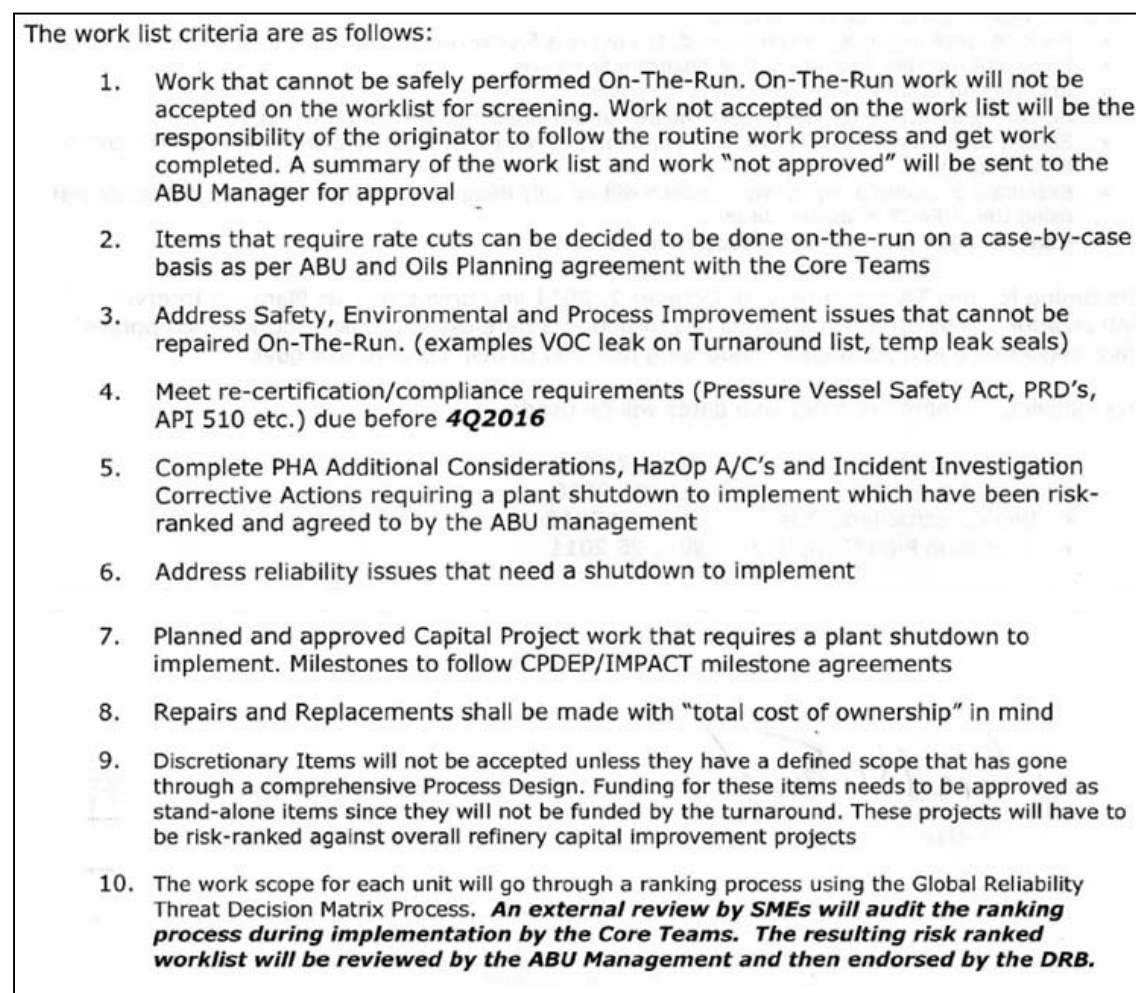
Figure 34. Work list criteria requirements specified in the Framing Document used during Chevron's 2011 Crude Unit turnaround.

A key change from the 2007 Framing Document directly affected whether work items such as 100 percent component inspection or replacement of the 4-sidecut could obtain Core Team approval. In 2007, the Core Team could approve a work item as meeting 2007 Framing Document criterion #10 for inspection, repair or replacement of equipment or piping if it was needed to ensure a minimum of 10 years (two turnaround cycles) before the next inspection or if maintenance was required. The guided wave inspection devices on the 4-sidecut met this criteria. In 2011, this Framing Document criterion was deleted. The Core Team in 2011 should refuse any work item for inspection, repair, or replacement of equipment or piping unless it required a rate cut or shutdown within only 5 years, before the next turnaround (items #2 and #6).

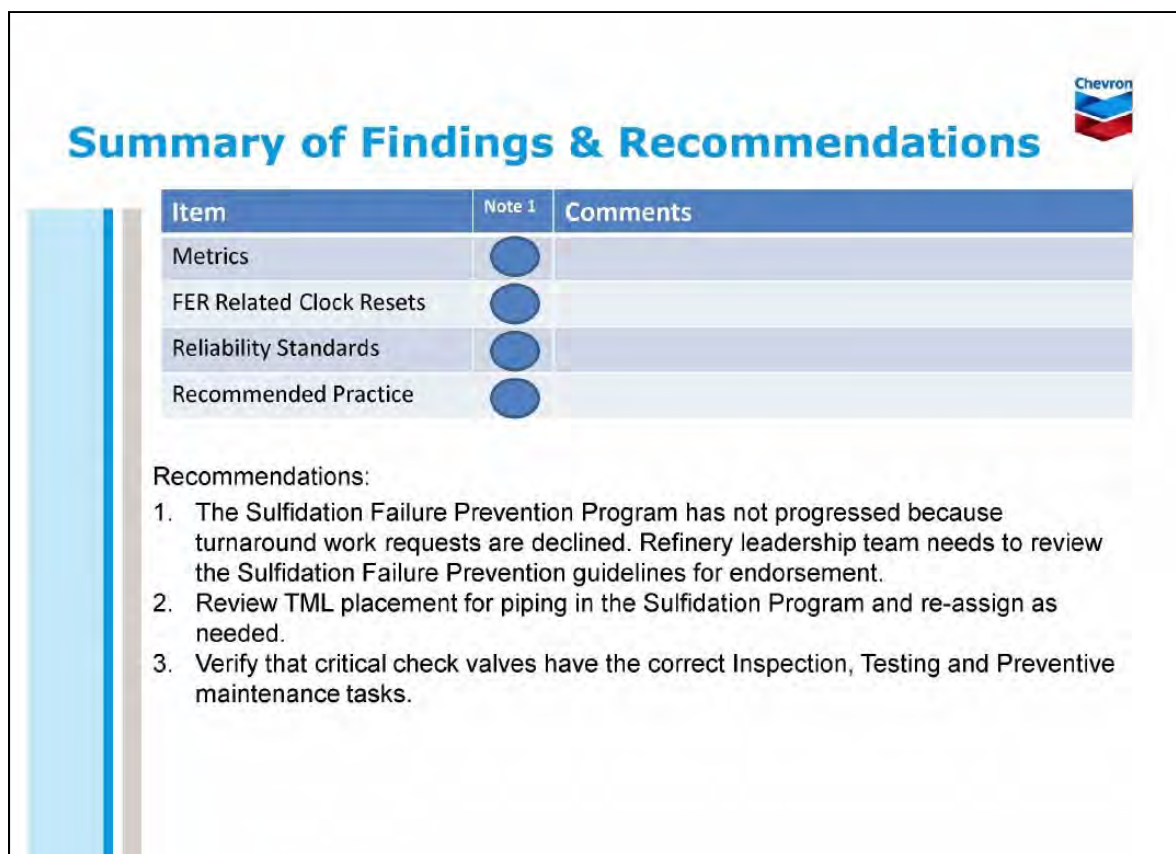
In March 2012, five months prior to the incident, the FER BIN Leader visited the Chevron Richmond refinery and identified that inspection of all carbon steel components susceptible to sulfidation corrosion was not being performed as recommended by the ETC Sulfidation Failure Prevention Initiative (Figure 35). In addition to identifying that CML placement for piping may need to be reassigned, this review found that the IMPACT team was denying critical inspection recommendations during the turnaround planning process. The FER BIN Leader identified that Richmond refinery leadership needed to review and implement the 2009 Chevron ETC Sulfidation Failure Prevention Initiative report and recommendations.

**Figure 35. Presentation slide showing corporate reliability leader’s findings that the Richmond Refinery was not complying with the ETC Sulfidation Failure Prevention Initiative.**

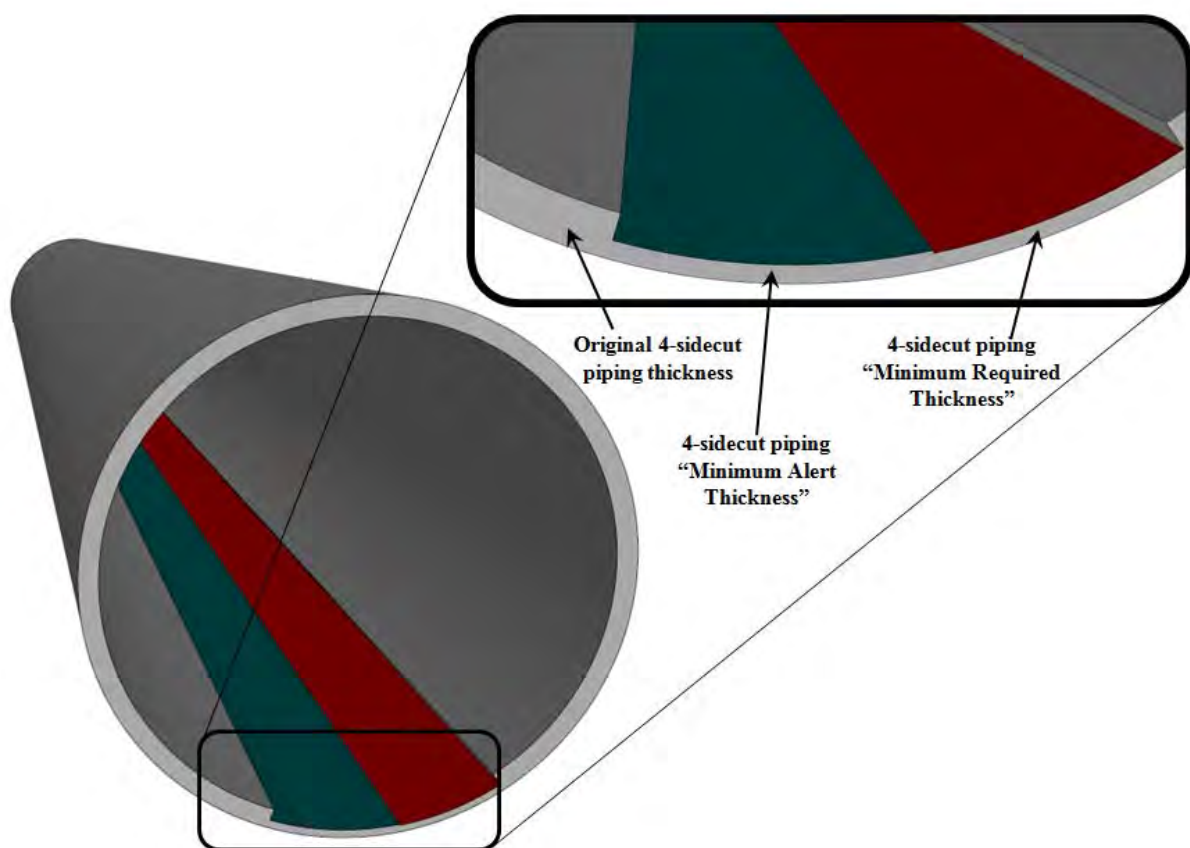
A visual depiction of the 4-sidecut original wall thickness, its Minimum Alert Thickness, and its Minimum Required Thickness appears in Figure 36.

**Figure 36. To-scale schematic of 4-sidecut piping original wall thickness (0.322-inch), Minimum Alert Thickness (0.13-inch), and Minimal Required Thickness (0.11-inch) using API RP 574 default values.**

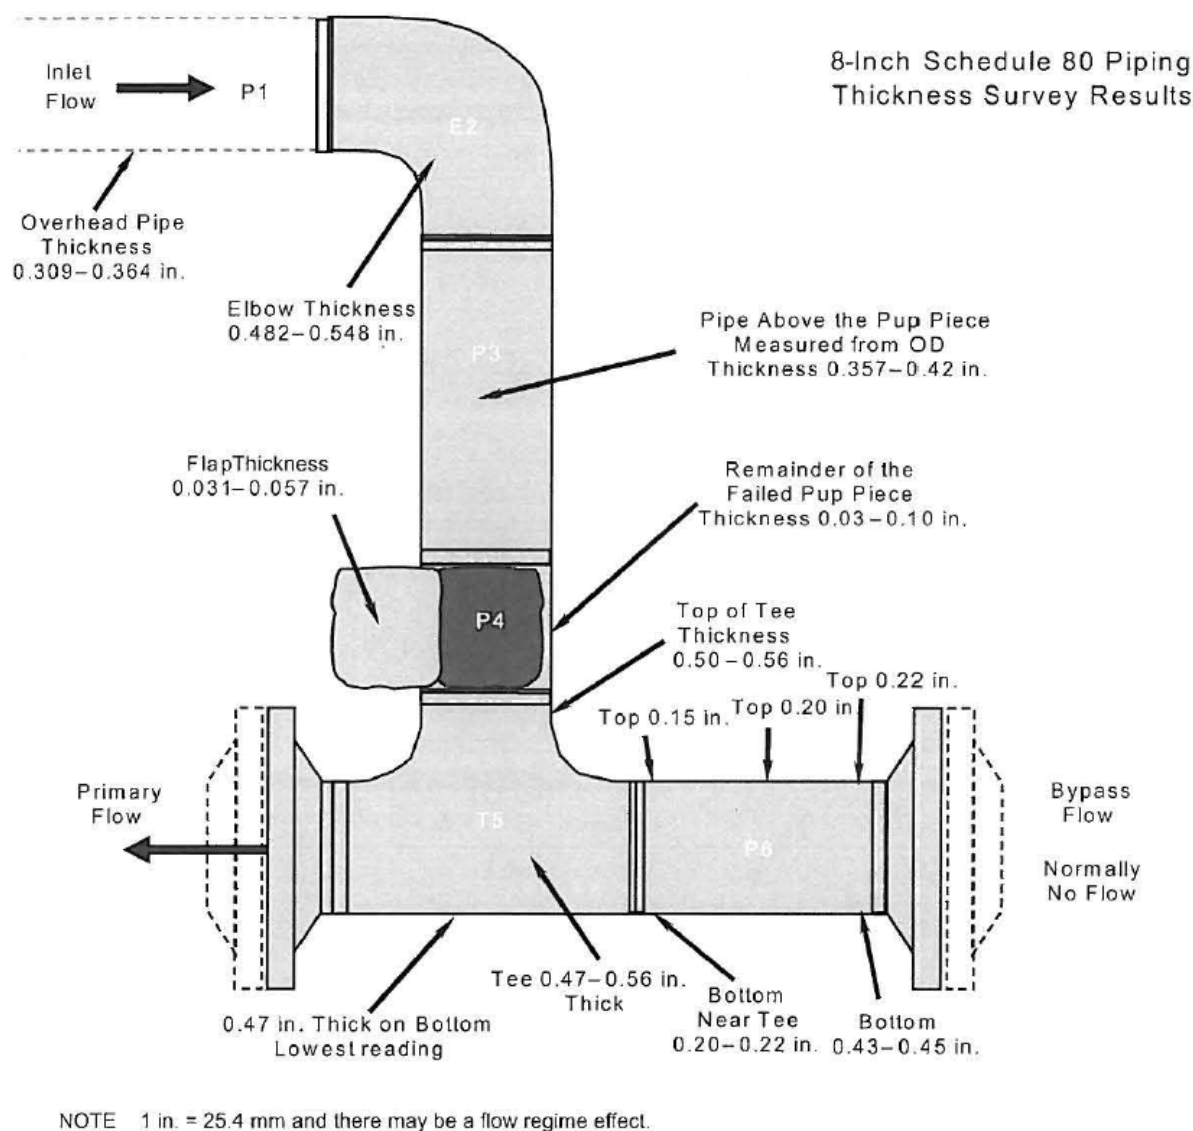
**Figure 38. Photo from API RP 939-C of a low-silicon pup piece that ruptured at a BP refinery. The surrounding piping had higher silicon content, and the pup piece’s accelerated corrosion rate was unmonitored.**

**Figure 39. Schematic from API RP 939-C of the piping shown in Figure 38. The piping component that ruptured was significantly thinner than the surrounding piping.**

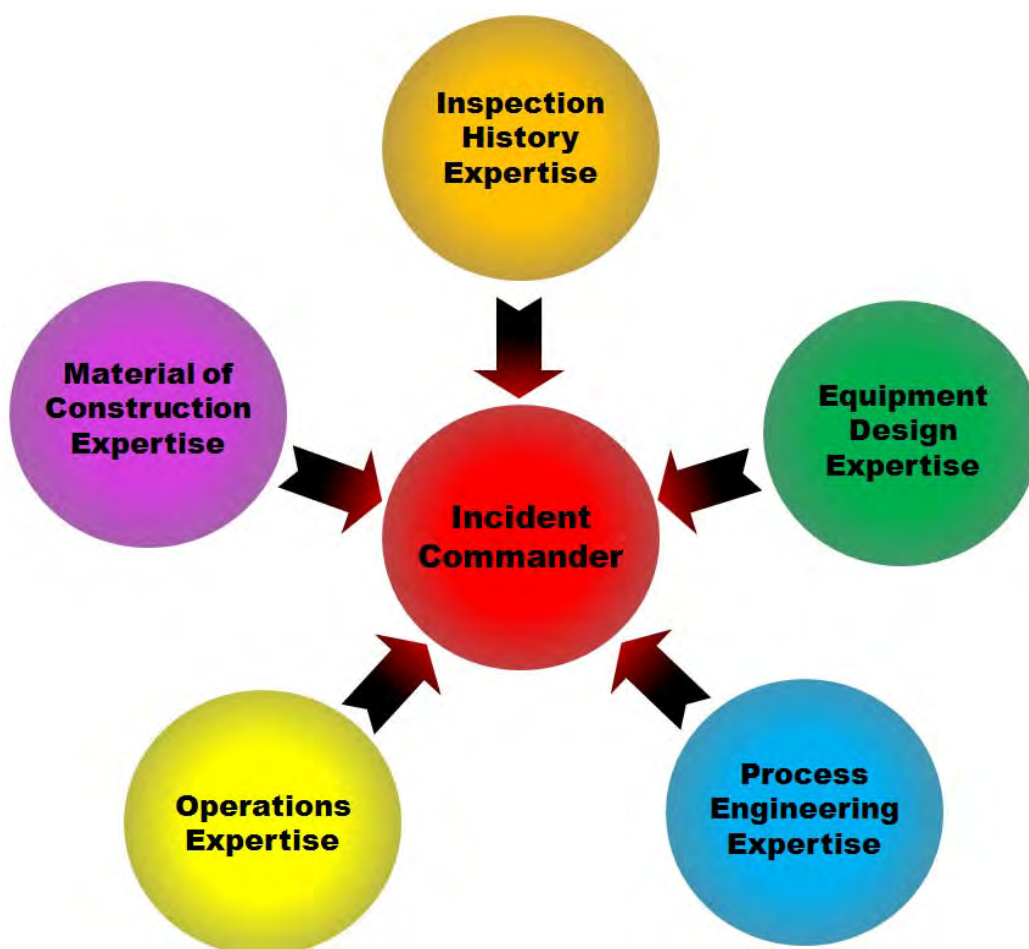
**Figure 42. Ideal communication flow to Incident Commander during refinery process fluid leak incident. In industrial process fluid leak emergency situations, it is essential that various personnel with different areas of expertise communicate their relevant knowledge to the Incident Commander.**
