Subj: Petition to Amend Title 8, CCR 3212 (f)

This request is being submitted in order to clarify the verbiage in said section 3212 (f). It appears to be vague and ambiguous as it relates to compliance or implementation.

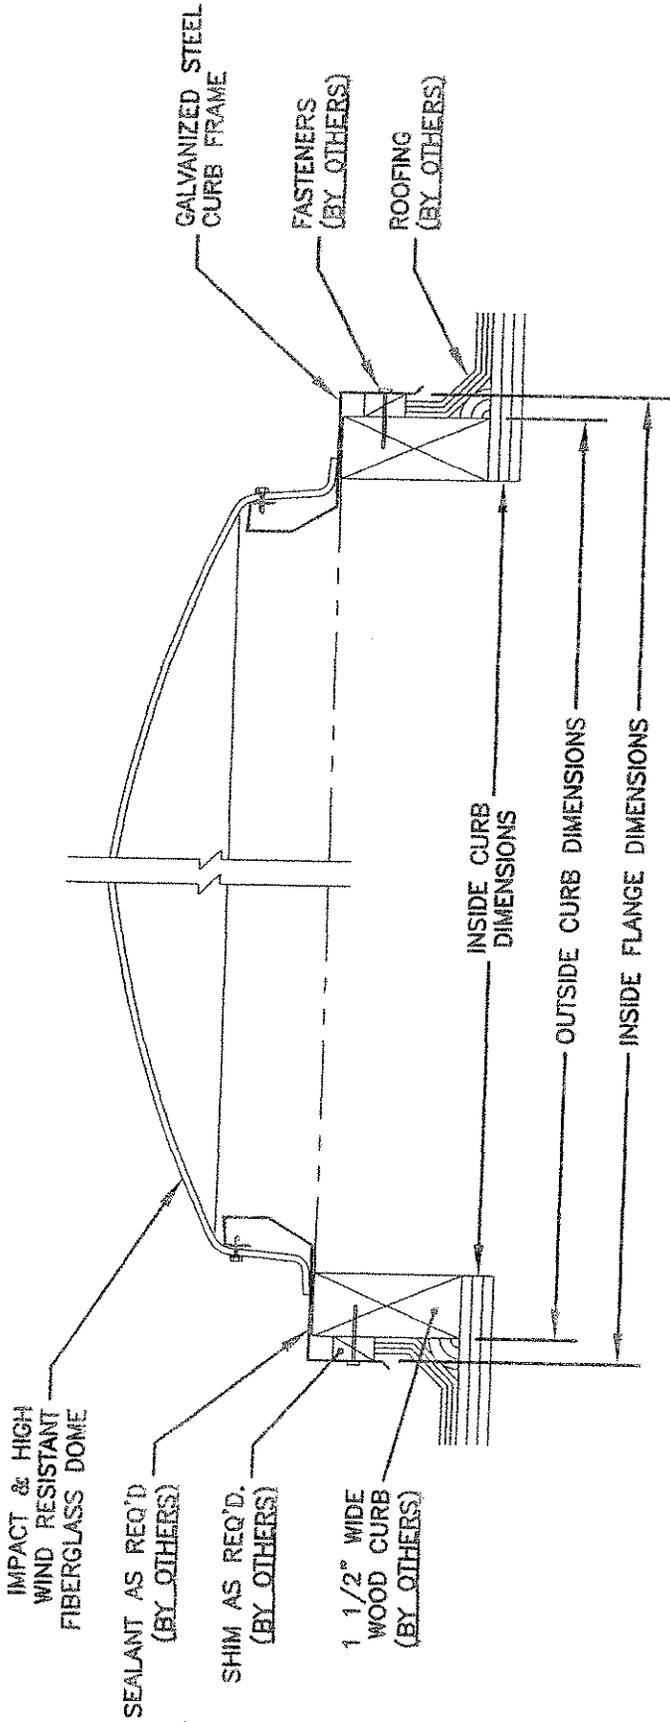
**APPENDIX A**  
**(Drawing -1 Page)**

## CURB MOUNTED SKYLIGHT

MODEL : H4896-SS-CM-1-FTH-IR-HW-MF  
 N.T.S.

SS - GALVANIZED STEEL FRAME  
 CM - CURB MOUNTED  
 1 - SINGLE GLAZED

FTH - FIBERGLASS TRANSLUCENT HIGH MF - MILL FINISH  
 IR - IMPACT RESISTANT  
 HW - HIGH WIND

MODEL NUMBER	INSIDE CURB DIMENSIONS	QTY
H4896-SS-CM	RECTANGULAR 48" x 96"

DOMESTIC MATERIAL TESTED IN CONFORMANCE WITH:  
 \*OSHA FALL PROTECTION - MEETS OSHA STANDARD 29 CFR 1926.502  
 HIGH WIND RESISTANT - DOME OF THIS UNIT HAS EXCEEDED 90MPH UP-LIFT IN TESTING  
 BURN RATE - CLASSIFIED AS CC1 MATERIAL

\*FALL PROTECTION TESTING HAS BEEN PERFORMED ON BRISTOLITE'S 48" x 96" DOMES

Load (lbs)	Pass / Fail	Comments
400	Pass	Held for 1 minute.
480	Pass	Dome pushed below 2 x 6 frame
500	Pass	Fibreglass broke away from steel side rails
1235	Fail	Fibreglass broke away from steel side and end rails and collapsed
