Recent Incidents

Eastern Municipal Water District Incident

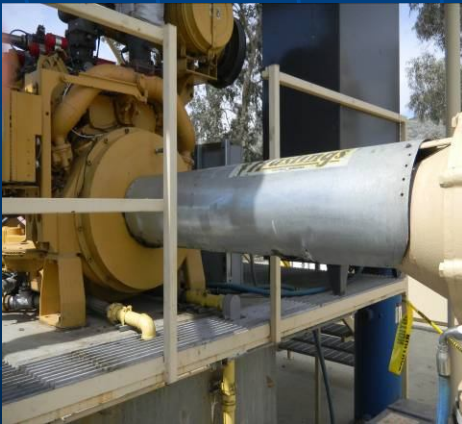
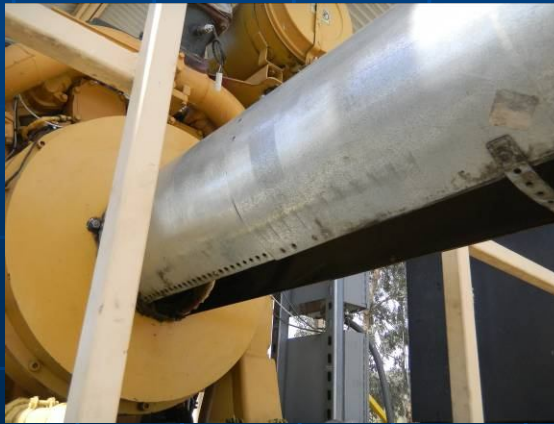
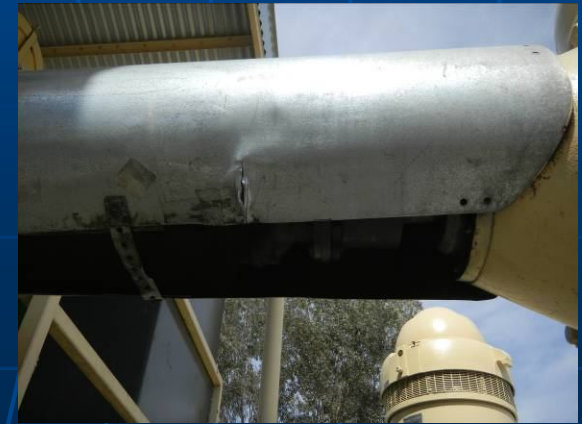
Eastern Municipal Water District Incident

- **Root Cause of Drive Shaft Injury**
 - Improperly Guarded Drive Shafts on Engine Driven Equipment
 - Utilize Pre-Use Analysis to better identify hazards during design phase
 - Just because the manufacturer says it is okay doesn't mean it is – Manufacturer stated that equipment meets all OSHA requirements

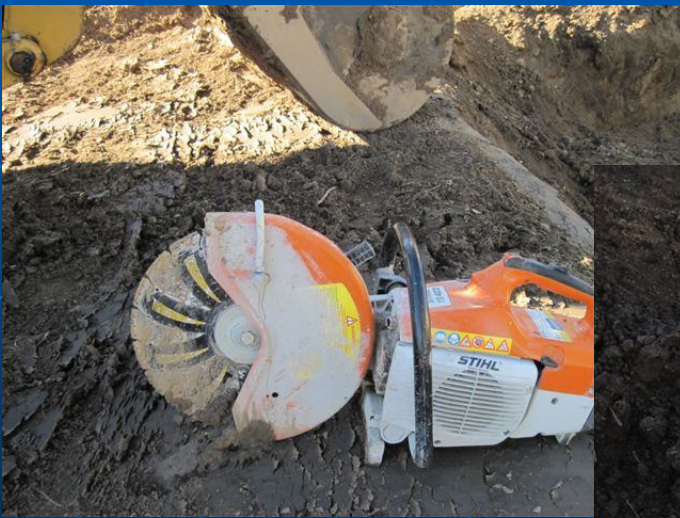
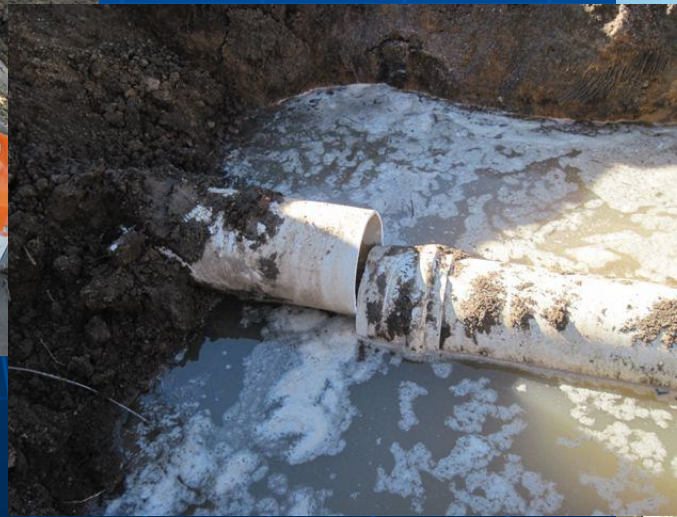
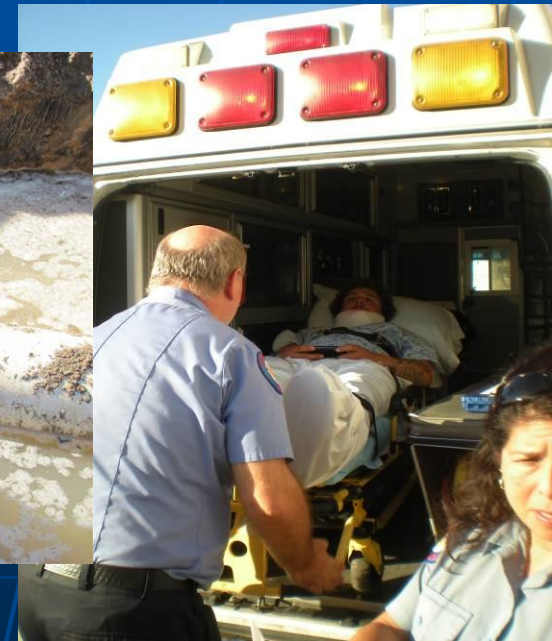
Eastern Municipal Water District Incident

- ***Root Cause of Cut Off Saw Incident***
 - Insufficient Horizontal Supporting of Pipe
